CYLINDER BLOCKS

R-R Silver Dawn, Silver Wraith, Bentley MKVI, R type and S1 cars

N. W. Geeson

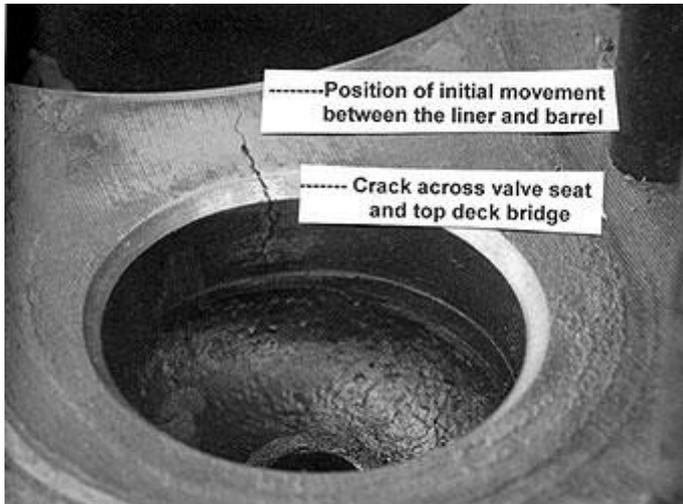
FIG3. R type cylinder block, showing cracked valve seat and top bridge.

Fig 3 shows the result of very hard driving on a 4.5 Litre; the crack rising in the valve port core has crossed the seat area and continued across the top deck bridge piece. Very often smaller cracks appear which are more over to the left or right hand side than that shown in Fig 3. All these cracks have one thing in common; they commence in the exhaust

port under the seat and continue in the direction of the cylinder. Very rarely will a crack appear in the seat area on the opposite side to the cylinder bore. The company initially installed exhaust valve seats, on production engines, to combat this defect.

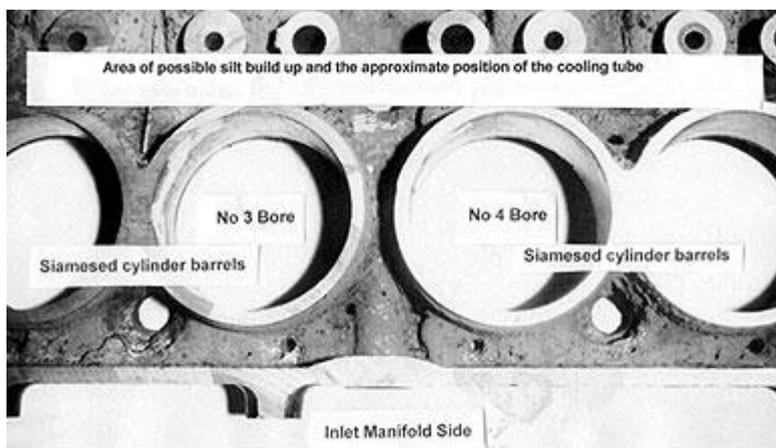
Fig 4 shows the underside of the top deck, or cylinder block ceiling, when the crankcase top has been sawn off. The smaller holes along the top are the valve guide and inlet push rod locations. The area where dangerous silt build up can take place, between the parent barrels and exhaust valve ports, is clearly shown. In practice it is difficult to clean this area, especially when the silt has compacted and hardened because access is very limited. Comparisons between fig 3 and this photograph will show that the cracked top deck bridge area runs directly above the cooling tube. One of the most important functions of the cooling tube is to sufficiently scour the areas around and between the exhaust ports, to prevent or displace any steam pockets forming. Later S1 crankcases had bulged exhaust ports to increase the area available to the coolant.

FIG4. Cylinder block top deck cut through on a 4.5 ltr R type.

The siamesed barrels and the difficulty of providing even cooling of the cylinder barrel areas can also be seen in this view.

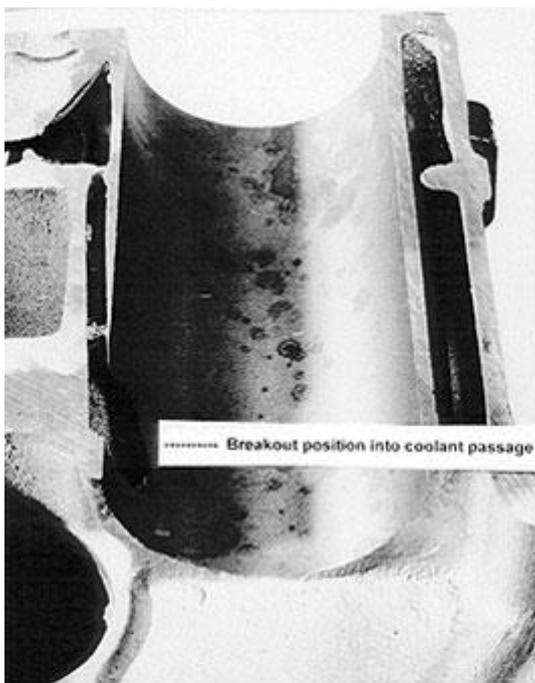
Fig 5 shows a particularly bad example of core slippage causing a thin barrel wall. Accurate positioning of the sand cores is obviously vital to produce a uniform cast iron wall thickness and the necessary dimensions; any collapse of the cores, or slippage from their original positions, will result in an imperfect casting. This example is one of the 4.9 Litre early UE450 crankcases produced by the Leyland Farington foundry. Later UE 2018 crankcases had bulged exhaust ports and were produced by Beans Industries as well as Leyland.

Anyone who has been unfortunate enough to bore through a barrel of one of these six cylinder blocks will no doubt have placed the cause down to corrosion of the barrel. In practice, however, they will have encountered an original foundry fault, which was not only confined to Rolls-Royce crankcases of the period, but a scourge of many manufacturers, only accelerated by corrosion.

FIG5. Section through a 4.9 ltr cylinder barrel, showing break through of the bore.

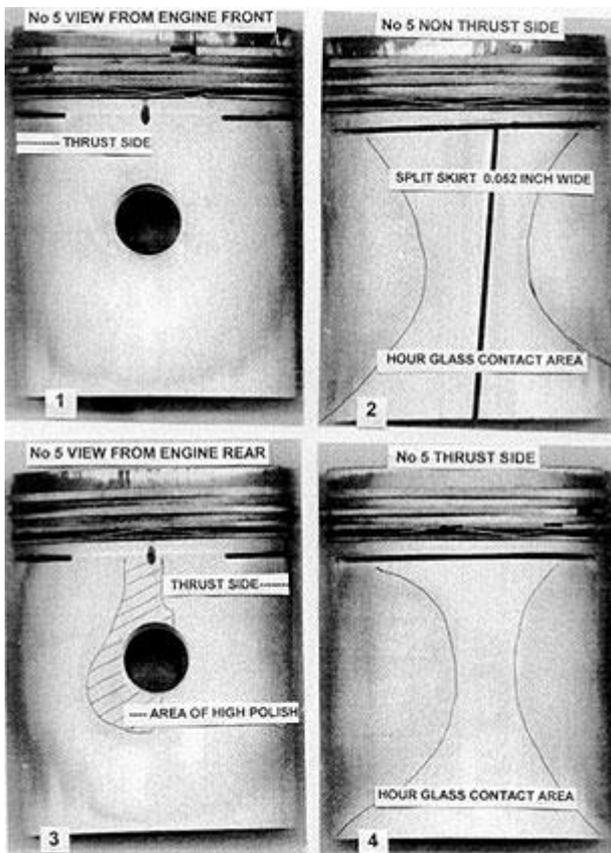
FIG6. View no 1 to 4 of No 5 Piston from chassis B87 UL.

Unfortunately reflections in each view give the illusion that all the piston rings are carbonised. In fact this is not the case and all the rings are bright, so this point should be ignored. Views 1 to 4 show that number 5 piston is in good condition, except for the area marked on view 3, which is in fact a highly polished local area that corresponds with the siamesed block tying the barrels of 5 and 6 together in the cylinder block casting. The picture showing these siamesed links was formerly shown in fig 1. The split skirt slot is full width right up the length of the skirt and the normal hour glass shape contact area of the thrust and none thrust sides are normal. The highly polished area in view 3 does however show that this piston was starting to be pushed by the liner because of the siamesed jointing to cylinder 6.

Comparing view 3 on piston no 5 and view 5 on piston no 6, shows the piston damage that occurred in the liner area adjacent to the joint between the cylinders. These two piston positions were opposing each other.

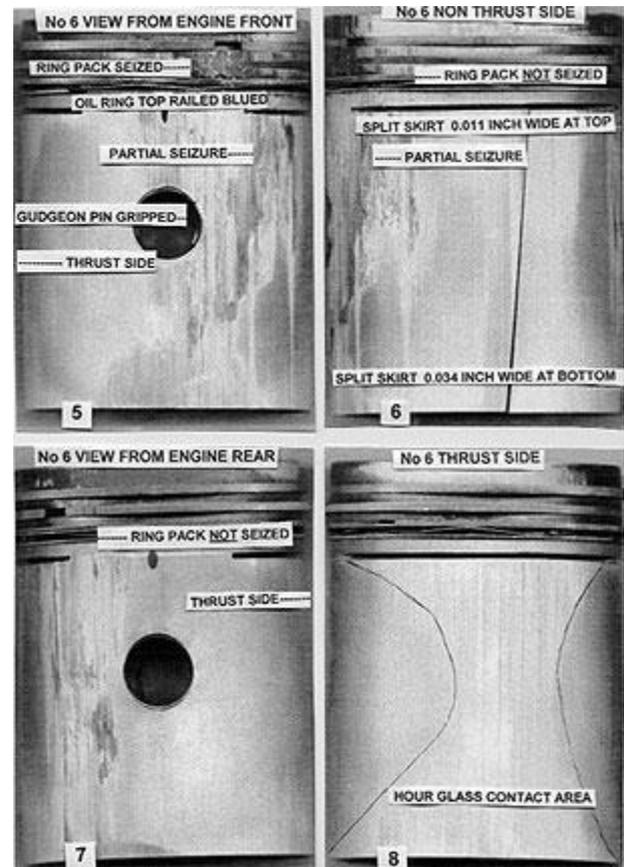
FIG7. View no 5 to 8 of No 6 Piston from chassis B87 UL.

Taking piston no 6, view 5 and view 7 are the most interesting. Reference to view 5 shows most damage has been caused by the front part of the bore, adjacent to the adjoining no 5 bore and the damage has extended right up to the ring pack. In fact the top ring is entirely free, but the oil ring rail is actually blue from heat, exactly on the line of the gudgeon pin. The lower two rings are entirely seized by distortion of the piston ring lands and the gudgeon pin itself was seized in the piston at this position. On the side opposing the exhaust valve and cylinder bridge, in view 7, piston damage is confined to the area below the ring pack and the gudgeon pin bore is entirely free and not distorted.

Before I purchased the car, the engine had suffered from an alloy gudgeon pin cap wearing away, most likely the result of an internal water leak, allowing the gudgeon pin to score the forward part of no 6 bore. The cylinders had been fitted with top cuff liners and these were over bored 0.035 inch to remove the scoring and genuine RE 15784 Wellworthy oversize pistons fitted. The original gudgeon pin end would have caused severe localised overheating down the forward end of no 6 bore at the junction with no 5 barrel. This would have distorted no 6 liner away from the parent barrel and even if the liner had returned to its position, a stress area and a localised pocket would have occurred, however small, between the barrel and liner. Over boring the liner only hastened the eventual failure. The push from the area between no 5 and no 6 bores would have forced the piston over to the other side of the bore where it also had the chance to pick up on the other bore high spot adjacent to the exhaust valve. Measurements of the bore showed the normal series of large waves running down the bore.

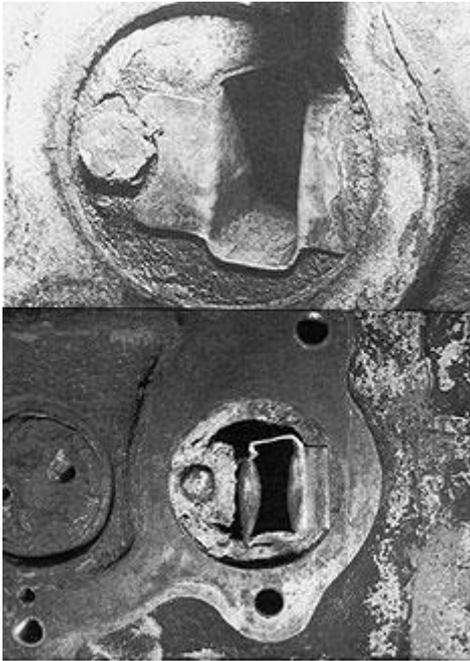
FIG 7E Photographs of corroded front end plates on the type C gallery

advised to make and fit a new front plate made from 0.125 thick brass plate and fit a brass retaining set screw, to eliminate any future corrosion.

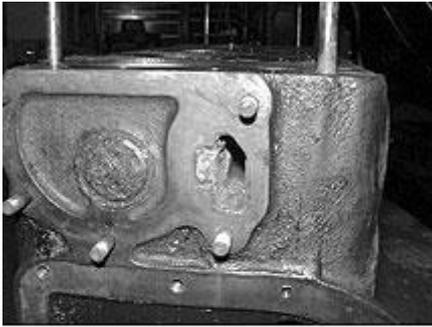
FIG 7F Photograph of RE 12893 Gallery fitted in RE9421 Block instead of Gallery EB4066.
