CRANKSHAFT DAMPERS, SPRING DRIVES AND CAMSHAFTS – PART 2

THE HISTORY FROM 1953 – 1958

N. W. Geeson

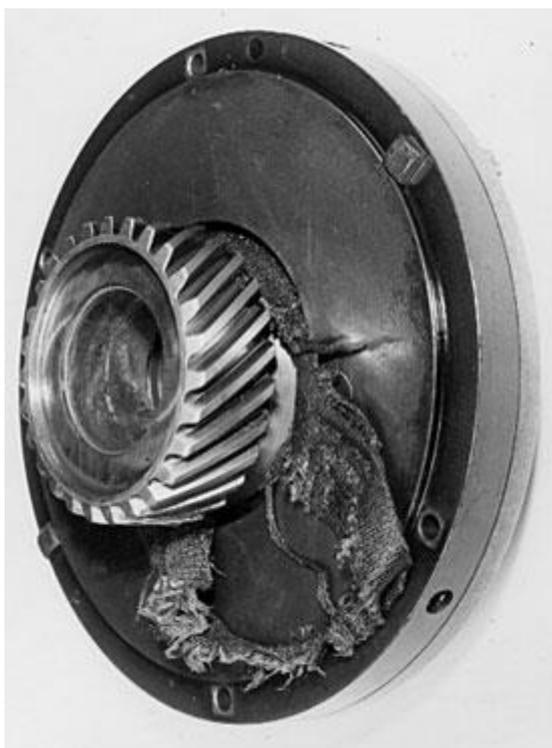
FIG 1 DAMPER TRAPPED COTTON DUCK WASHER

The engine was then stripped and the spring drive extracted with some difficulty and, although the slipping load of the damper was 14 – 16 lbs., one friction cotton duck washer was trapped between the friction drum and damper wheel. This trapped washer was fairly significant, as we shall see later during the study of the actual dampers. A typically trapped friction washer is shown in Fig 1 but it should be pointed out that this photograph is from test number EER 1143 dated 19th October 1955. The front taper on the crankshaft had picked up; the flywheel had fidgeted on the crankshaft rear abutment and no's 5, 6 and 7 main bearing caps had fretted. Trailing all this damage the crankshaft had cracked right around the forward end of no 6 crankpin.

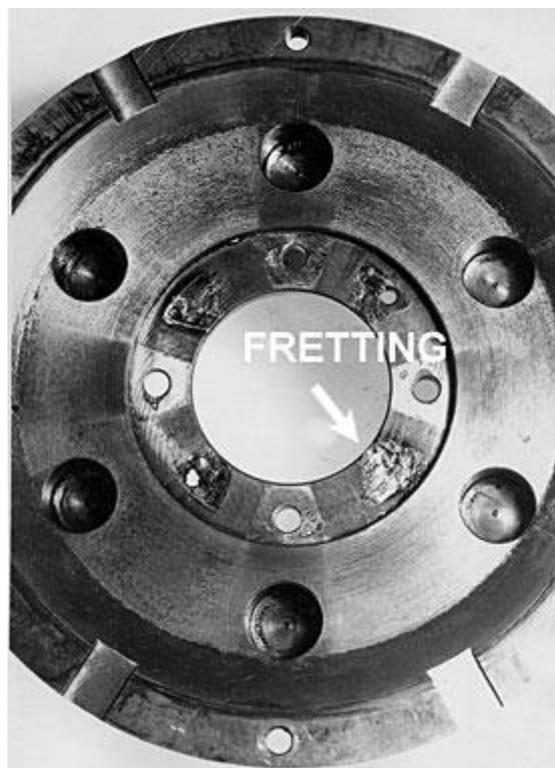
FIG 3 DAMPER SLOTTED TYPE FRONT DRUM

The term slotted was used to describe a damper shell or casing that had slots formed around its periphery so that sludge and oil could be expelled and centrifuged out of the damper. The slotted damper and the Ferodo VM41 material was later to be used in 1955, on the very last of the 4.5 litre engines and was also intended for the later 4.8 Litre engines. Reference to Fig 1 will show what looks like sludge drain holes drilled in the periphery of the rear damper drum. It is possible that this method was tried to test the theory. Fig 3 shows slots machined in a front drum, this one showing fretting evidence after a crankshaft breakage test.

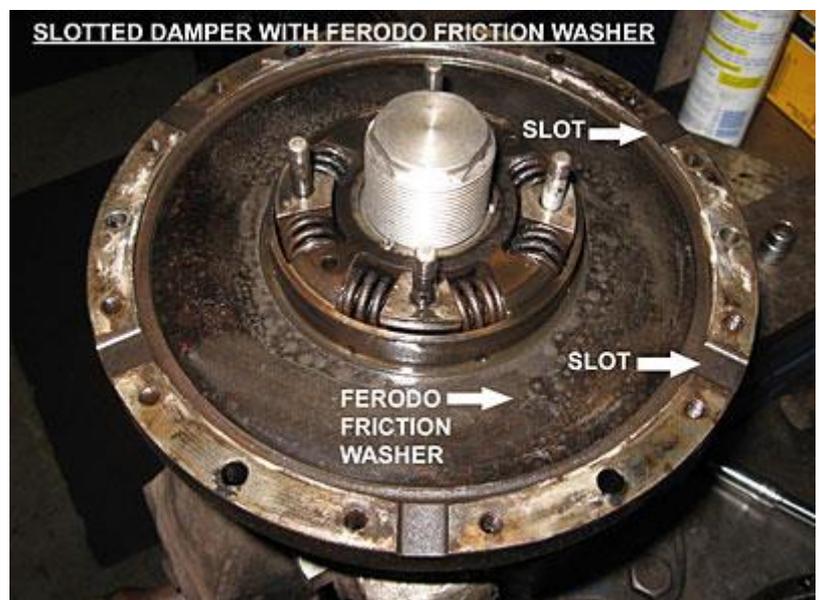
FIG 4 DAMPER FERODO FRICTION WASHER AND DRUM SLOTS

A slotted rear drum taken from a late Z series R type part no RE 21657 is shown in Fig 4 after considerable service and the damper parts were all still intact and working.
