THE ROLLS-ROYCE SILVER CLOUD II V8 ENGINE

By David Chaundy

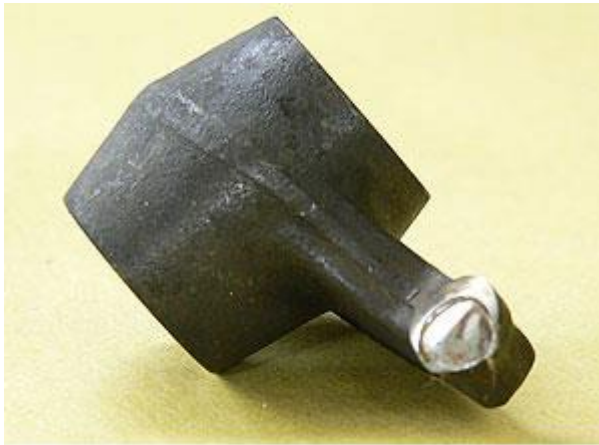
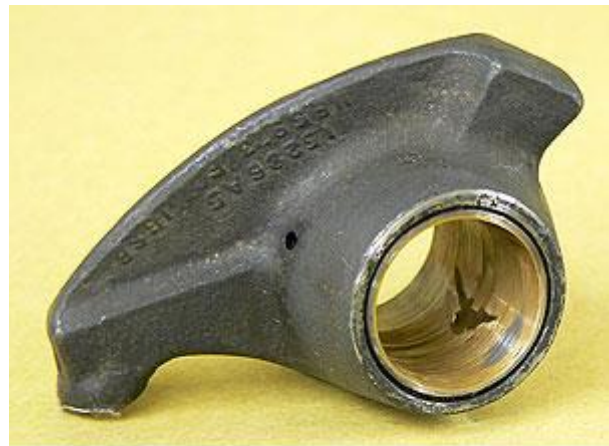
When I removed the rocker assemblies to my horror I found every rocker had excessively worn tips and bearings (see pictures 1 & 2). The rocker shafts themselves were deeply ridged (see picture 3). Both rocker assemblies were clearly scrap. Upon deeper investigation I found all the hydraulic tappets were showing holes in their hardening and some camshaft lobes looked sick too. Having removed the cylinder heads I discovered all the valves and guides were worn beyond use. It was clear the car had suffered at the hands of a gorilla, who had fitted some rather odd looking "O" rings to the valve stems, the purpose of which I am not quite sure about. If they were to prevent oil being drawn down the guides the gorilla need not have bothered, they were useless. Having seen the state of the upper engine I decided on taking the engine out for a complete re-build.

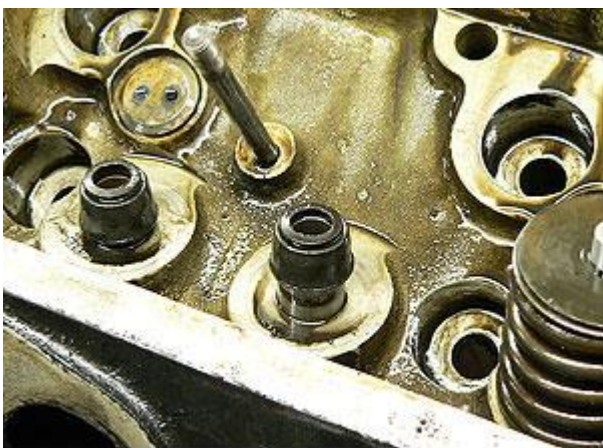
Picture 5

Firstly having removed the cylinder heads, the valves were extracted. It is possible to see the non-Rolls-Royce garter style seals in situ. (see picture 5)

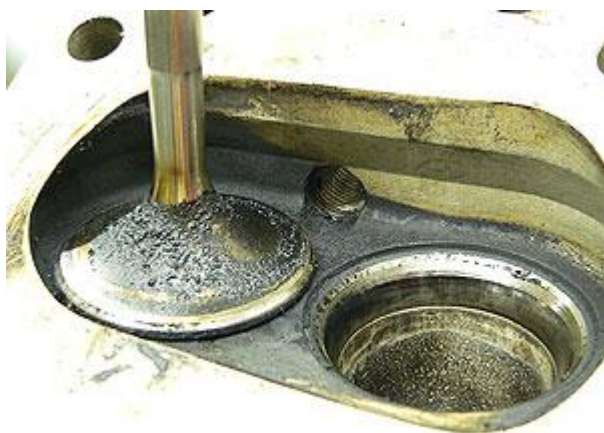
Picture 6

With the valves removed, it becomes obvious the non-Rolls-Royce garter seals had not been in the least effective. The inlet valves were all showing this sticky residue of carbonised oil on their back faces, this is a direct result of ineffective oil control. (see picture 6)

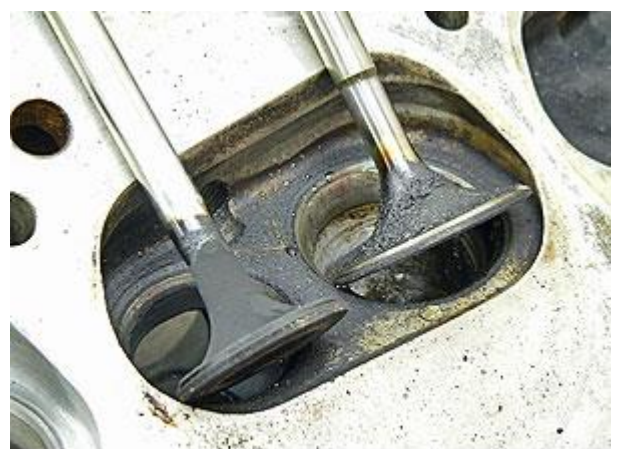
Picture 7

The exhaust valves similarly were excessively covered in carbon after only 2500 miles, a situation that was causing them to stick slightly. It is worth noting carbon deposits are able to climb further up the valve stem/guide if an engine is not fitted with valve stem oil seals. With such carbon build up combined with the

lack of Tetra Ethyl Lead in today,s fuel, the problem of sticking valves can occur. Both inlet and exhaust valves may be seen in (Picture 7) Lead additive certainly did more than just boost octane levels in 4 and 5 star fuel (which the Silver Cloud range were designed to run on). It provided a cushioning effect for the valve seats, which prolonged the life of the seats. In addition it acted as an upper cylinder lubricant, helping the smooth operation of the valves in their guides. It is worth considering adding an upper cylinder lubricant to modern fuels to lessen the risk of sticking valves when using unleaded fuels.

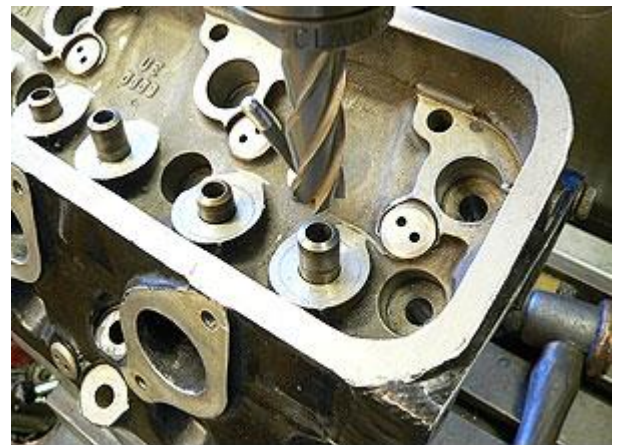
Picture 9

The protruding lengths of the valve guides can be seen here (see picture 9) Originally the inlet valve guides stood proud of the cylinder head. The exhaust guides were only slightly higher than those of the later specification at $\pi\%$ The correct protruding height of the modified valve guides should be 450% A height gauge was made to fit around the guides, this would turn when the cutter reached it making it easy to see when the correct height had been reached. Having set the machine with a pilot in each guide, the inlet guides were milled down to 450% gauge.

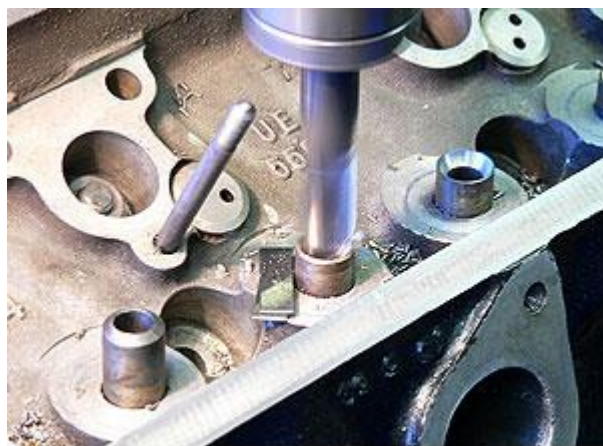
Picture 10

d the protrusion of the inlet guides, the cup face was added to both inlet and exhaust guides with milling cutter, ground to the correct profile (see picture 10)

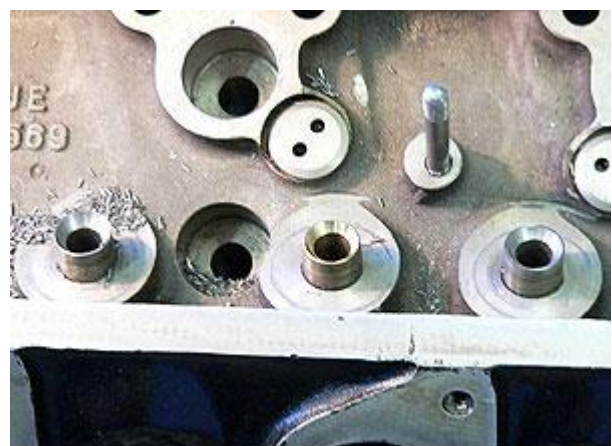
Picture 11

The shortened and modified valve guides can be seen here, with

swarf still around them. (see picture 11) After cleaning, all the internal bores of the guides were polished to reduce friction. Their internal dimensions were once again checked, and found to be text book perfect.

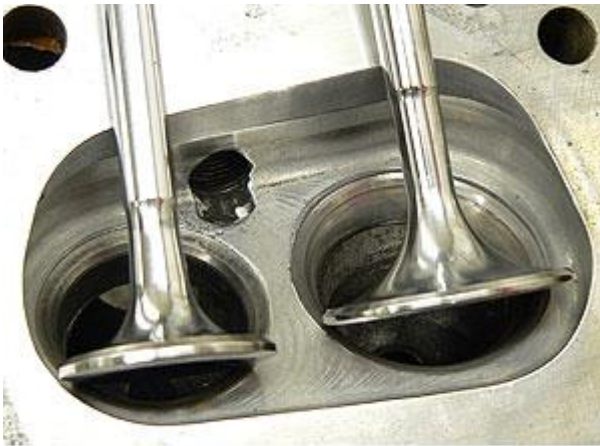
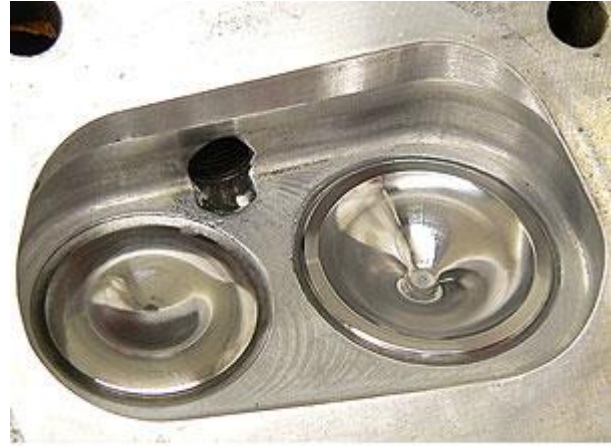
were polished all over. Both their stems and heads received attention. (see pictures 12 and 13). Polishing helps reduce friction and aid gas flow, at least for a while until carbon deposits build up and destroy the effect.

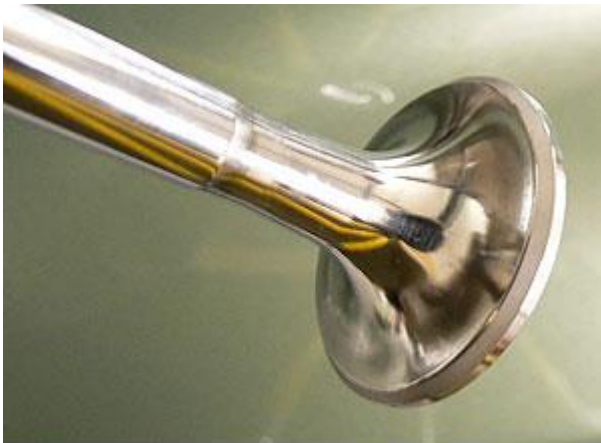
Picture 14

After polishing the valves were carefully lapped together with their mating seats in the cylinder head to ensure a gas tight seal. (Picture14) shows a fully polished and lapped exhaust valve. With the valves ready for assembly their stem diameters were measured to ensure that the correct running clearance was present in each case.

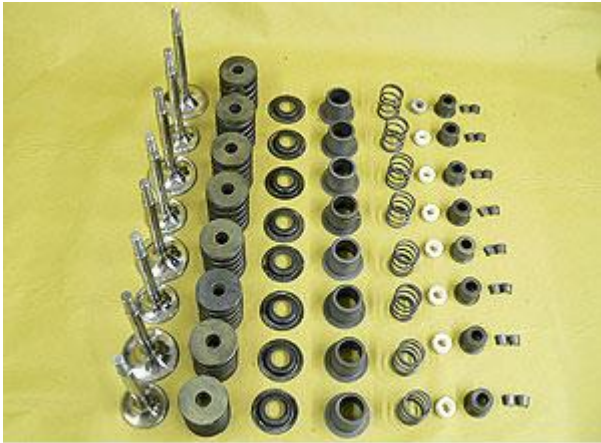
Picture 15

(Picture 15) shows the cylinder head components ready to be assembled. From left to right, the components are as follows; Inlet and Exhaust Valves, Valve springs including caps, Original Valve Springs Base Washers, Late Silver Cloud II valve spring base washers, the string and tallow seals, valve stem seal cups, and finally the valve retaining collets. I should point out at this point the original valve spring base washers are not used on modified cylinder heads.

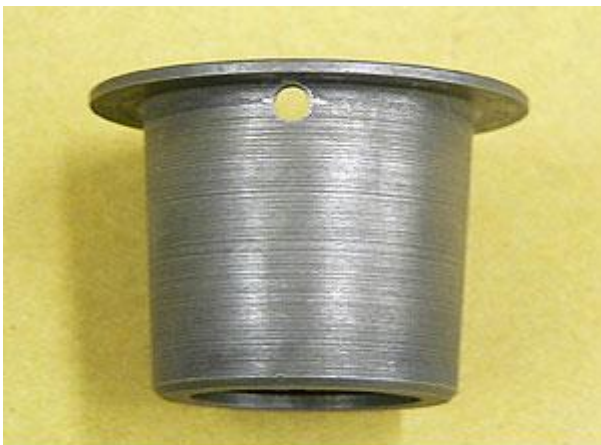
Picture 16

A further modification I felt desirable is the addition of an oil drain hole to the late type valve spring base washer (see picture16). I was unconvinced these top hat section items once filled with oil would have drained effectively left in their original state. I didn,t want to risk the possibility of a pool of oil surrounding the string seal. Therefore the drilling was added to ensure effective drainage. As I was using Silver Shadow rocker gear sufficient oil is certain find its way down the valve stem to ensure correct lubrication, especially as all my valve retaining collets have lost their seals.

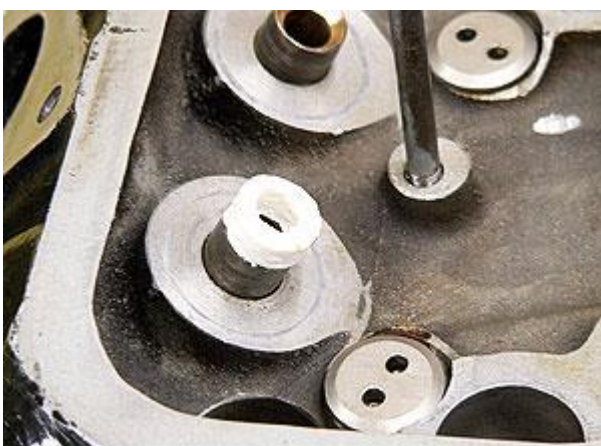
Picture 17

(Picture 17) shows the string seal in place on the valve guide cup face.

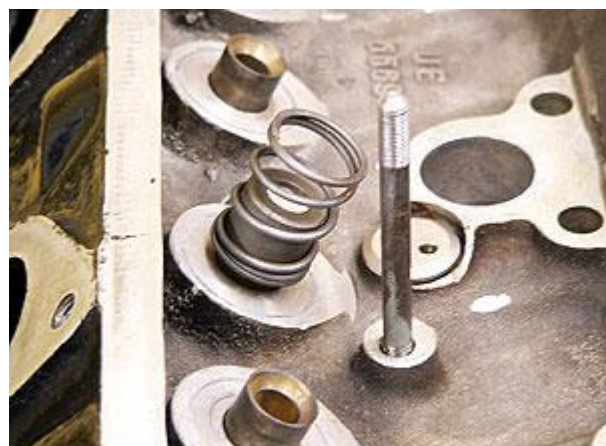
Picture 18

(Picture 18) shows the string seal in its retaining cup which is in turn fitted with its retaining spring.

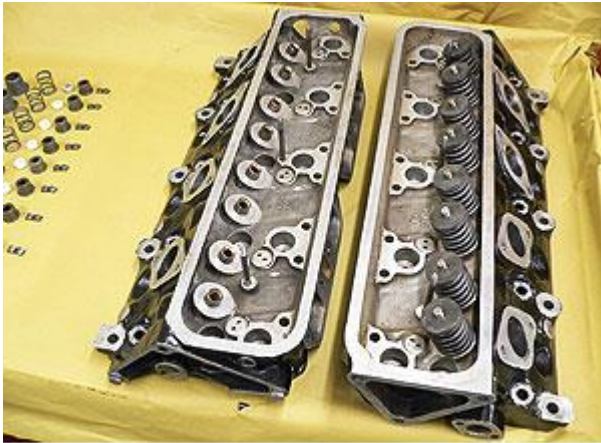
Picture 20

(Picture 20) shows the cylinder heads, one complete, the other awaiting assembly.
