# FRONT BRAKES (LATE TYPE) REBUILDING

R-R Silver Dawn, Silver Wraith, Bentley Mark VI, R type

N. W. Geeson

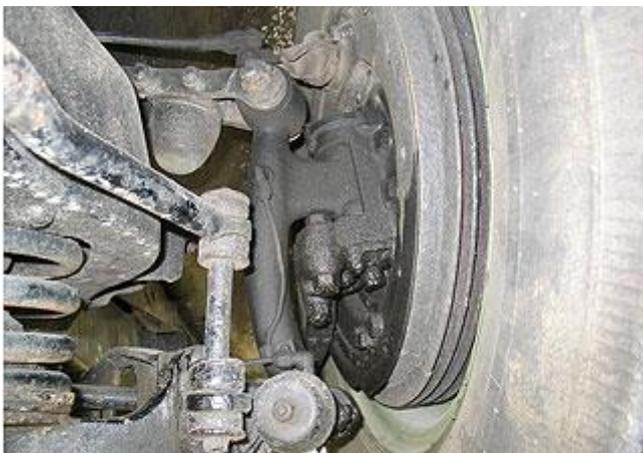
The early Bentley Mark VI hydraulic front brake was based on the mechanical wedge front brake arrangement that was used on the Bentley Mark V of 1939/40. Fig 1 shows the external linkage of a 1940 Bentley Mark V, note the mechanical link at the top of the king pin with another universal link under the

Fig 1. No, not a Bentley MKVI brake arrangement but a Bentley MkV of 1940

Comparison of Fig1 with Fig 8 shows how the changes affected the exterior of the brake from 1940 to 1950.

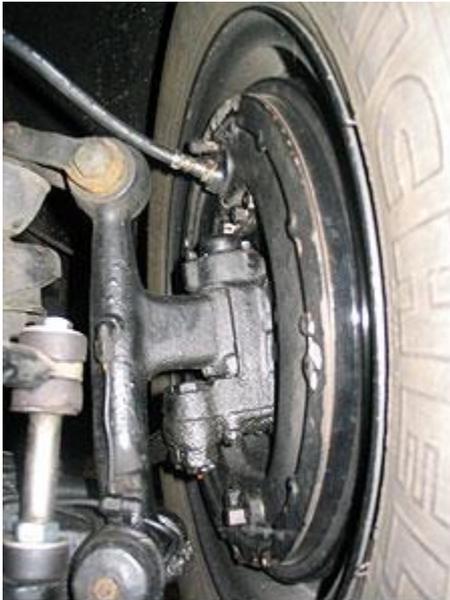
Fig 8. The back of road wheel view of the later brake, compare this with Fig 1

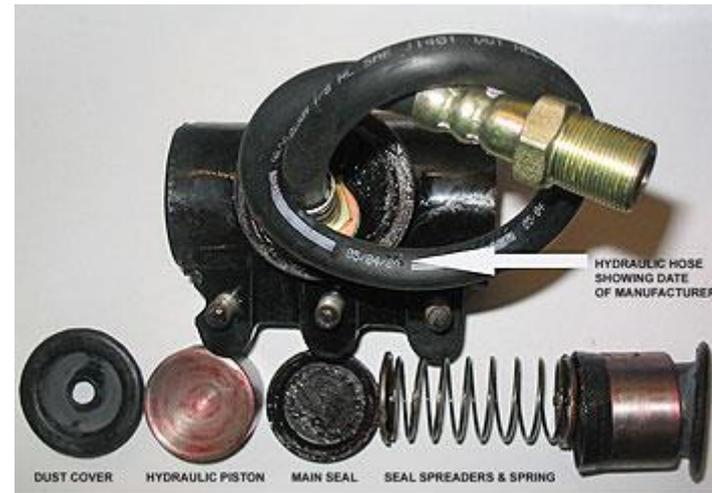
Fig 11 and Fig 12 show the hydraulic components of a cylinder; in this case both images show a left hand side cylinder, each side being handed. Fig 12 shows bronze inserts in this cylinder, these half inserts are fitted only half way down from each end of the cylinder so that any insert movement does not cut off the hydraulic fluid supply. Currently it is possible to source replacement cylinders of better

Fig 11. Hydraulic parts of one front brake cylinder, in which cleanliness is essential

quality material than the originals, so the viability of inserts might be questioned. The bronze inserts, or indeed stainless ones do prevent seizures especially if the cylinder is also fitted with stainless pistons as shown in these views. The red coloured material on the pistons and rubbers is special rubber grease.

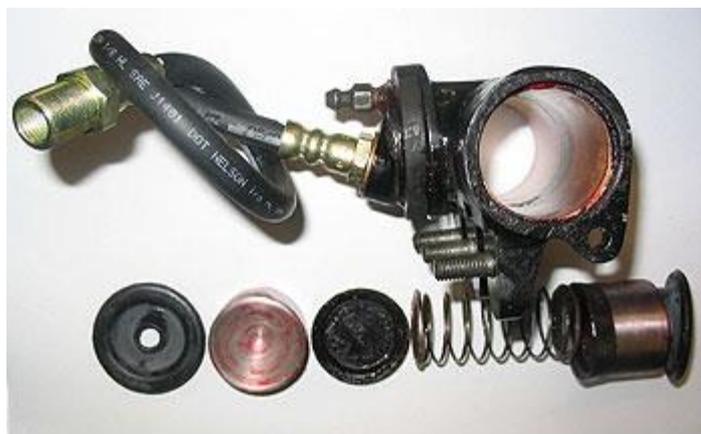
Fig 12. Hydraulic cylinder after having bronze inserts fitted and stainless steel pistons

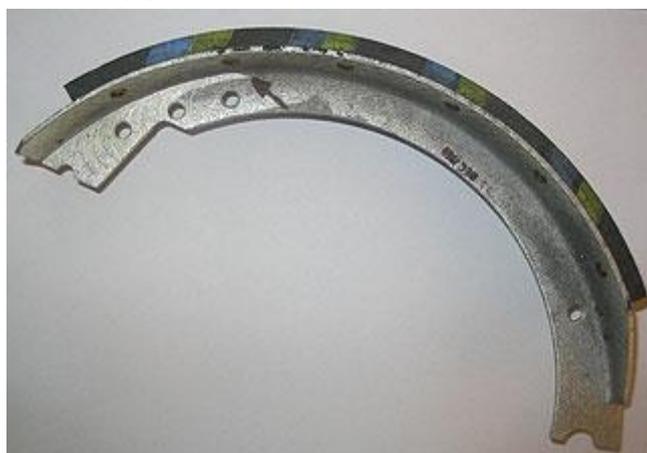
Fig 10 shows a new lined shoe of the latest type. Although it is not shown on this image, the leading lining edge that is at the left top should be ground down fully across the lining for approx. one inch from the edge. This provides a gently lead to the leading lining edge and can help prevent brake grabbing.

The actual lining thickness on both early and late type brake shoes, front or rear, is 0.322 inch + 0.015, most suppliers will provide 0.312 inch linings, which will suffice. The correct thickness is however listed for the record. Each lining covers 102 degrees of the drum surface at an inner lining radius of 5.800 inch and the width is 2.250 inch (+/- 0.015 inch). A number of different lining part numbers have been used, differing only in the material used, these part numbers include GB 3760, GB 4685, RG 3305 and RG 7146.

Fig 10. Late type front brake shoe, compare this with the earlier types in Fig 3

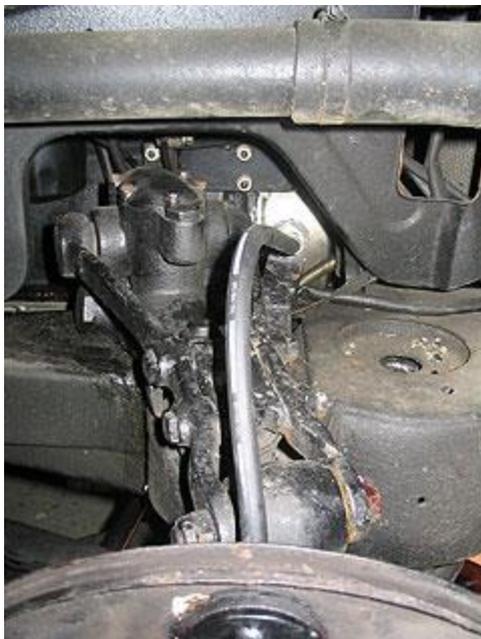
Fig 15 shows the white guideline along the front brake hose, so placed to ensure the hose is not twisted during the tightening process. Note that hoses are now marked with their date of manufacture.

Fig 15. Front brake hose alignment, notice the white dashed line exhibits no twisting

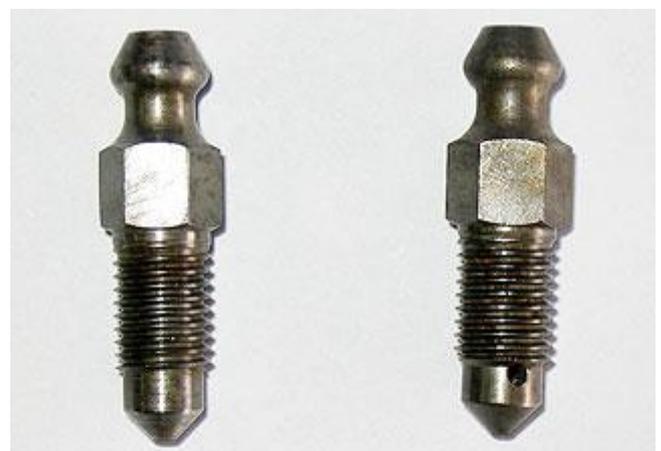
Fig 13 shows the special brake bleeder used on these late cylinders. This brake bleeder part no RG 5253 is 0.312 inch diameter and threaded 24 T.P.I to WHITWORTH form. This is not a normal TPI for 0.312 inch Whit, and the equivalent size in UNF will not do the job and is dangerous. Beware your local brake specialist is unlikely to stock this bleeder screw and because they are frequently seized it is advisable to purchase new genuine ones from a Crewe Parts source before undertaking the work.

Fig 13. Late type front brake bleeder with Whitworth form thread, these are none standard!

For the record the brake bleeder fitted to the earlier Bentley Mark VI, with the different brake cylinder, before June 1950, is a standard BSF thread and part no RG 7050.

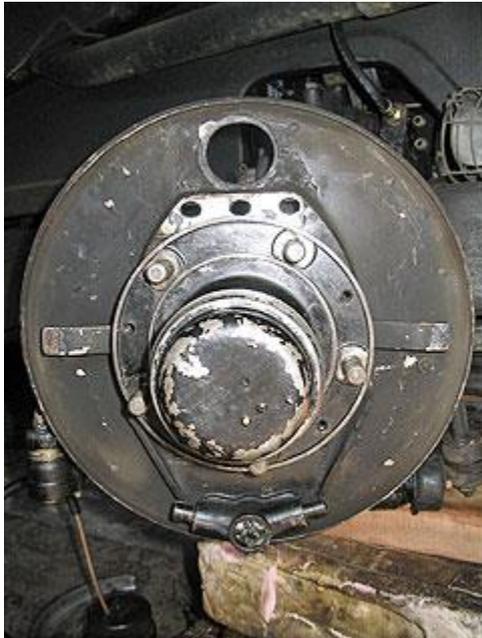
Fig 16 this is the start of the assembly and to aid recognition the sequence has been confined to describing the rebuild of the right hand brake. To assist  
Page | 7

At this point the adjuster is fitted loosely, not forgetting the rubber seal that fits between the back plate and adjuster.

Fig 16. Initial stage of rebuilding, the brake adjuster is fitted loose

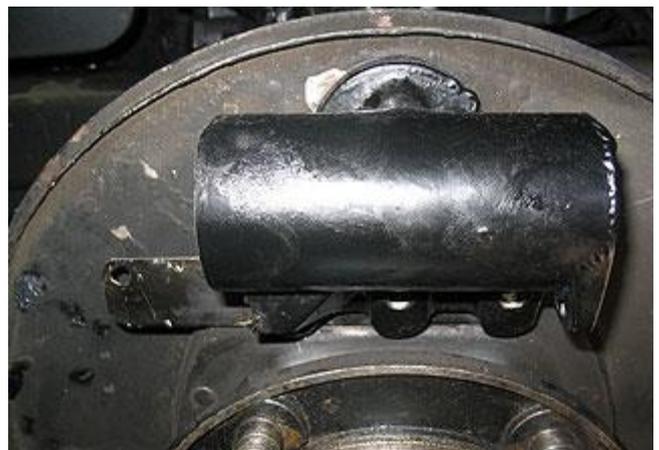
Fig 19. Close up view of the hydraulic cylinder, note the link anchorage hole

Fig 19 A close up view of the cylinder, note the position of the hole in the top left corner of the anchor plate. This hole will eventually accept the inner end of the “W” link, after it passes through the web of the trailing shoe.

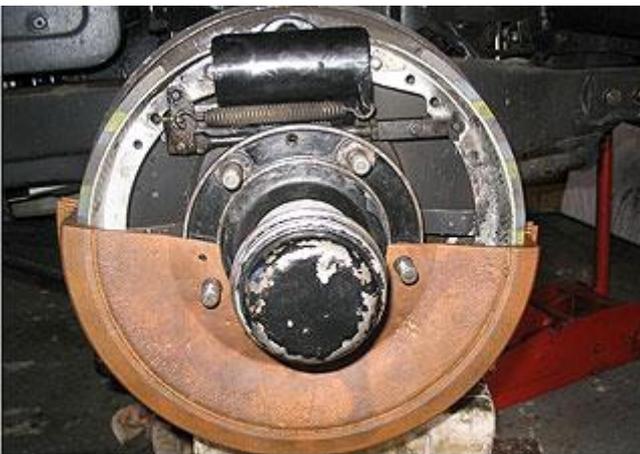
Fig 22. Viewing the results using a test drum if you are lucky enough to possess one!

Fig 22 this shows how useful an old front brake drum can be, and it is even more desirable when working on the rear brakes. This later type drum can be used on the very early Bentley Mark VI brake assemblies, but the earlier Mark VI drum will not fit the later front brake.

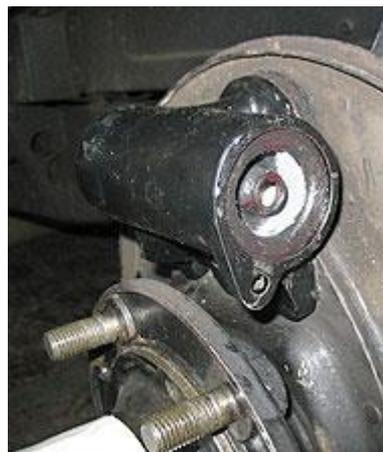
Fig 20. Close up view, showing p

Fig 20 this view shows how the rubber dust seal is trapped between the cylinder and the back plate. The cylinders are fitted with a dust / water seal at each end in the position illustrated at the end of this cylinder, the red appendage is rubber grease.

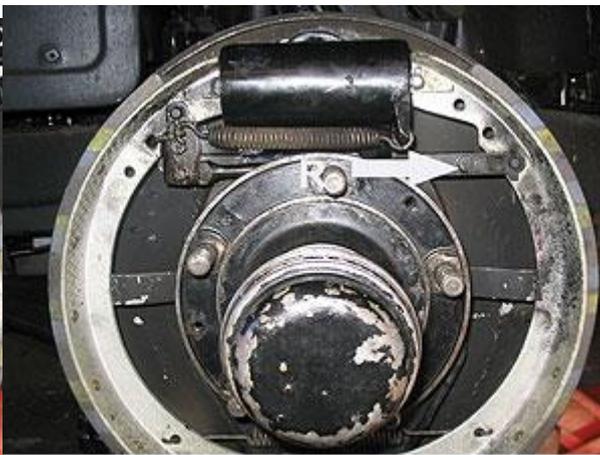
Fig 30. Fitting the locking screw when the intershoe linkage has been set

Once an equal drag or touching situation has been reached, fit the pin shown at point “P”, tighten up the rod lock nut and then fit and secure the pin lock plate as shown in “R” in Fig 30.

Fig 30 when all the brake setting is finished ensure this locking pin is tight and secure.

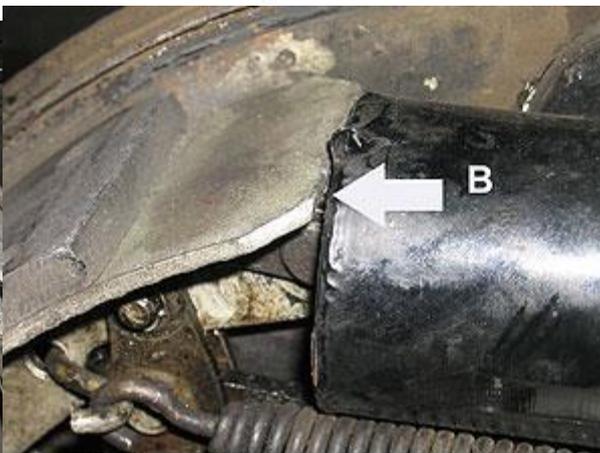
Fig 32. There will be gap between the trailing shoe and the wheel cylinder, and it could be larger than the gap that is shown

Fig 32. This shows in close up the gap between the trailing shoe and cylinder when the brake is assembled correctly.
