EXHAUST MANIFOLD, REPLACING THE STUDS AND MAKING A JIG

R-R Silver Dawn, Silver Wraith, Bentley Mk VI, R type

N.W. Geeson v1. 2007

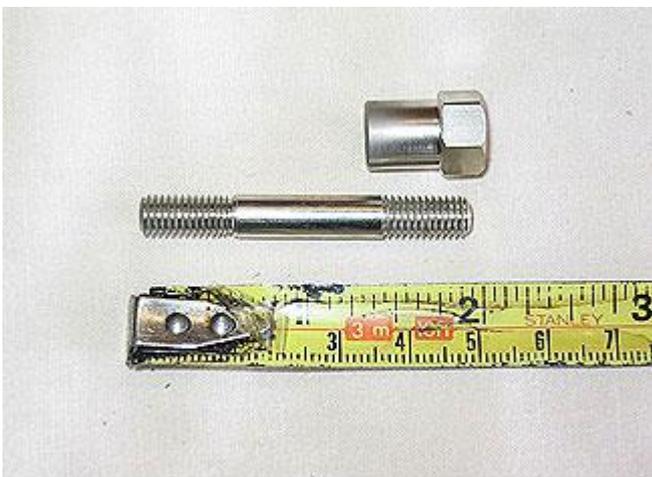
Fig 1 shows a stud and its mating nut, in this case both nickel plated, but they do not come from Crewe or elsewhere in this finish. Note the stud thread at each end is 0.50 inch (12 mm) long and prior to the 1955 'S' series cars the threads were BSF, whilst from 'S' series cars they became UNF. In our example the threads are BSF as the article illustrations are conducted on R type chassis B87 UL.

Fig 1. Exhaust manifold stud and reach nut, in this instance plated after purchase

At this point the non-engineers are inevitably thinking of curing the problem for the future by fitting stainless steel studs.....don't even think about it. The material used for exhaust manifold studs on any engine is very ductile and the use of incorrect material is very likely to leave you with a row of broken studs. Cylinder head studs fall into a similar category and only a short time ago a very famous company in Jaguar circles had to learn the hard way. With the head stud threaded ends buried deeply in the water jacket, they used stainless

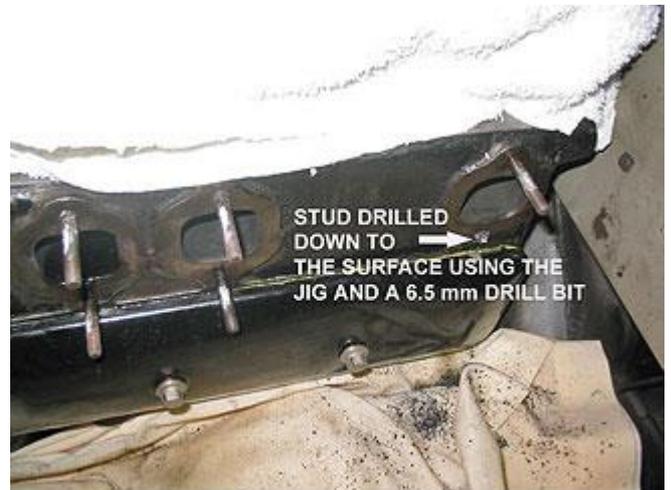
Fig 5. Stud drilled down to the block face

left longer. Cutting the stud off closer to the block means there is less of the stud carcass to drill out. Once the stud is cut off the jig plate can be fitted to the engine with 'B' type 6.50mm guides covering the manifold studs. In practice three or four guides are enough to provide accurate jig location. When the jig has been located in this way some existing manifold nuts can be reversed and used to hold the jig in position. This situation can be seen clearly in Fig 4 with the cut off stud only awaiting the fitting of a 'B' type guide. After fitting the guide a 6.50 mm drill is used to drill the stud down until it is nearly flush with the block surface Fig 5. Careful depth measurements should be taken before any drilling takes place and then the drill positioned into the chuck so that it is impossible to drill too deep.

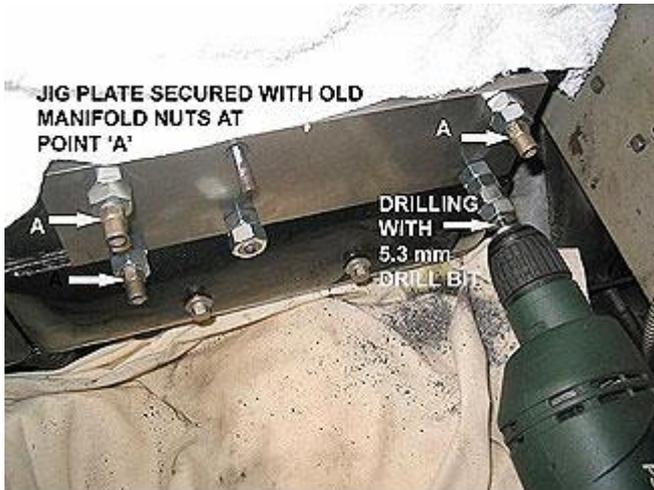
Fig 7. Pilot drilling with 5.3 mm drill ready for taper tapping

Fig 7 shows the jig plate in the configuration shown in Fig 6 being used. In this instance a 5.3 mm drill is being used to drill 0.625 inch below the block surface. This drilling depth needs controlling, by setting the drill position accurately in the chuck as further drilling is likely to damage the coolant side of the exhaust port. It should be noted that the manifold studs by design communicate directly with the water jacket and the drill will be felt to break into the coolant passage near the end of the drilling exercise. For this reason appropriate sealer should be applied to the ends of new manifold studs to prevent initial coolant loss.

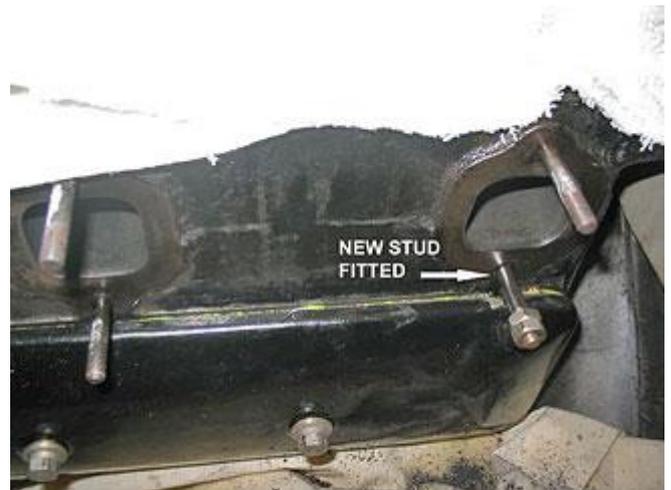
Fig 9. Stud successfully fitted, accurately and without damage

Fig 9 shows the new stud fitted by locking together two nuts to the outer end, not forgetting to apply sealer to the inner end threads before the stud is screwed into position.
