CANCELLATION OF END OF YEAR

OVERHAULING REAR CALLIPERS ON SZ CARS

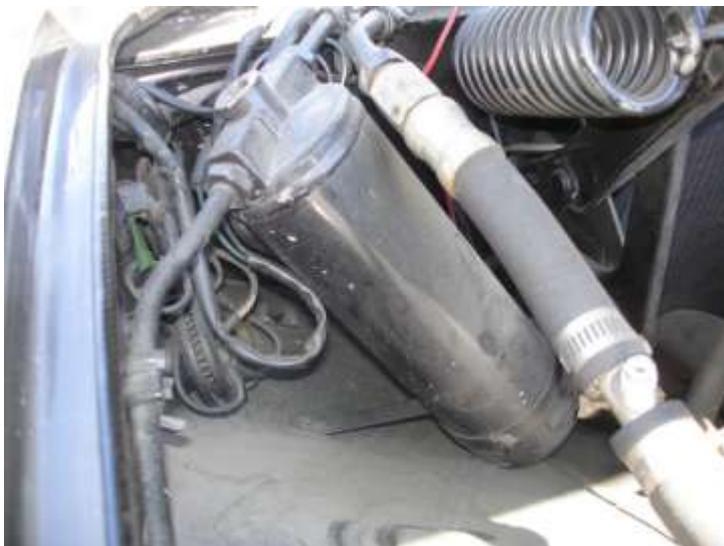
Shadow Air Conditioning

Most owners will be familiar with this cylinder jammed into the left front corner of the engine compartment. This is a drier. Any moisture in the circulating gases will quickly freeze as the pressure increases and fine ice slivers will get under valves and other crucial bits and the whole system will fail.

Initially when the system is charged it is evacuated to as low a vacuum level as possible usually about •0065 psi and some operators sweep the system with nitrogen to minimize the possibility of water vapour remaining. Even then there is a risk so a drier is put in the lines and that is your cylinder in the corner that we see in the picture. It is filled with a desiccant, a compound that absorbs water, variations of which you find in small bags in new camera boxes and the like to prevent rust from water vapour.

If you change to the 'new' refrigerant it is essential you change the drier along with some 'O' ring seals in the system. This is all academic since in this country work on air conditioning systems HAS to be done by a licensed operator! But the information above is something you should be aware of so you can drop the bon mot while the work is being done. And when the operative announces that the drier fitted to your Shadow is no longer available, do not despair as a shortened version is available and works adequately albeit with a modified bottom mount to replace the one seen in the picture.

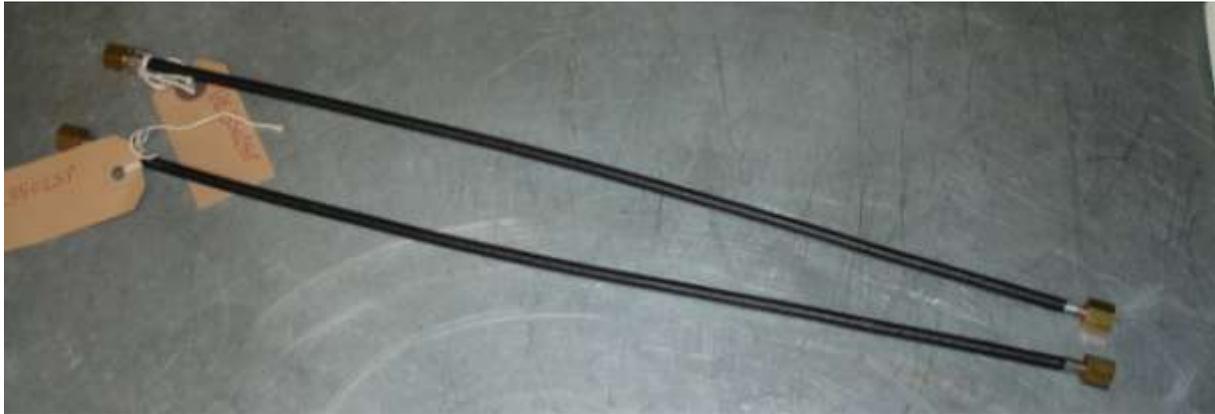
STOVE PIPE LEAKS

The above items are the new version of an old fitting which goes back to the start of the vee eight in 1960. Their function was simply to pipe a small quantity of induction air through the choke coils to heat them up expand them and open the choke. The heating is done by passing the piped air through a 'U' shaped tube in the 'B' bank exhaust manifold. Originally the pipes were lagged with asbestos cord which looked very business-like. With age the cord frayed and the pipes looked like a dog's breakfast. Worse still the pipes rusted and burnt with the heat and eventually if they didn't snap off at the manifold they at least punctured which allowed cold air to enter and the choke would close up a bit and your wallet would open a bit to pay for the extra fuel.

The last price I had for Factory replacements gave me a week in intensive care for shock so I was delighted to find the above aftermarket items from Introcar in London www.IntroCar.com at a very reasonable price.

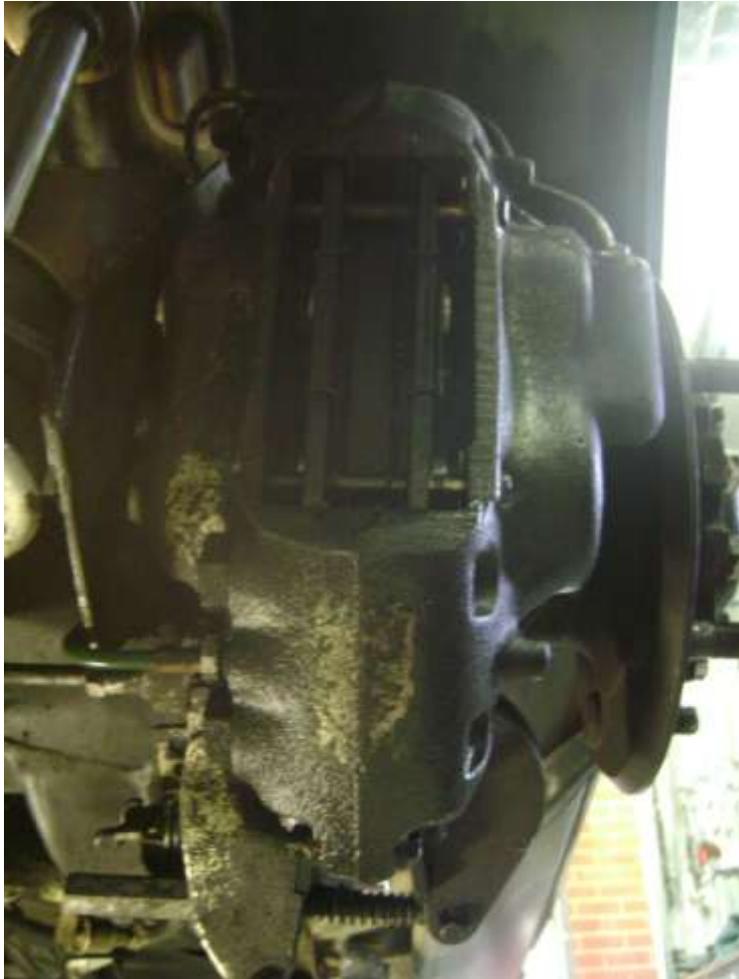
One of our members complained that his Spirit under heavy braking would frequently skid. He wasn't sure which wheels or why. Crawling underneath revealed the above which have actually been cleaned! The callipers were swimming in LHM. This effectively reduced the rear braking to nil so the whole effort to stop the car fell to the front wheels which presumably eventually gave up and skidded!

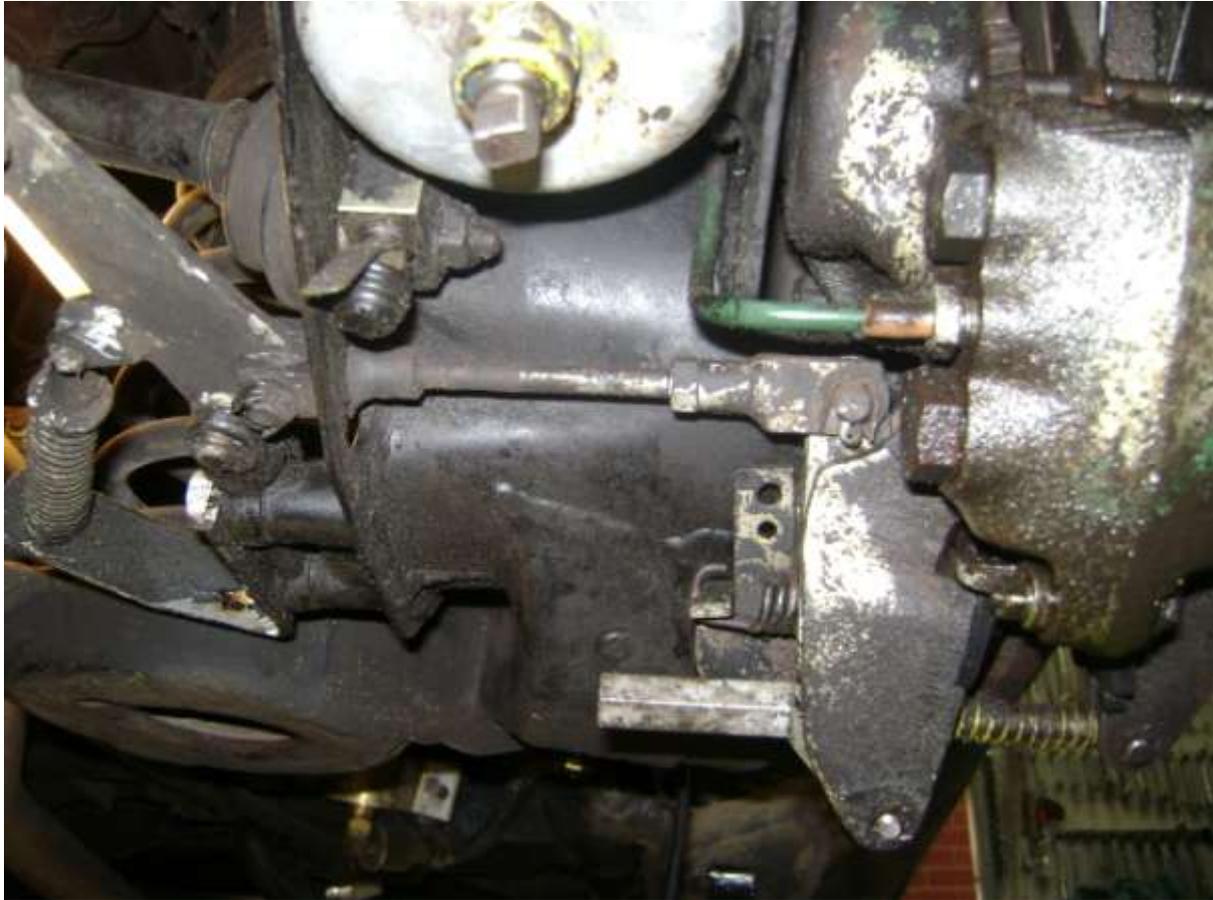
Above we have the worm's eye view. The large washer at the top is the lower end of the suspension strut. At lower left of the strut is one of the bleed nipples complete with ribbed dust cap for the caliper, remembering that there are two systems operating in the one unit! Next down is one of the parking brake operating rods with the actuating mechanism to the left. To note here is that the rod passes through the left hand strengthening plate, one of the two supporting the lower end of the strut!

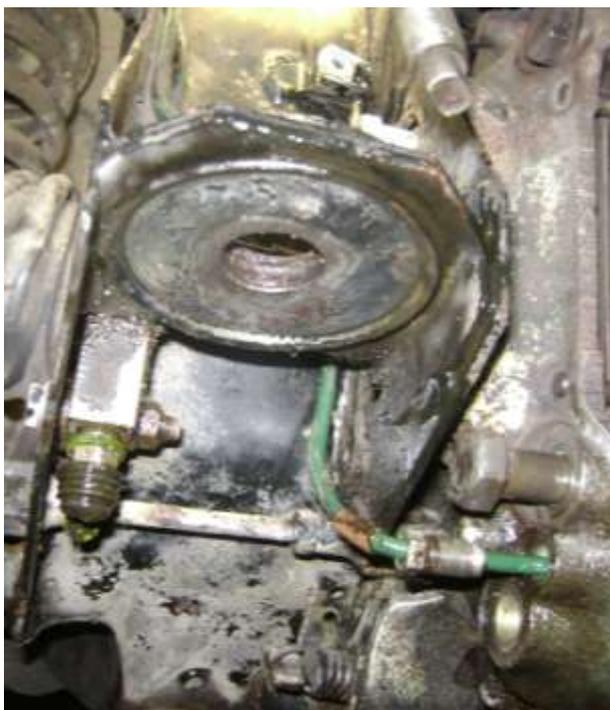
It is not necessary to remove the strut from the suspension arm which has been done here. But the platform for the strut mount with its vertical supporting plates can be clearly seen.

Bottom left shows that one of the four caliper bolts that hold the two halves together has been removed. This was done to allow access to the supply nipple seen withdrawn from the caliper. The heads of the two large bolts allow only an open 7/16" AF spanner to be used on the nipple so if it is very very tight there is a good chance it will burr and you may have to repair to your garage shrine for prayer and whisky!

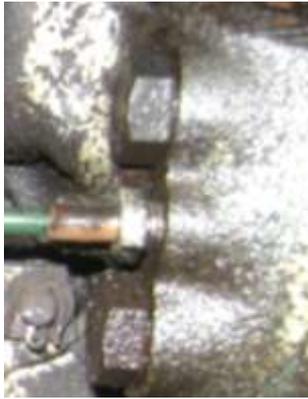
See what I mean????

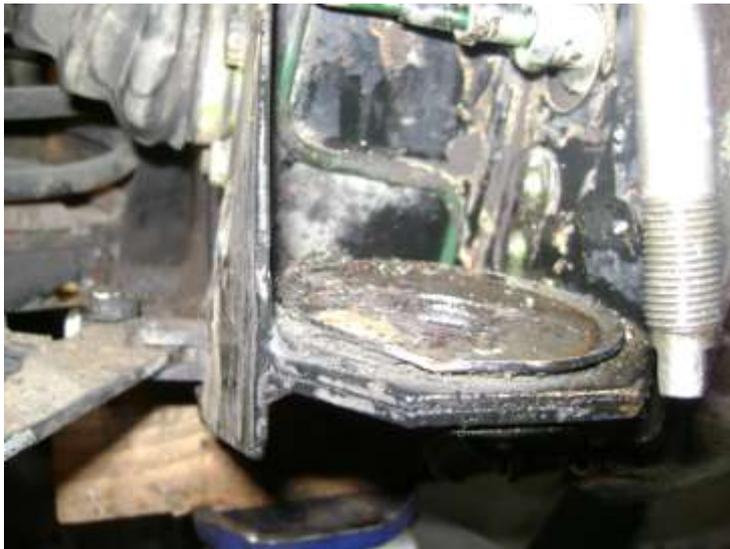
Here most of the pipes have been removed. The jungle consists of the two supply pipes (one for each system) the transfer pipe that runs from one side of the caliper over the top to the other to feed the piston on the other side and lastly the bleed nipple pipe for the lower cylinder.

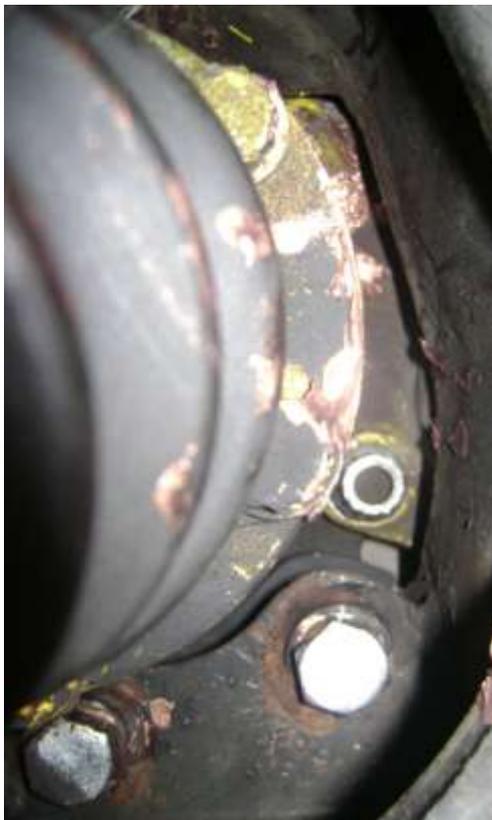
Next task is to unbolt the caliper. The attachment is the same as the front except that given the space restrictions and the very high poundage the attaching bolts are torqued to, special headed bolts are used. Here the lower caliper bolt can be seen, the other larger bolts are half of the four that hold the whole axle assembly onto the suspension arm.

The view to the left is inside the end of the rear end of the swinging suspension arm. The nearest and brightest bit is the end of the Lobro joint where it bolts onto the rear wheel stub axle.

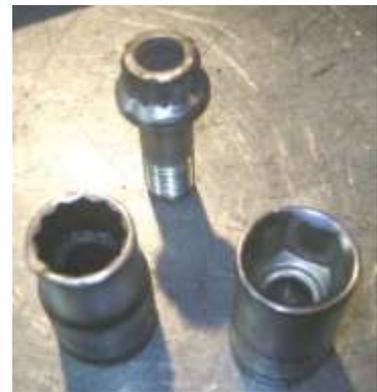
You should not take fright at the sight of these bolts. They are known as double hexagon head bolts or dodecagon heads, given that they have 12 'sides'. A standard multi point socket fits them very nicely!! Above is a picture of a standard multi point socket and a simple hexagon socket. The latter can't be used on these bolts!

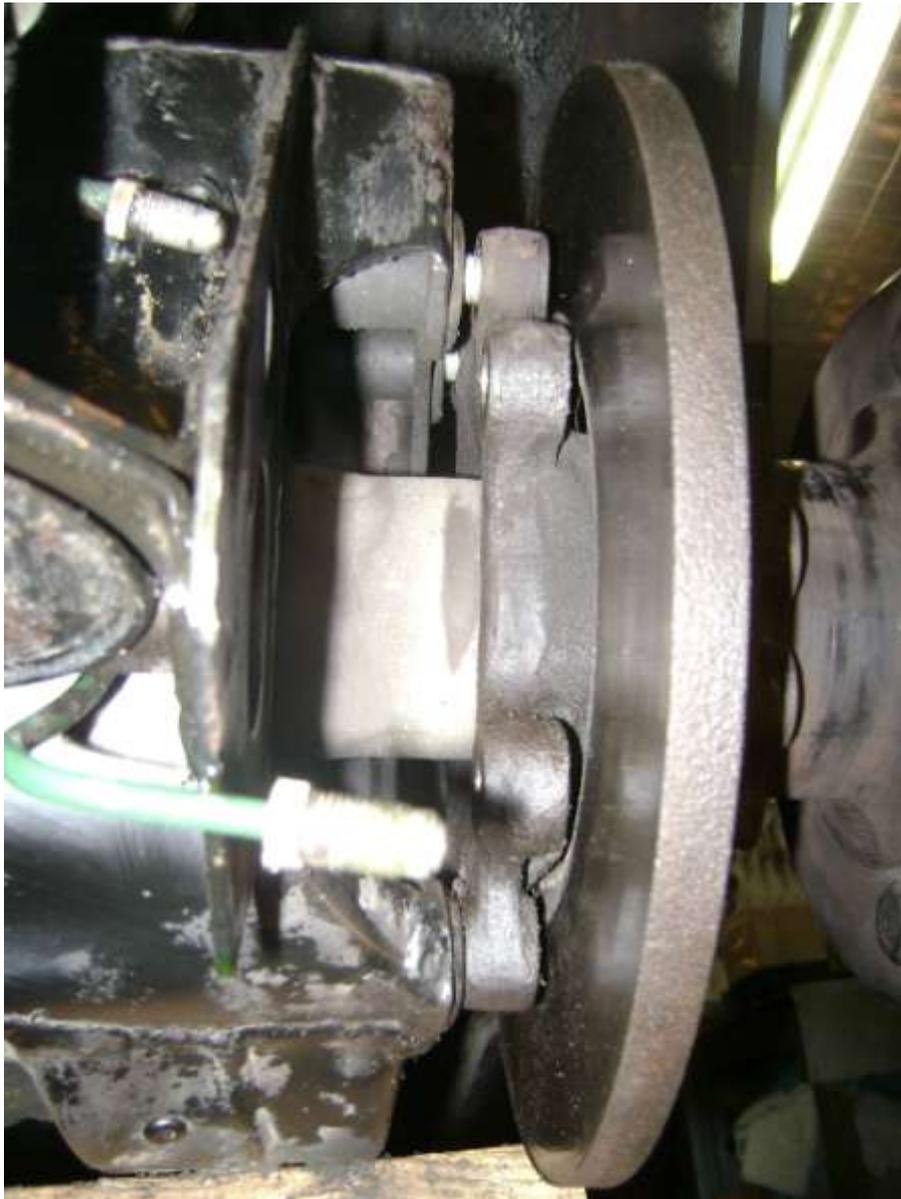
Now comes the interesting bit. You are looking at the rear of the right hand rear brake rotor.

The mounting lugs for the caliper can now be seen.

The calliper has been removed but because a few bits of it slightly protrude into the holes on the rear strut mounting plate beside it, the whole axle and calliper assembly need to be loosened and the assembly moved outward allowing the caliper to be withdrawn to the rear.

This simply involves loosening the four hub retaining bolts a few turns and pushing the axle outward. It can't be pulled too far lest you split the Lobro joint on the end of the axle.

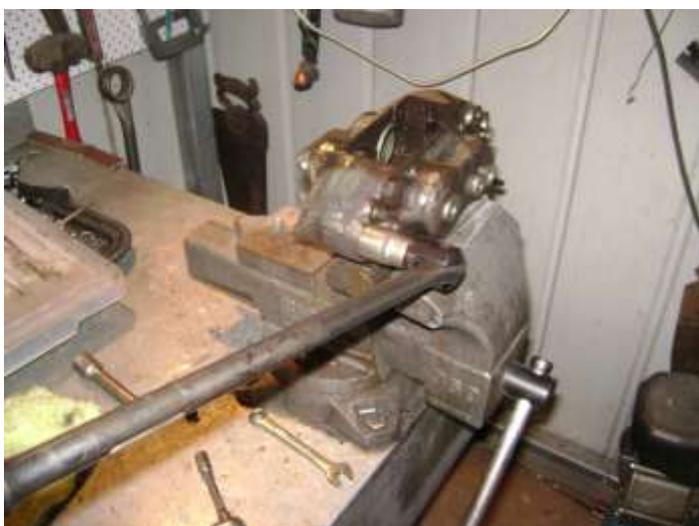
There is nothing special about the callipers if you have done them before. Here we are unbolting the two halves to clean them. Note the break bar because once again these bolts are very very tight

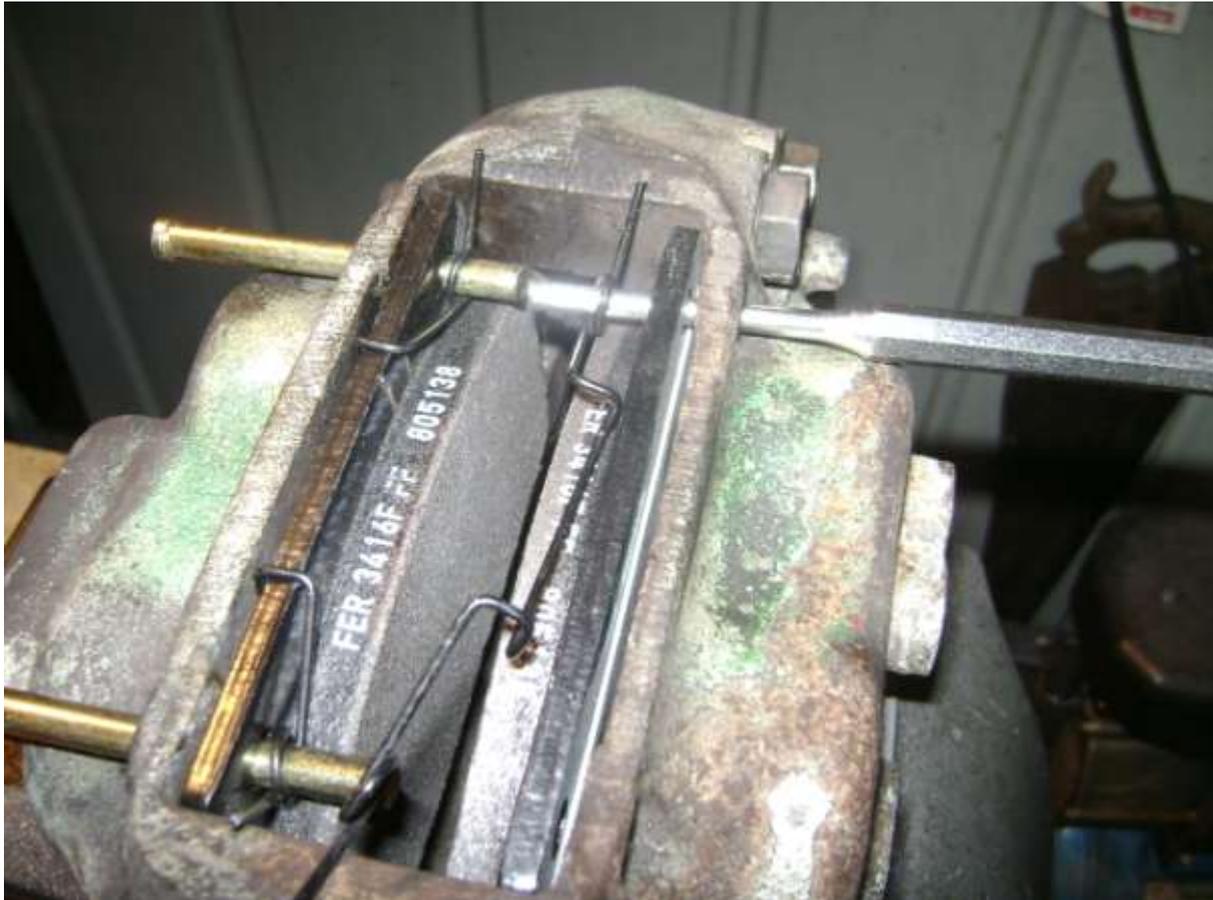
And finally here are the new pads going in with their anti-rattle springs. The latter can be like trying to get a live tarantula into a small pepper pot but the judicious use of a suitable centre punch makes life a lot easier! Overall if you have the time and facilities to do this job you will need at least 20 hours spare. Multiply that by your man hour rate and it may be worth your while and you should achieve a great level of satisfaction!

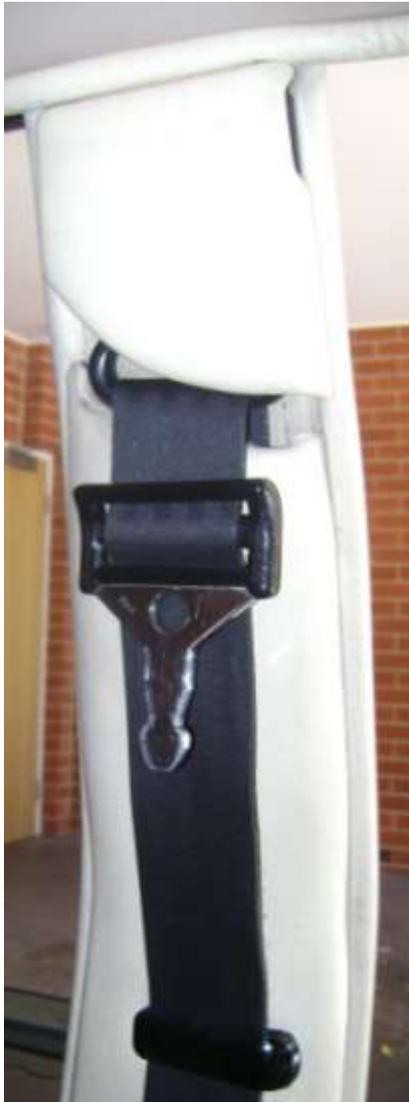
The dinky little cover for the upper belt mount is pure Roycery. The top is held by two little prongs and at the bottom by a clamp held by two small self tapping screws. You start from beneath with a torch and a Phillips Head screwdriver. To get the cover off having removed the two hidden small screws, drawn the bottom of the cover away from the 'B' pillar then push it up firmly to release it from the prongs. Practicing on the driver's side pillar, I was startled to find wires and things that did not look very seatbeltish. Then I remembered my curiosity as to why this cover had side slots in it and the other did not! One of these can be seen in the picture. It appears that the wires and bits were the upper temperature sensor for the automatic air conditioning system and the slots let the fuggy air in to talk to them.

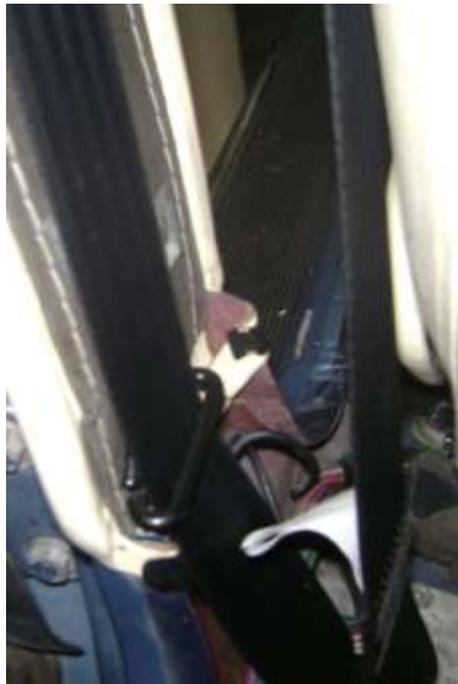
The long 'B' pillar cover is held to the floor by a couple of bolts and the screws securing the Stainless scuff plates on each door sill. With the little top cover removed, the log cover simply slides up an inch or so and then lifts off!

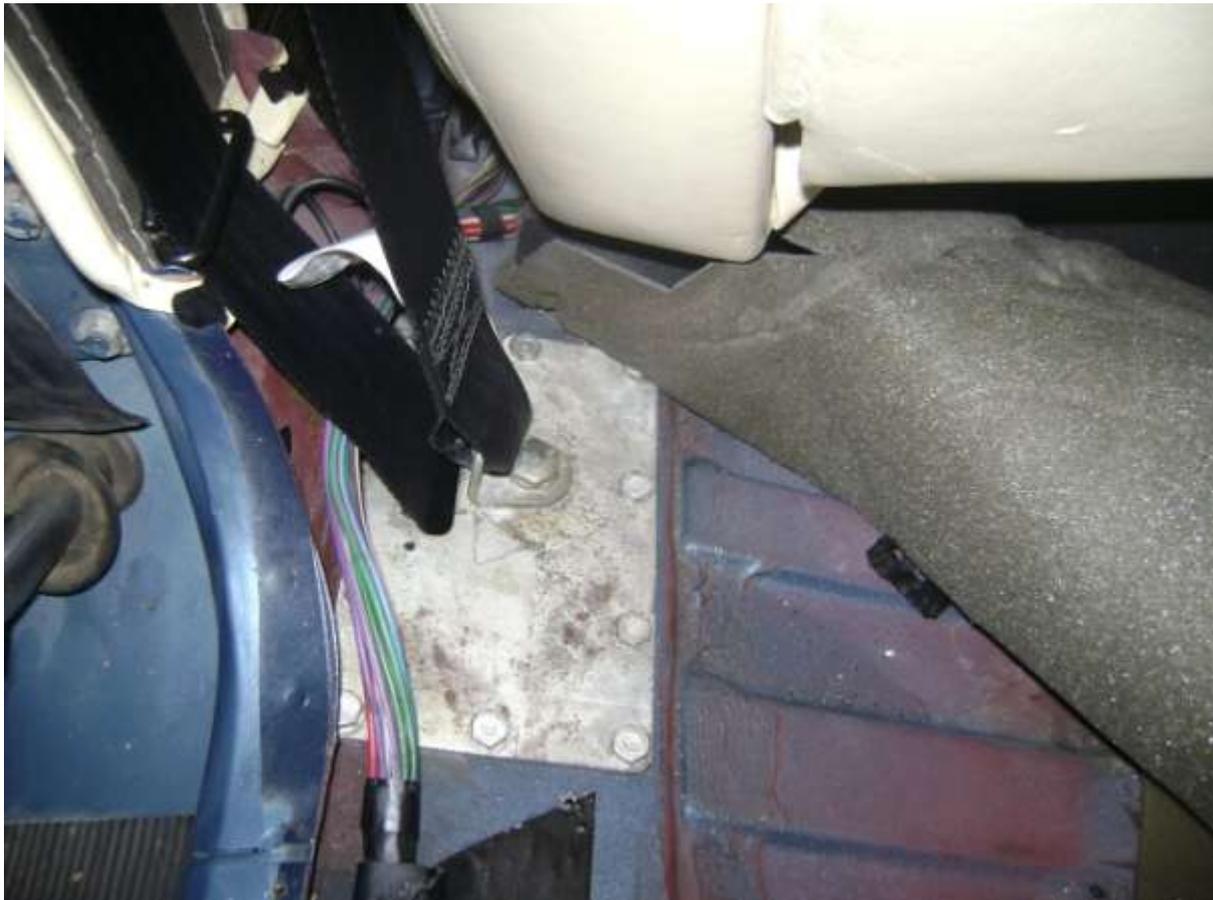
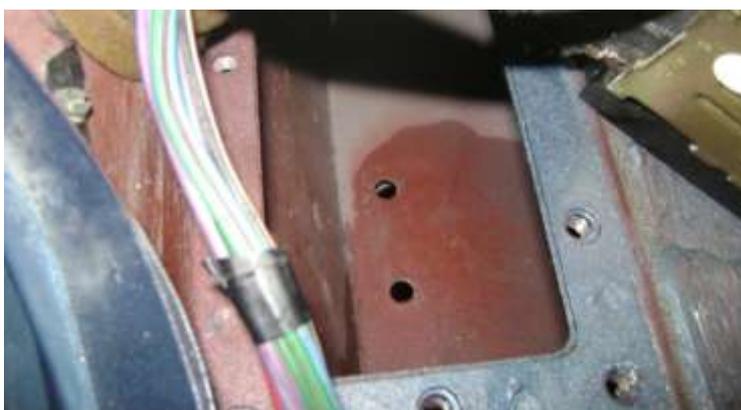
So that's where it is? Yes the front belts are secured in a hole in the floor just behind the driver's seat and

covered by a massive steel plate fastened to the floor by no less than 10 bolts. This is not to prevent the seat belt escaping but provides an anchor for the fixed end of the belt seen here. The belt underneath feeds through a slot which has a right angled insertion slot to thread the thing.

At left is a picture of the box opened and belt removed. Bolts are screwed from underneath and the retractor actually sits in a plastic bag to protect it from serious water invasion into the sill

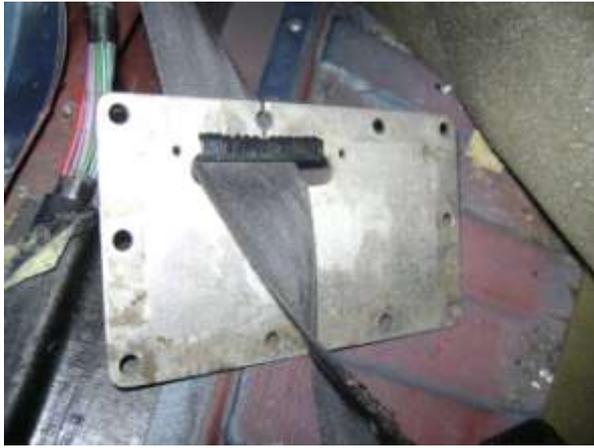
Here is the plate showing the insertion slot and the simple remedy to prevent chaffing of the webbing.

The unit is known as a vertical mount, which fits to the Factory angled mount the latter catering for the slope of the body sill.

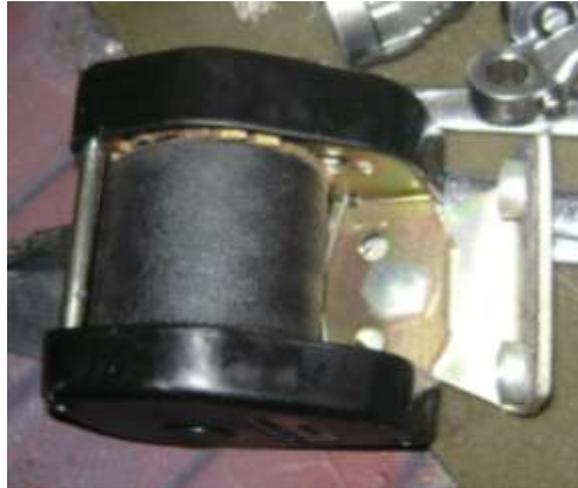
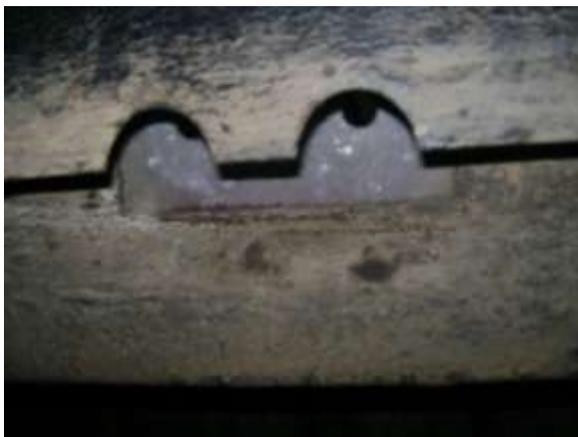
At left is a worm's eye view of the mounting holes

The retractor is designed to release the belt when it is vertical but will tolerate a 3° lean in any direction. This obviously dictates that when the mounting bracket is bolted to the sill and the sill is horizontal, then the belt must be vertical. This was my way of ensuring this – and it worked!

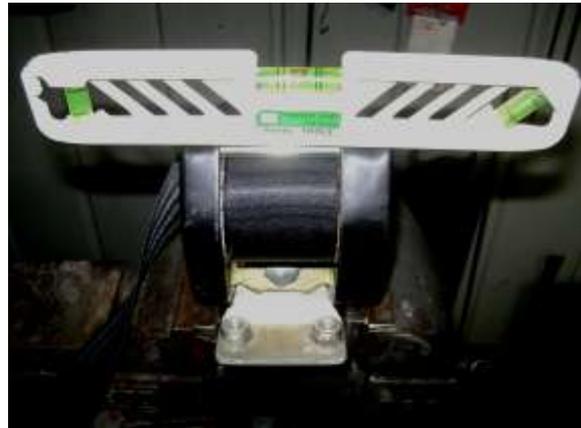
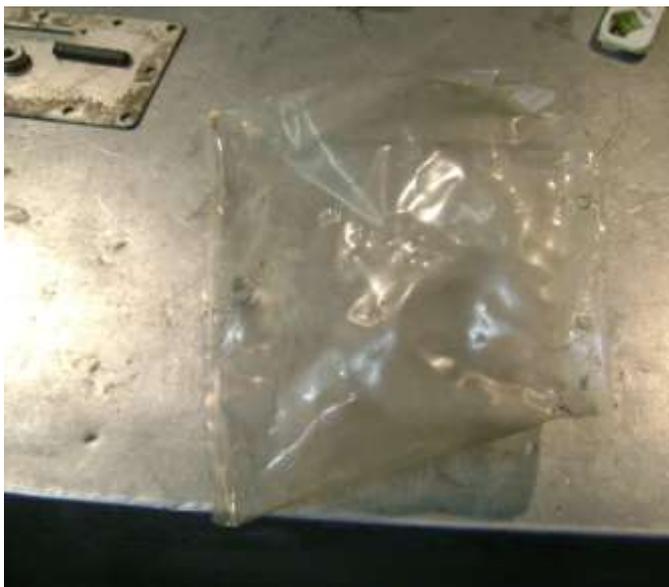
And this is the plastic bag in which the reel sits. The bag has two holes in it to accommodate the mounting bolts when they come through the bottom of the sill. Since the reel doesn't simply drop in, it has to be put in at an angle and swiveled; the chances of the plastic bag holes remaining lined up on the mounting bracket are somewhat slim!

My solution was to whip the heads off a couple of bolts and use the shanks as studs screwed into the bottom of the mounting bracket. These will hold the bag in place and give you some hope of lining up the mounting holes with the sill holes. Having got the studs through, careful holding of the reel while you unscrew the studs, one at a time and replace them with the correct bolts should see the most difficult part of the job completed satisfactorily.

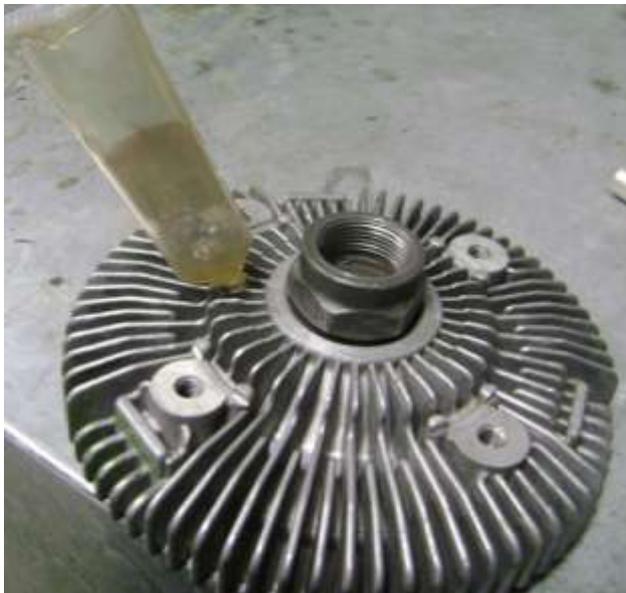
There have been various iterations used by the Factory. The early Shadows used a unit that apart from bolt mounting holes were identical to the ones used on the early Holdens. Whatever the unit used however they are very expensive to replace. It seems that there are only two scenarios of failure. First there is the failure of the internal bearings. This can be monitored by gently wobbling the fan blades forward and backwards. If there is any movement, replacement is indicated. The other fault is a lack of drive and you can see this very quickly when you switch off the engine. A good unit will stop the fan spinning in a few turns; a poor one will spin for quite a while. The problem is a lack of fluid in the coupling.

The fluid must leak very slowly but eventually there is not enough to provide drive. Richard Treacy put me onto the fact that Toyota, who has made more cars than there are grains of sand on the beach, has been fitting fluid couplings to their fans for yonks. When they lose their drive, you can unscrew a little plug and squirt in a tube (available as a Toyota spare) of silicon oil and order is restored.

Since we do not have the luxury of a little plug, Richard tried drilling a hole in the body, inserting the oil and sealing the hole. I had a spare coupling which had

good bearings and decided to give the idea a run. Problem was that nobody could tell me how much fluid this rather large unit held! I asked the Toyota spares man who advised filling it up. I stopped after three tubes and there was still room for more. Now the fan stops with the engine in less than a quarter of a turn and the fan noise is reminiscent of an AA380 on takeoff. So the next experiment is to put one tube full in the other unit and see how that performs!
