TEE ONE TOPICS

Number 39

September 2004

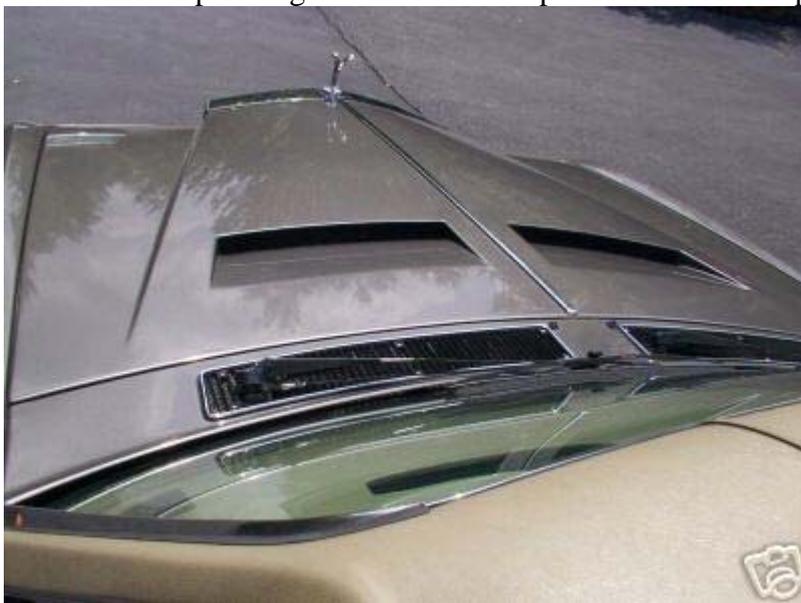
Found this on the web somewhere and threw it into the basket. We tend to scoff at such modifications to our cars but in the absence of much bespoke body equipage perhaps we can enjoy these sallies into a bit of originality. There was no picture of how the inside was treated. I have never had a categorical explanation as to why the post-Cloud cars had bonnet pads. Some say it was for sound proofing others believe it protects the bonnet paint from the considerable heat of the engine beneath.

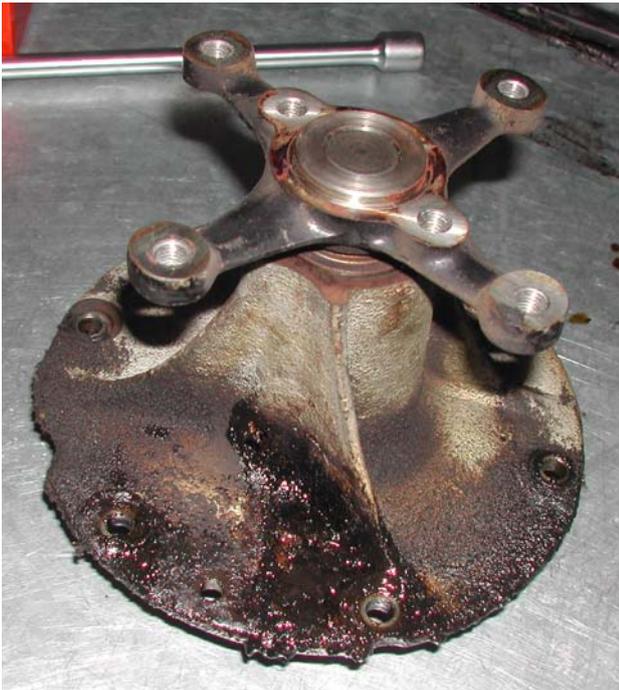
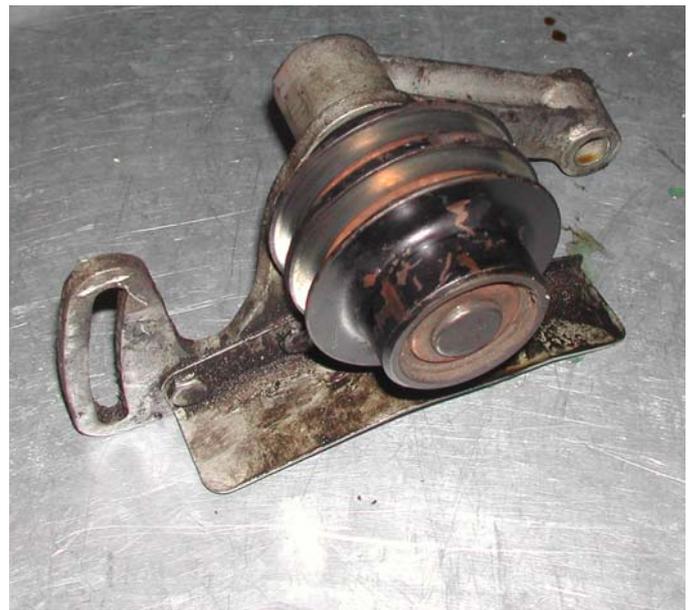
These two assemblies off a vee eight engine are usually forgotten until suddenly lights start coming on and you end up sitting embarrassed on the side of the road worse you could be wondering about very significant engine damage. On the left of course is the water pump. The shaft with its spider has a lot of work to do including turning an internal impeller (Fig 13) to circulate coolant through the engine. At the other end of the shaft it has to turn a monstrous fan at a pretty high speed. The shaft is carried in a fairly stout bearing (Fig 9) which is packed with grease and no provision is made for further lubrication.

There remains the problem of stopping the coolant from seeping through the bearing. This is achieved by a special seal (Fig 6,7). If you wanted the ultimate assurance that you would have no water pump problems and you used the car a lot perhaps an overhaul every five years would not be extravagant. The pump pictured was not noisy, usually caused by a worn bearing but it did have a slow leak as can be seen on the body of the assembly. In this installation the front of the engine was so crudded up with oil and dirt, the coolant tended to be soaked up and the leak was not detected. Actually it was the pursuit of the source of the crud that prompted the removal of the pump.

Unfortunately these units tend to fail suddenly usually with the collapse of the seal. Diagnosis is not difficult when you note the steady dribble of coolant at the front of the car! If you are wondering what state your pump is in there are two tests you can perform. One is to shake the fan for and aft – you should feel no free play but make sure that any apparent play is not in the viscous unit driving the fan assuming your car is fitted with one. The second is to buy yourself a simple

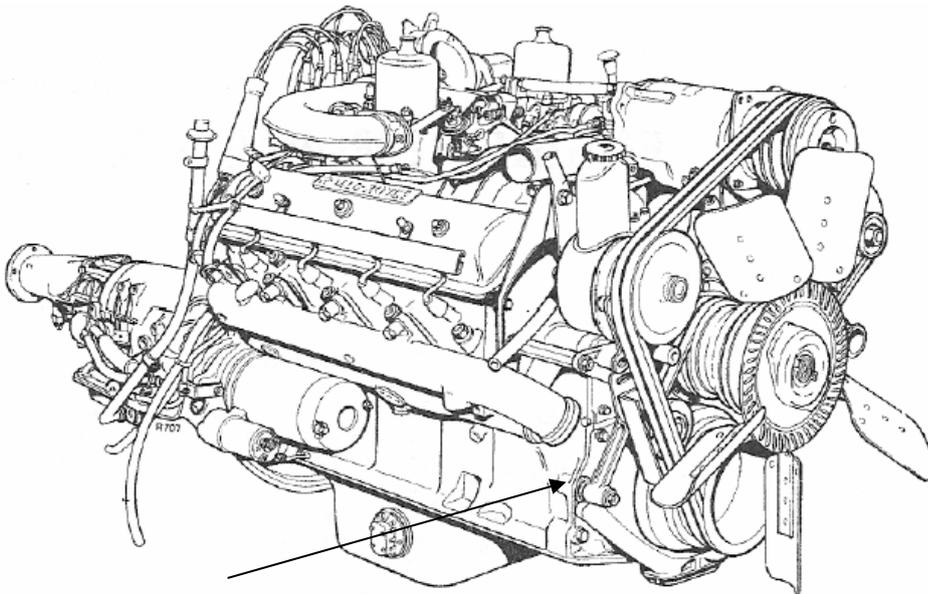
The second assembly pictured to the right of the water pump is the fan belt tensioner. This is almost invisible on most engines because it is hidden under other components. The water pump pulley is driven by belts from a pulley on the front of the crankshaft. To tension the belts so that they won't slip, the pulleys would normally be moved further apart but as this is not practical the belts pass over a third pulley (arrowed on the drawing below) which can be swung away from the engine to tension the belts. The bearing that this pulley on also has a hard job and needs to be checked. Probably the simplest way is to buy yourself a stethoscope from an auto shop and

The tensioner can be seen on the engine to

the left (arrowed)

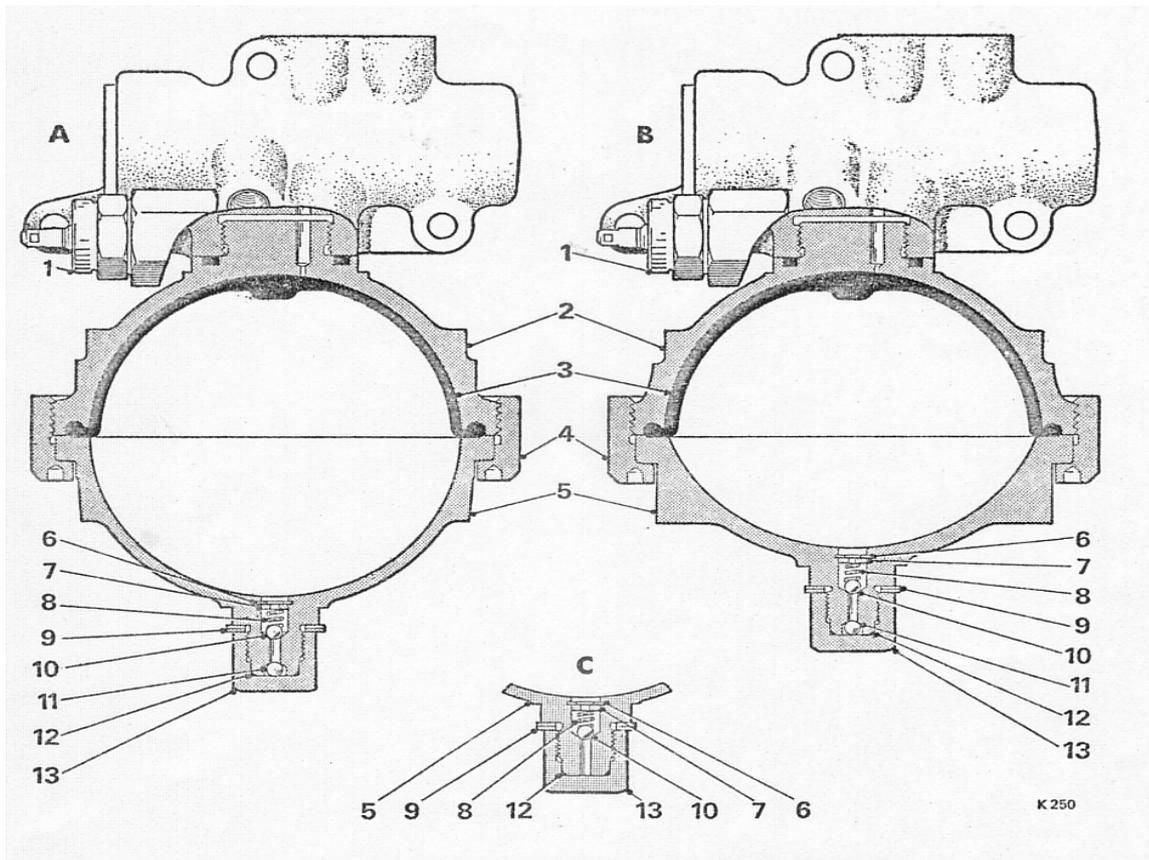
And here is the comparison of the Shadow I accumulator (left) and the Shadow II unit on the right. The positioning of the Shadow I accumulators allowed re-charging in situ. With the advent of the Shadow II and rack and pinion steering the accumulators had to be moved to either side of the engine block. There they were tucked in very neatly but denied any attempts to charge them without removal. One other important change was to move the pressure switches on the Shadow II to the engine valences remote from the accumulators. There has also been some discussion on the sealing of these units. Originally item 10 was a steel ball that tucked nicely into a conical recess above the charging hole. The latter with neglect condensation etc can get corroded making it almost impossible to get a good seal. The solution is to use one of the plastic balls item 12 and another one on the outside after you have done your inflating. A good method to clean the hole seat for the ball is a wad of steel wool jammed in there and rotated at high speed by an appropriate drill. Finally always test the finished accumulator for leakage by submersion.

A year or so ago I wrote to a former hydraulics designer retired from the Factory and among other exchanges he confessed that he was not aware that the Factory had reduced the size of the accumulators on the Shadow II. Since some of the outpourings on the topic I have had this fact queried by a number of my readers. Well here it is – the comparison. The obvious reason for the change was to allow the units to be tucked in more snugly to the engine block to make room for other new bits. But the very first cars were fitted with these truncated accumulators if they were destined for France. It is all a lot about nothing really except cars fitted with these have fewer pumps before the lights start ablinking!

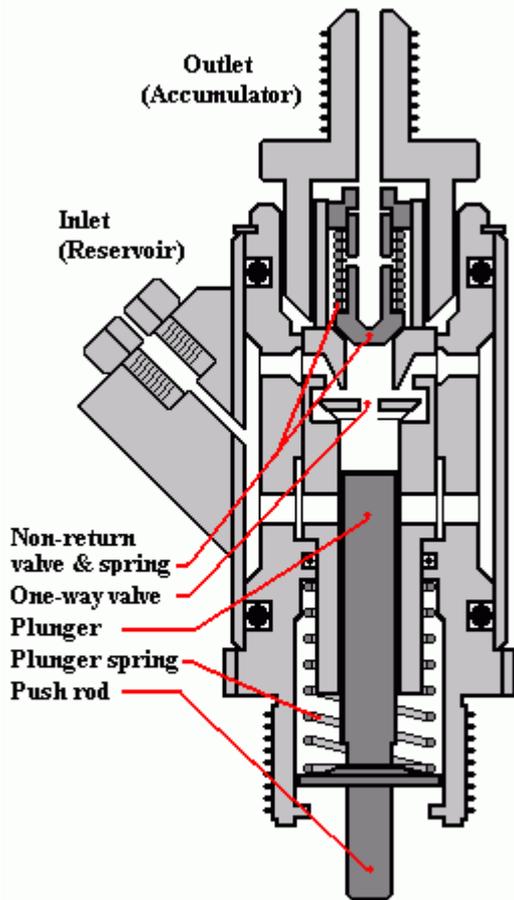
HYDRAULIC PUMP Rob Wilde ©

Hopefully this very clear diagram will re-assure owners that those little things that go click under the bonnet are not really that complicated anyway. The bits that usually trouble us are the two seals between the outer casing and the inner body shown here in cross section as four very black round dots. These with a bit of dexterity (the Factory loved that word) can be replaced in situ.

Warwick Grigg found a Netherlands web site devoted to the Silver Shadow. Included were some excellent illustrations of bits dear to our hearts one of which is appended here. The club produces a quarterly magazine that is excellent, regrettably however I don't read or speak Dutch. The photos however are tantalising and hopefully I will be able to cadge some from the authors.

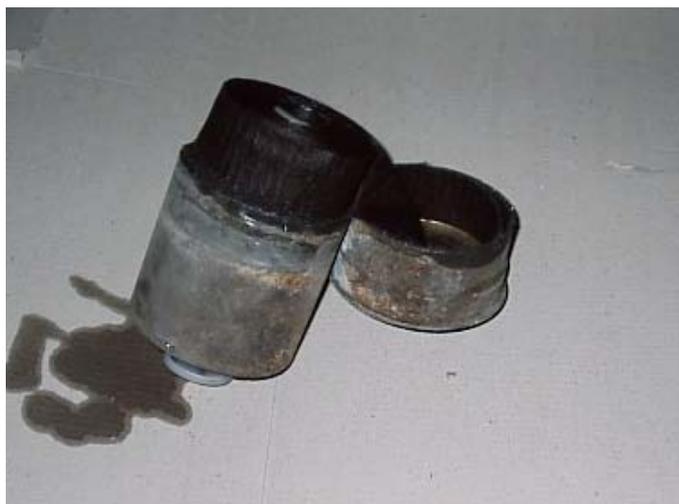
For those of you that missed it on the web our Swiss correspondent Richard Treacy sent this pic of the fuel filter of his Turbo which he changes regularly. Sadly this is a gadget that simply gets overlooked. When I bought the Blue Beast I changed everything in sight but completely forgot the fuel filter. I found a replacement sitting in the cupboard which jogged the memory and the change was made. I cut that one open and had a similar result to the photo.

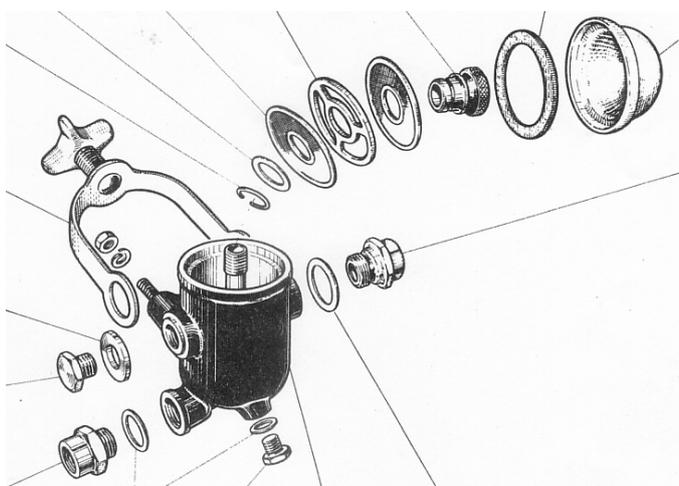
Below is a delightful drawing from the spare parts manual for a Silver Wraith. To make such a gadget today would be prohibitively expensive and sadly the finished product would not come near the modern filter in the field of performance. Compare the two mesh filters with the folds of a modern paper unit! Well we may have come a long way with filter design but it seems not far with getting clean fuel into our tanks. A further complication is that the older cars' tanks are starting to corrode and the deposits find their way into the system. The suggestion then is to discreetly insert some modern filtration into the lines preferably on the suction side of the pumps. Cars prior to the Silver Cloud three have metal pipes which will need to be cut but from there on some fuel hose a \$10 filter and a screwdriver will give you all the protection you will need.

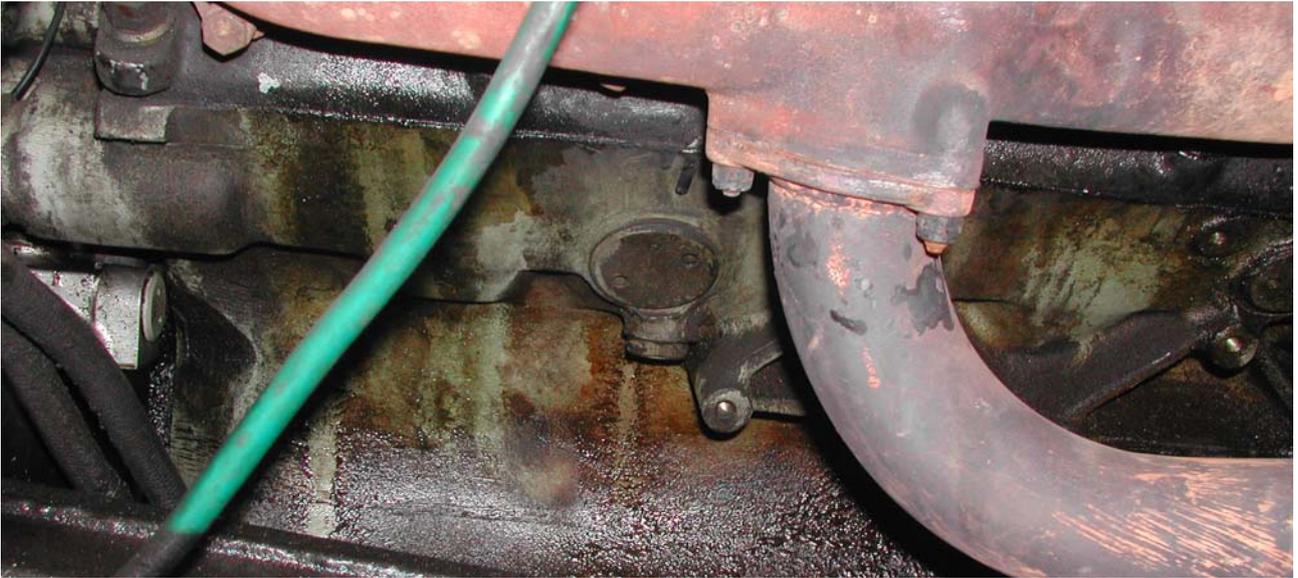
BEFORE

This is becoming a too frequent sight nowadays. There are two obvious leak points on the engine, the rocker covers and the tell-tale holes. Here is an example of the latter leaking. A friend tells me he had a Silver Spirit brought to him which was literally dribbling oil from several of the these orifices whilst it was idling. The car moreover had done only 45,000K! Probably out of sheer pique he wrote to the Factory asking for their suggestion for repair. The solution is apparently to remove the cylinder liners and replace the seals! That would involve apparently about 120 hours of work – say \$6000 at today's rates.

This leakage is more serious on Silver Shadows onwards since the escaping oil coats the suspension rubbers and proceeds to rot them. Talking to some English expatriates I discovered that the common solution on the misty Isles is to block the holes with fine dowling. Quelle horreur I hear you cry. The spin merchants promoted the weep holes as being the automotive innovation of the

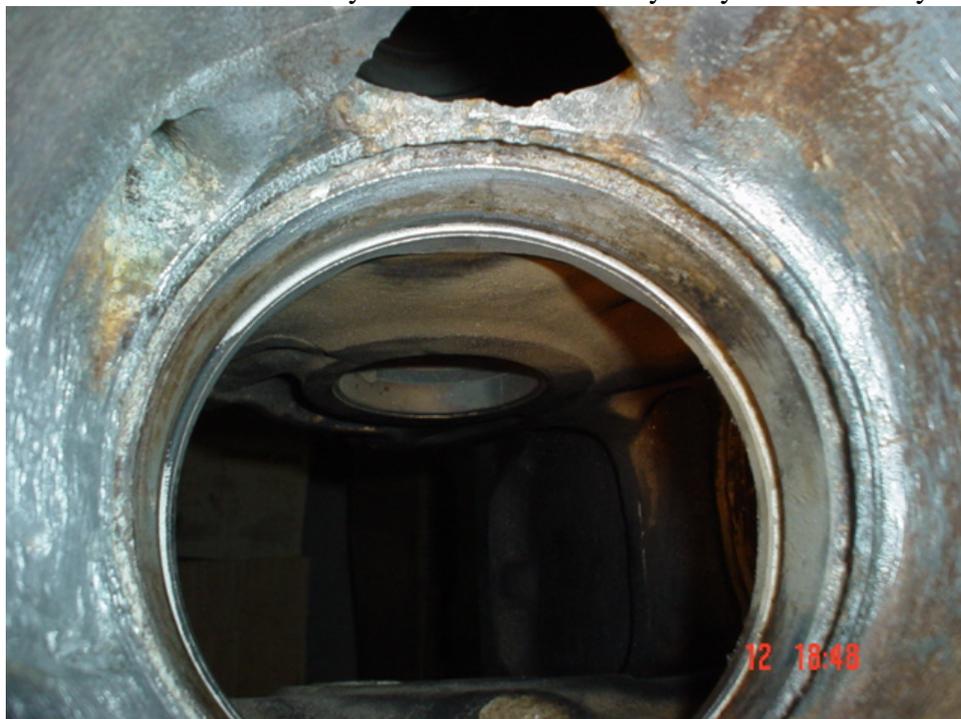
One of the favourite topics on the Club web site is what coolant to use in our aluminium motors. They are nothing new, so many appear in the Japanese catalogues and Rolls-Royce themselves have used aluminium in their cylinder heads for nearly 80 years. But they all rot. The photo at left is

testimony to the problem! You are looking down the hole that one of the cylinder liners fits in complete with specially shaped 'O' rings. The large hole to the top of the picture is a water passage.

But we are now driving 40 year old engines and that is a lot of time to get rotting! Furthermore word has it that blocks and reconditioned engines for the S2 and S3 cars are no longer available! This is no surprise either when one considers the saga of the Phantom III engine nearly 70 years old! They were the predictor for the later vee eight! Those who know have told me that no matter what one uses in the cooling system the rot still goes on. It is a matter of slowing it as much as possible.

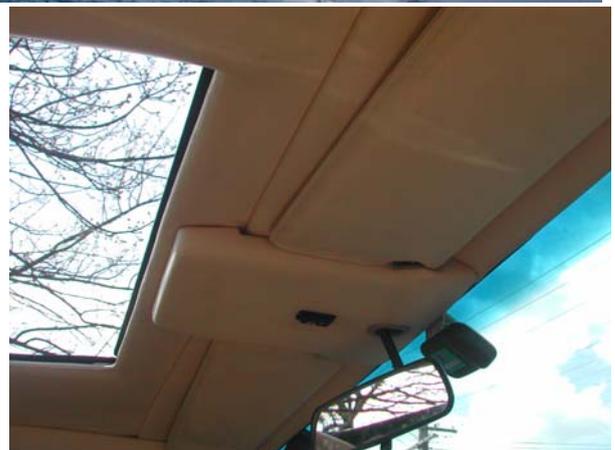
Seen at Bowral during the Tulip Festival this month, I assume it is a Factory fitting given the neatness of the switches. I may have been drunk

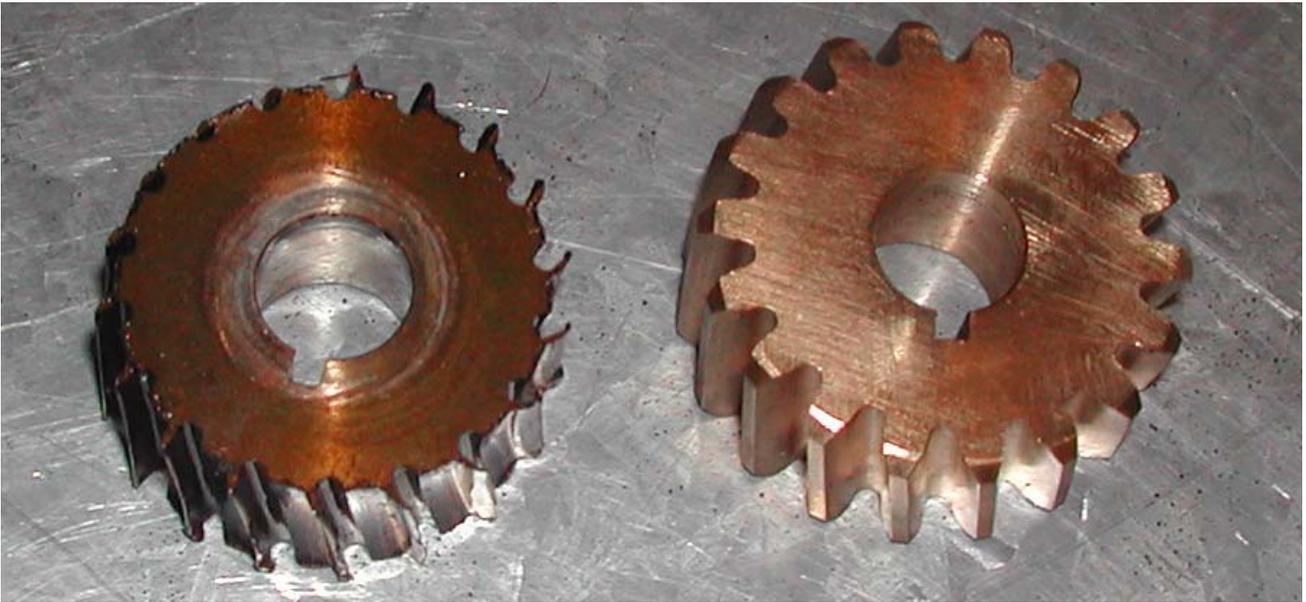
Obviously the one on the left failed and the one on the right replaced it. This is the gear that runs the oil pump for the entire lubrication system in the engine. And here is a picture of it in situ.

Before the 'I told you so' merchants get going I understand that the new solution devised by the factory is to replace the steel helical gear on the crankshaft with a bronze item and fit a steel little gear to the water pump. The parts cost however is in the realm of about four sets of the very best Reboks so the decision if you have to make it is yours.

What must not be done however (and it has been) it to replace the worn bronze pump gear with the new steel one. You then have steel on steel and apparently they tend to eat each other.

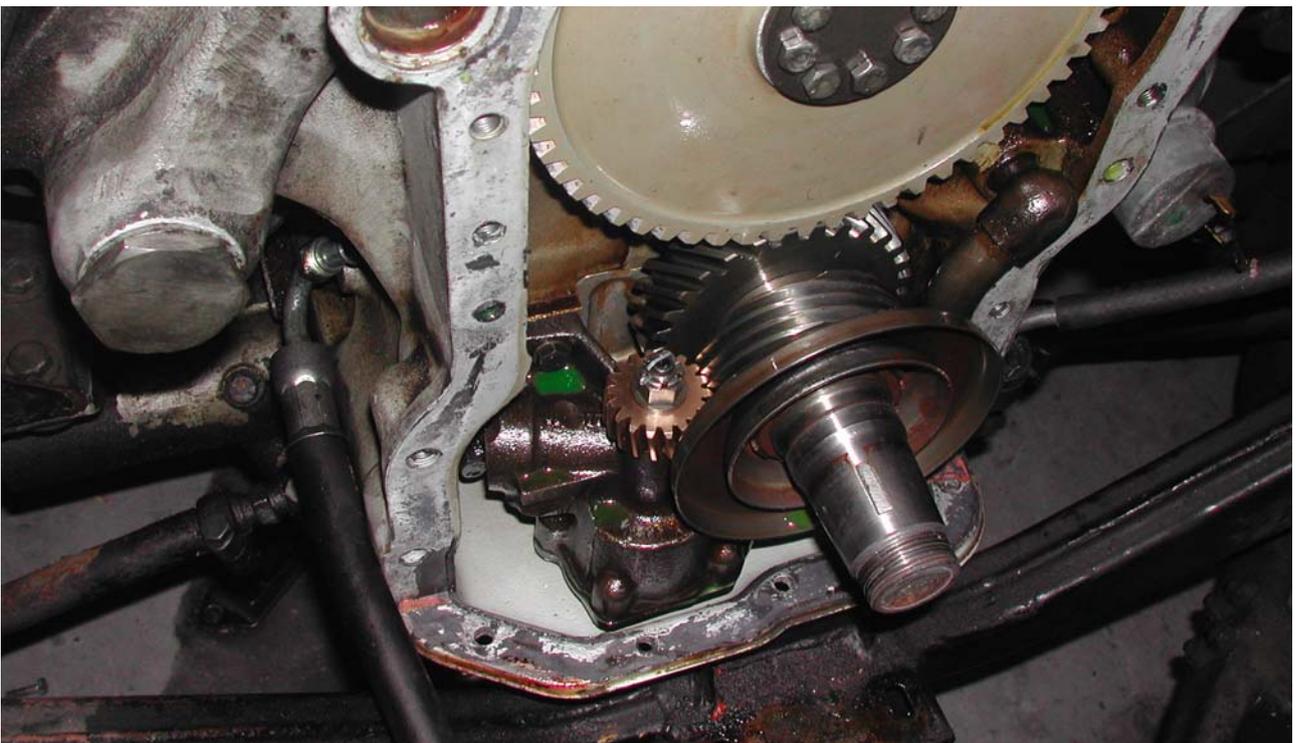
That poor little bronze gear working its mechanical ass off to keep the good oil up to everything, certainly earns its keep. Fortunately the shape of the gear allows it to be removed and replaced without disturbing the oil thrower in front of it.

So how did the driver know that the gear had failed? Elsewhere we have covered this ad nauseum but suffice to say the failure of the pump caused a drastic drop in oil pressure which was sensed by a switch (one of three) sitting on the top of the later cars' oil filter head. This in turn switched and cut off the power to the electric fuel pumps and the engine – she stopped – thank God. There was no damage done and all that was required was to remove the entire front of the engine, the grille radiator bonnet and lots of skin from the knuckles and there was the culprit waiting to be fixed.
