TEE ONE TOPICS

Number 41 December, 2004

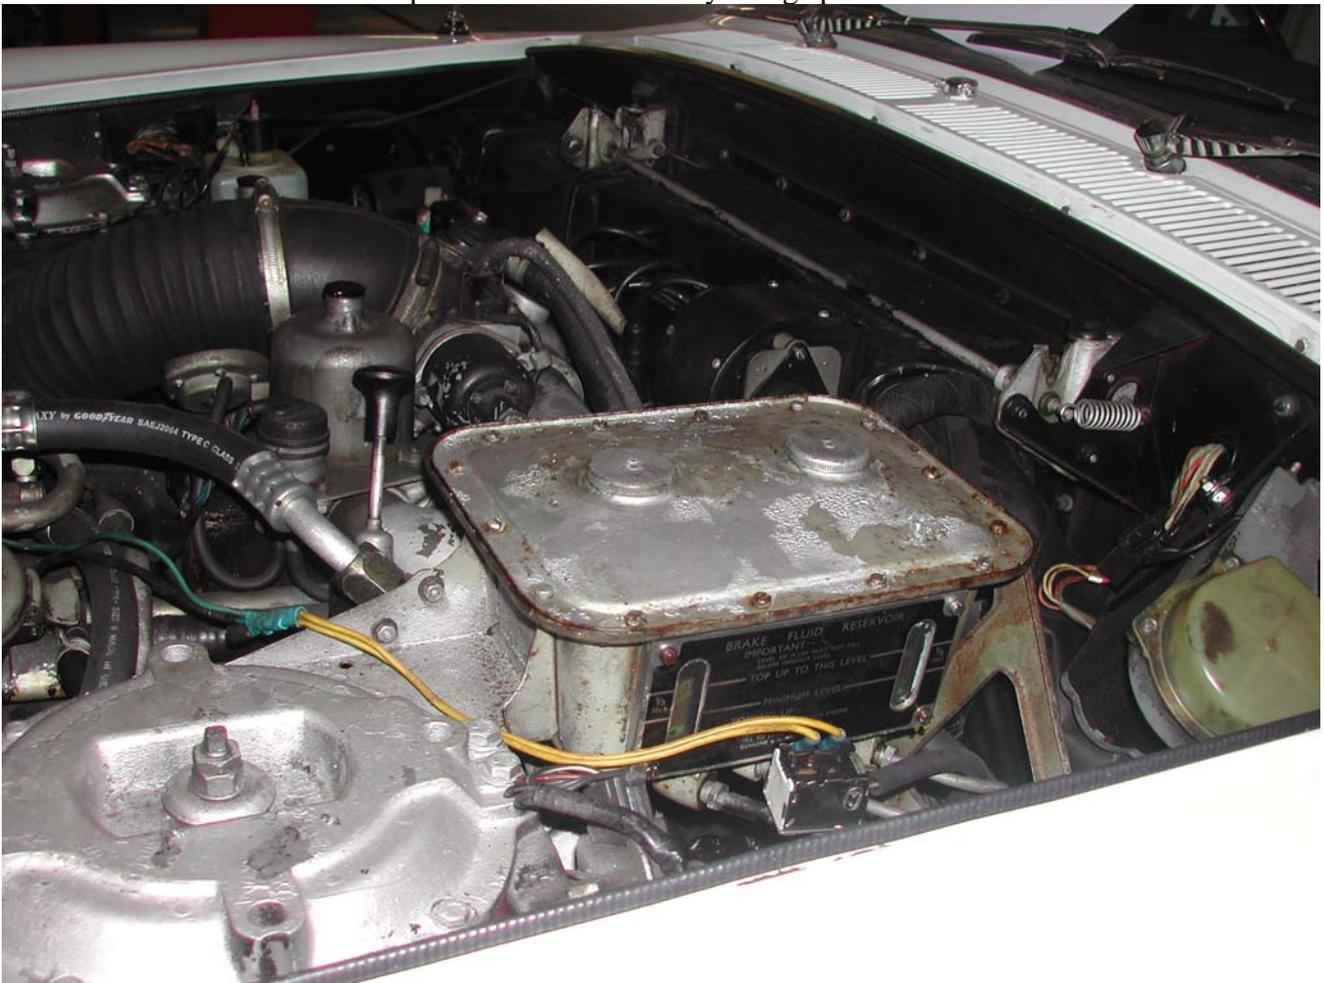
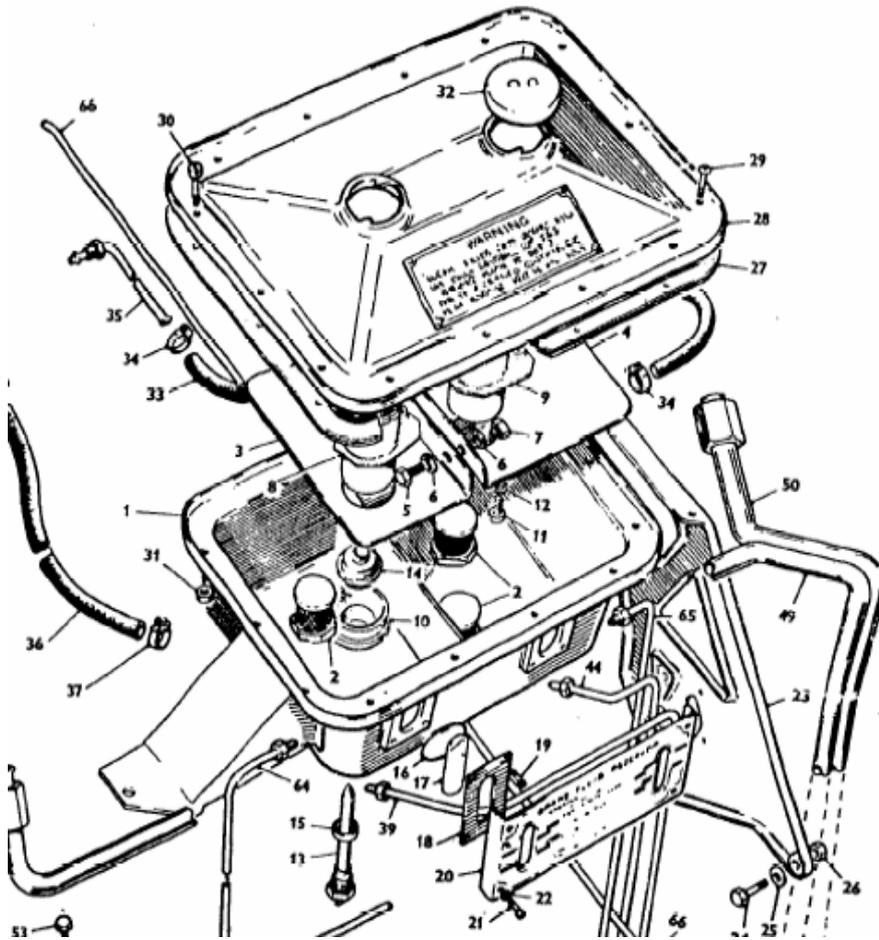
In talking about these bits I am using reference numbers that refer to parts shown in the Spares Book diagram pasted into this story. The main body can be a challenge. There were I think four iterations mainly to cope with dropping the little master cylinder feed (the lower outlet of the two shown at 2 above) and fitting reed switches (13) for the low fluid level indicators apart from changing the mounting arrangements (23). They all had common sight glasses (17) which are literally windows on the hydraulic system. The two glasses are located on 'O' rings (16) in recesses in the front of the reservoir. Two oblong plates with suitable apertures (18) are screwed over the glasses and the 'instruction plate' screws on over them. And here is the last major challenge. The four screws (21) holding the 'instruction plate' (20) usually come out quite easily. The aperture plates beneath them though have four hexagon head countersunk screws (19) that can be quite difficult to remove. If firm pressure with the Allen key won't release them try placing the side of the reservoir over an anvil beneath the screws. Place a flat round punch that just covers the screw head on the screw and give it a belt. This will usually loosen the thread and the little darling will come out. If you have to resort to drilling etc take it to a machinist and have him do it properly. The screws are still available.

Get all the bits except the countersunk screws plated including the remaining screws and bolts and plates. Have the filters (2) repaired if they are damaged and check that the reed switches still have their terminals. Make sure you use brake fluid compatible 'O' rings in the sight glass recesses. If they are not they will swell up and you will see nought. When you are replacing the screws be sure to douse the threads in anticorrosive grease for the benefit of the next poor sod.. Replace the low pressure feed hoses (36) with the correct brake fluid compatible items not fuel hose nor

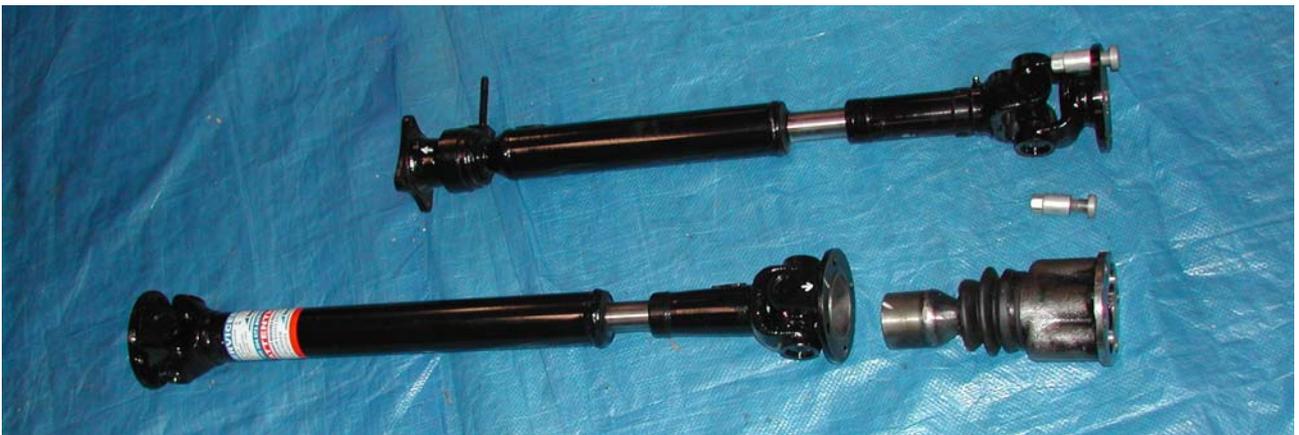
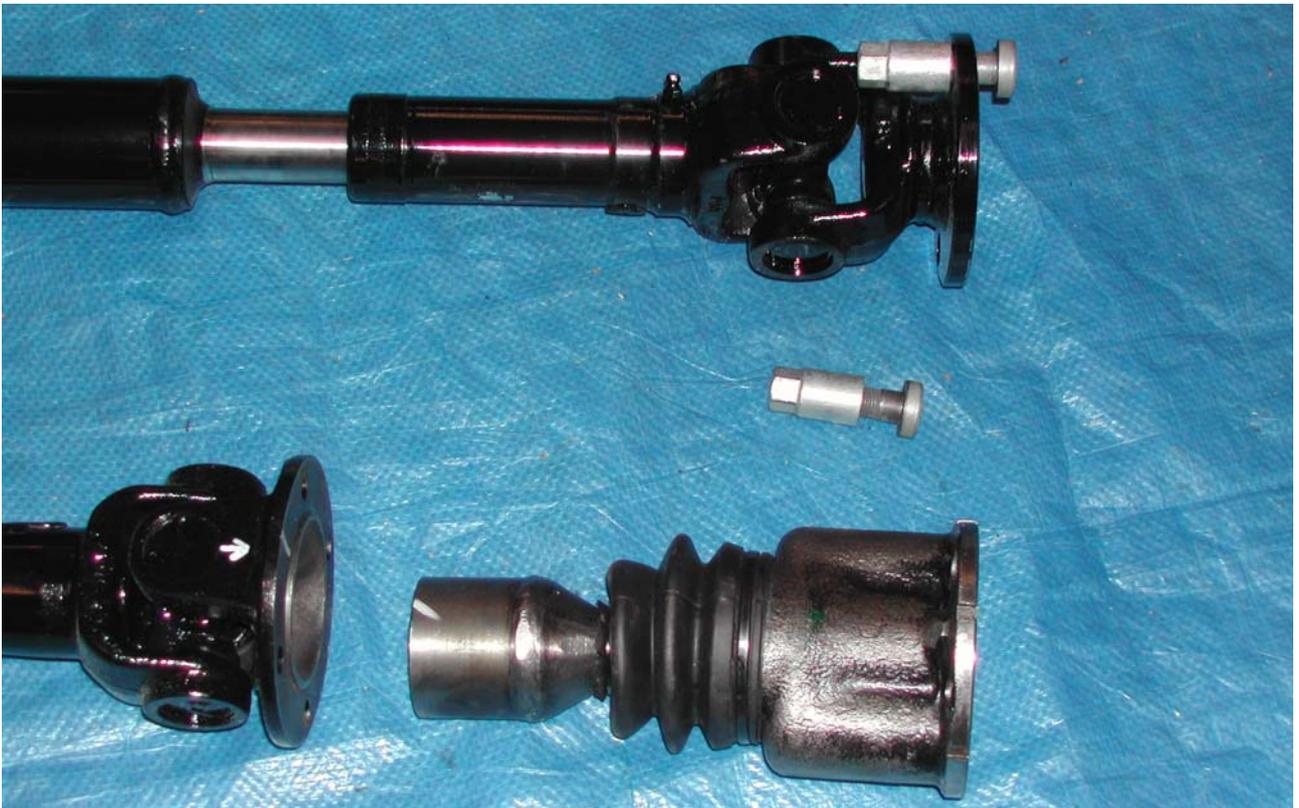
After the last issue of Topics I had a couple of mild scoffings about the damage that can be caused by a tail shaft, propeller shaft, call it what you will, that had got out of control. Just take my word for it and if you are still sceptical feed into your Google Machine tail shafts and see what they come up with, particularly with trucks! Meanwhile we have had a Cloud with a very perished rubber boot on the back of the front CV joint and quite worn universal joints on the rear shaft, not to mention a fairly worn centre support bearing!

The rear shaft shown as the lower one in the two pictures posed no great problem as the universal joints are perfectly standard Hardy Spicer units as is the sliding joint at the front of the rear shaft.

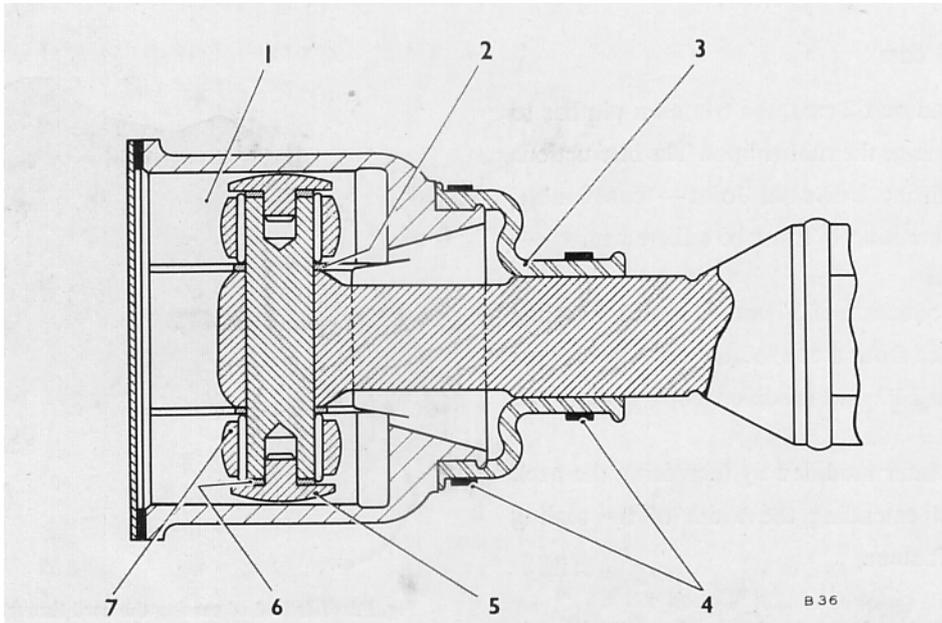
But then we needed to address the front shaft where the Factory fitted a plunge type CV trunnion joint as a means of minimising shaft vibration. As will be seen in the cross sectional drawing below, these not only provide for flexing of the drive but also longitudinal movement. With this car it was found that there was very considerable wear in the trunnion. The severed joint above has had a non standard boot fitted to replace the original item which was perished and broken. If you want

Having found the joint worn I enquired about the replacement cost of the trunnion (1 in the drawing) without the associated pin rollers and buttons. It was apparently \$3600 and since we couldn't get one the colour we wanted (joke) we decided to scrap the

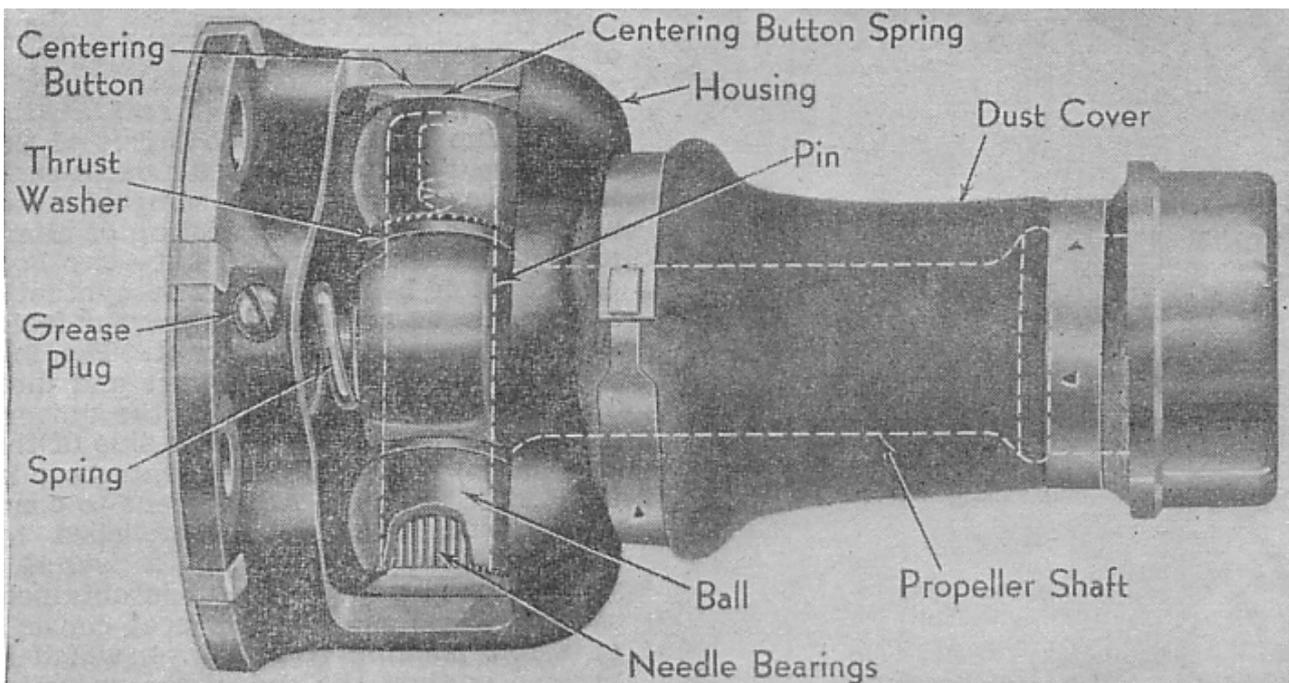
design. The alternative universal and slip joint is shown fitted. This is the standard approach to this problem I am advised and having had it applied some 20 years ago to a local S2 Bentley with complete success, I have no doubt this latest application will be similarly successful. What is important is the subsequent balancing of the two shafts AS A UNIT. This of course has to be done by specialists who will paint correlation marks on the adjacent joints as they were setup in the balancing machine.

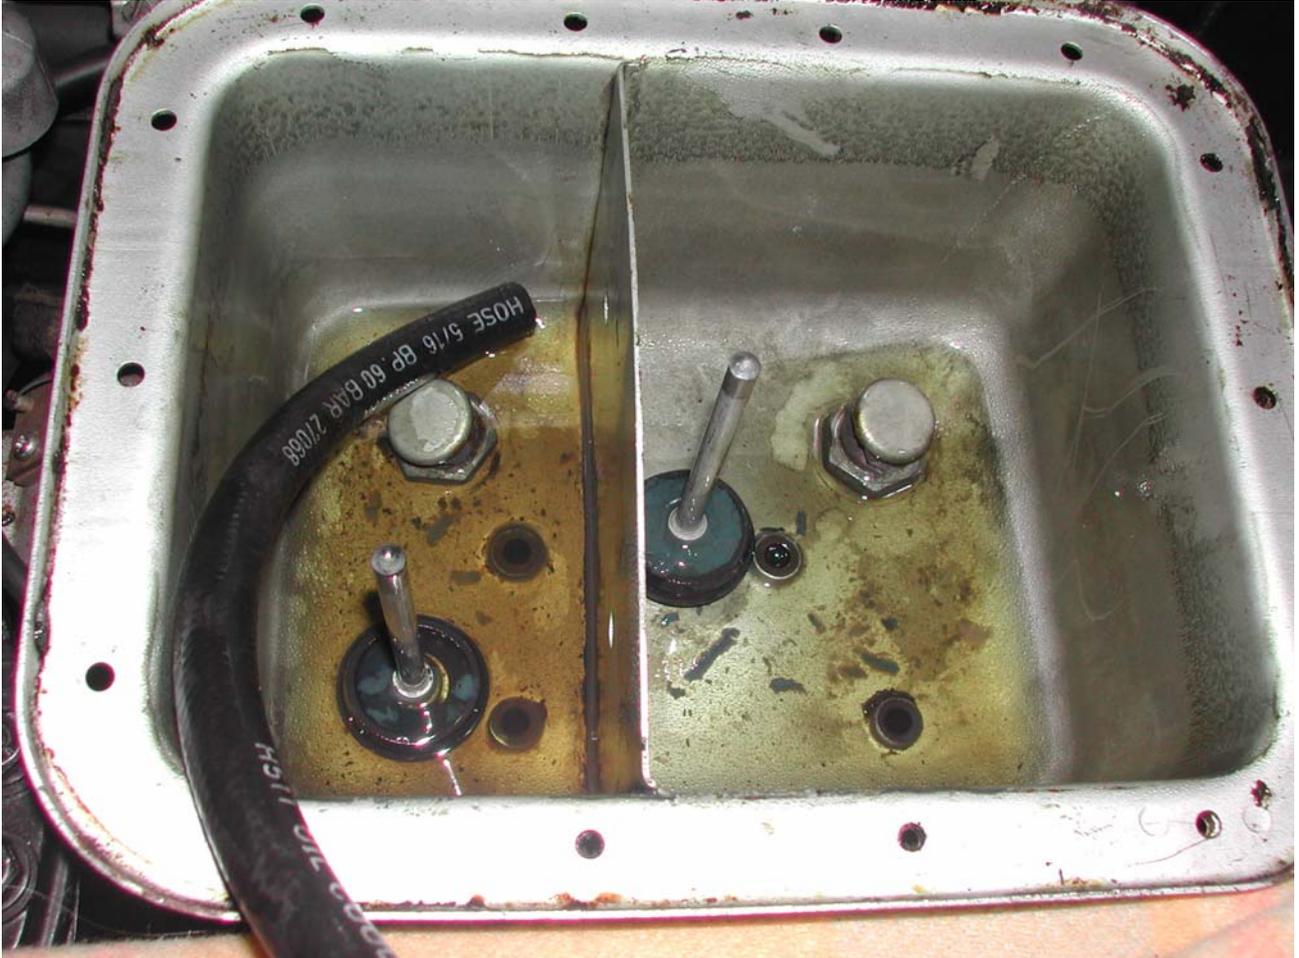
Back to reservoirs and here is a first hand example from an otherwise immaculately maintained Shadow II. This car had all its brake hoses replaced 12 months and some 7000 miles previously. Needless to say the system was thoroughly flushed and refilled with the old version of RR363 not that the latter category would deteriorate any faster than the new stuff. At any rate the muck seen above accumulated in that short time. After cleaning out the reservoir some 8 litres of the new RR363 were flushed through the system and it will be interesting to see the bottom of this container in another year!

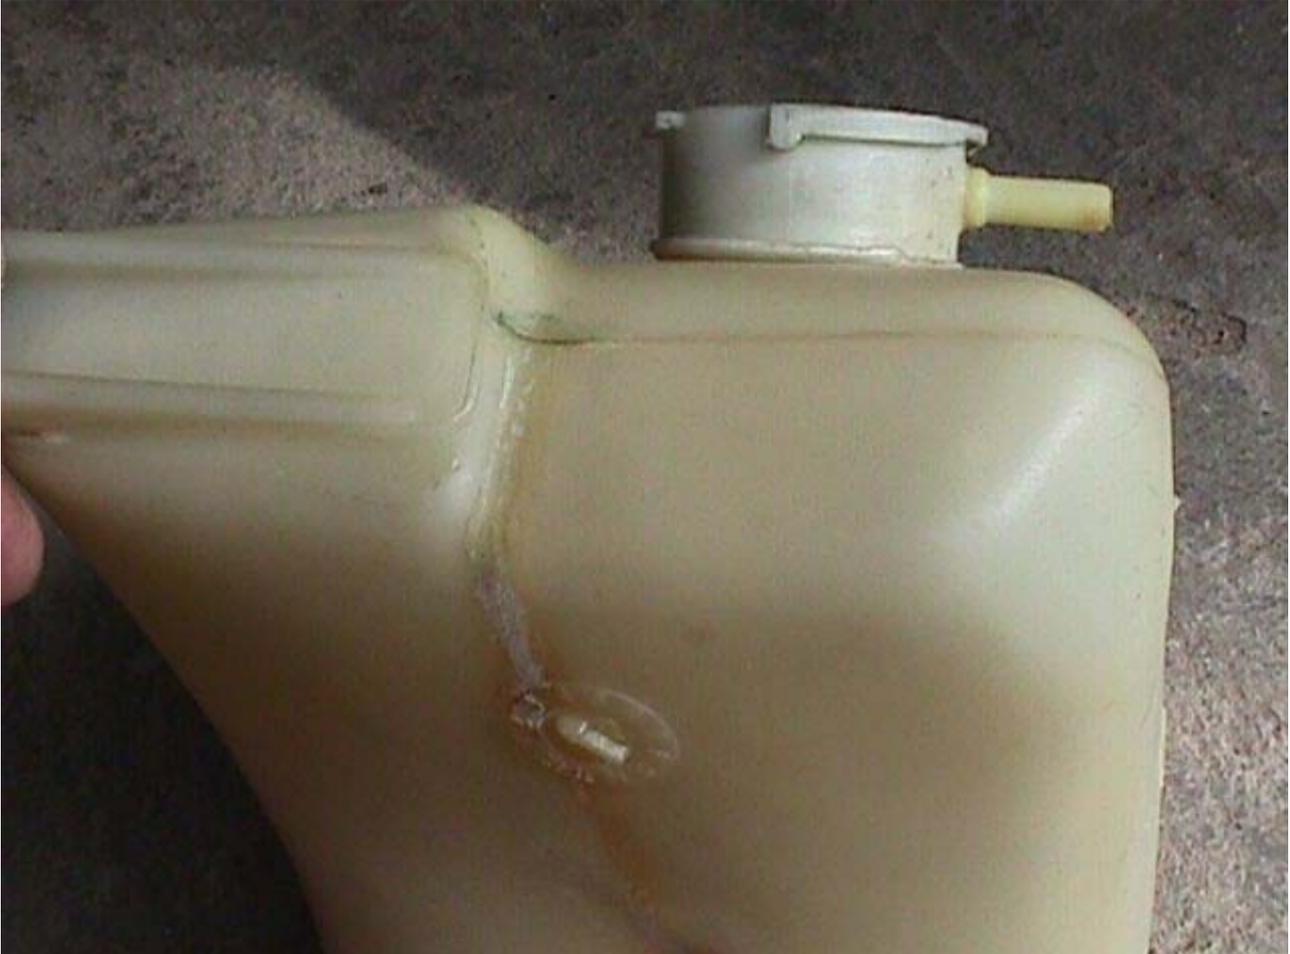
installed the Turbo R's coolant bottle last night after work and here are the pictures of the failed unit removed. One is, as we would more readily recognise it and the other, a close up, shows the staining from the fracture in the seam weld almost at the top of the unit, well above the high mark for the coolant. While almost no loss of water has been detected during my two years as custodian, there was however, no pressure in the system it would seem. This only became evident late last month, the day we had a rally to Palm Beach via the northern beaches of Sydney. It was a very hot day reaching about 40C. In really heavy traffic the temperature gauge climbed to the extreme high end of normal. I turned off the air conditioning and drove with the windows down which was rather pleasant, along by the beaches. Once the traffic thinned and a decent speed was attained, the temp gauge returned to normal. I thought it was the electric fans not working but all was normal in that department.

I would think that an annual pressure test by one's friendly radiator man might be good practice as well. As you might well imagine, if the fracture had been a little further to the left it would have been obscured by the wiring loom. I will be testing the car on the next "Stinker" and duly report the results. Hopefully it will be good news.

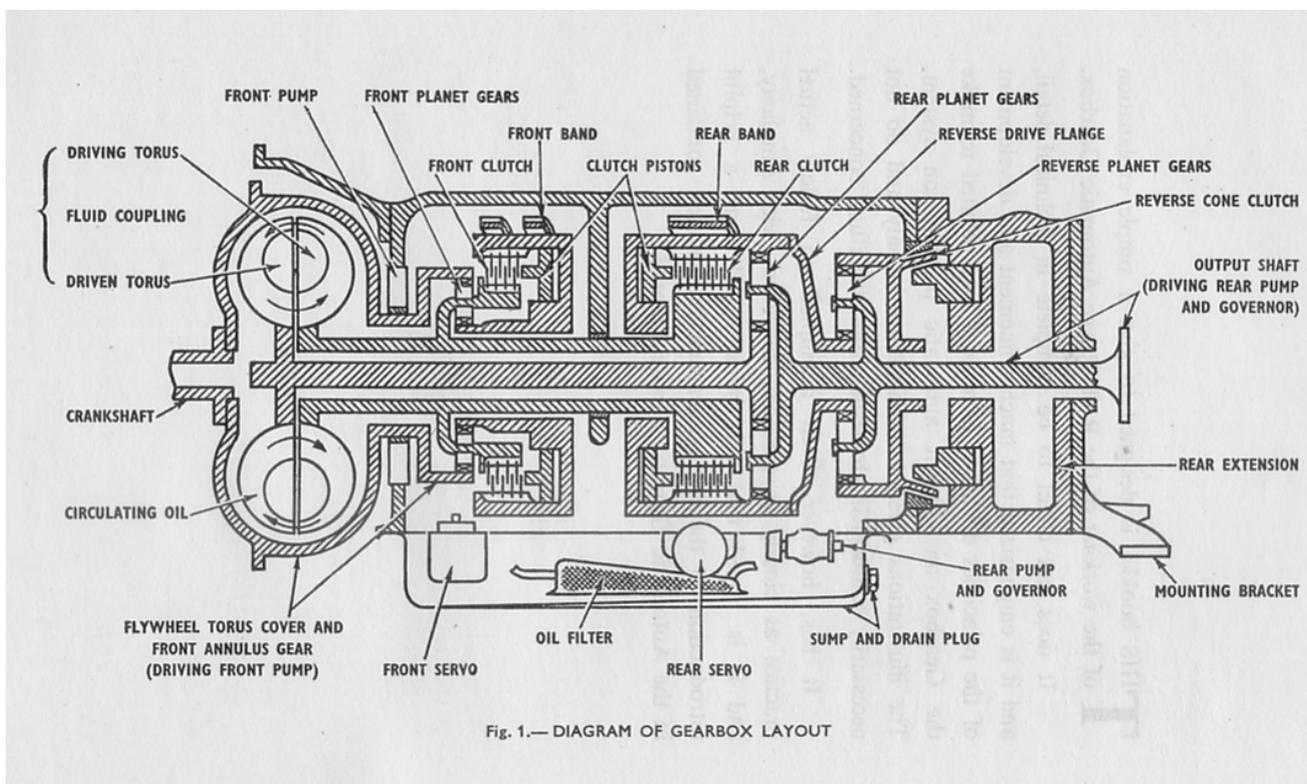
Checking the oil level should be done with the transmission hot, the rubber bung out of the floor, the dipstick withdrawn and wiped and laying on the festoons of rags you have spread about the hole

to catch the inevitable drips! With the engine running at a slow idle, and the handbrake hard on, move the selector lever to each position for a few seconds returning to 'N'. Then dip the stick and withdraw it. Check the level. It should be just on 'H' not above it. If it needs topping up – use good old Dexron and be very sparing with the pour as it doesn't take much to lift the level. If indeed you overfill the box, it is not necessary to turn the car upside down to get the excess out.

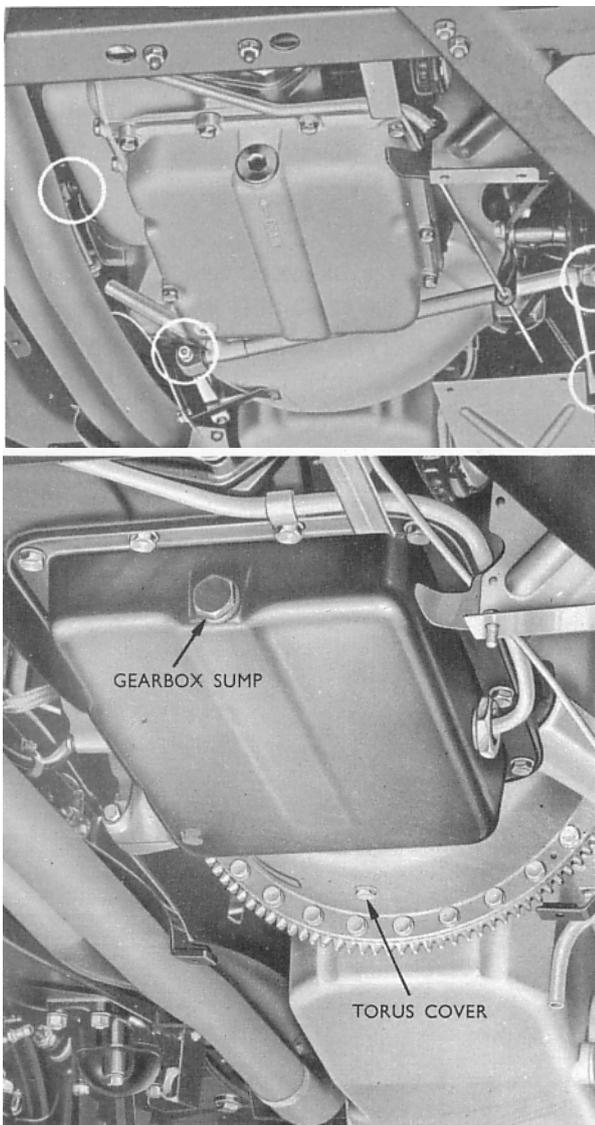
Preferably this is done at the same time as draining the sump. The catch is that it involves more work and disturbing some more bits. The circled bits to the left are the disconnection points for the gear change mechanism. This is also a good time to clean these joints out and if necessary fit new boots, grease the joints and adjust them so that there is just no play. Having got the levers etc off the next step is to remove the torus cover just ahead of the gearbox sump.

The picture below shows it all. Obviously you will have to turn the flywheel round with your hands to get the drain plug to this position. The little plug in the cover has a very small thread so should you drain the torus be very careful to just nip the plug up preferably with some nice Loctite on it to stop leaking and coming undone! Modern torque converters are virtually undrainable so an oil change in one of the later boxes is always going to leave a bit of the old stuff behind. Given that only a pint of oil is left behind in the torus in the early boxes, it hardly seems worthwhile risking stripping the plug and/or having to take off the levers etc.

The more observant of you will identify the chassis in these pictures as that of an 'R' Type Bentley. That is because my manuals on this box in that model are the best. The pipe seen coursing around the sump in the lower picture is for the hydraulic ride control used in the pre-Cloud days! And
