# TEE ONE TOPICS

Issue 52 April, 2006

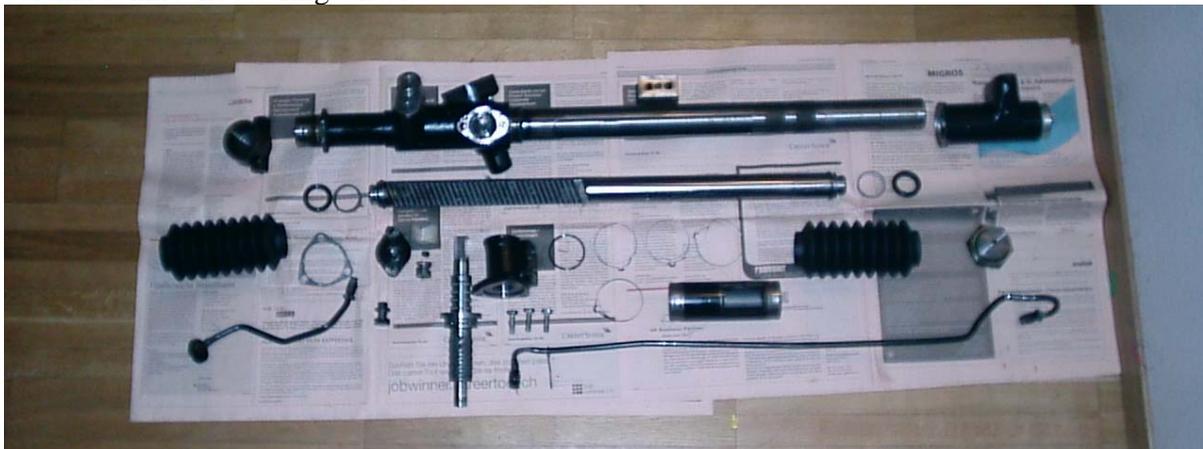
**Above:** Richard Treacy gave up when his third exchange rack expired and decided to overhaul the thing himself. Kits are available for the do-it-yourselfers but as cavalier as I am I would avoid the task particularly as removing and replacing the things is not the most enjoyable of tasks.

He is now consulting with various authorities and hopefully we will benefit from his observations. The opening pictures are of his rack dismantled. My experience? apart from removing and replacing the units, none. But only yesterday I had a call from a friend down the coast who has a leaking rack. I had it professionally overhauled not four years or 90K kilometres ago!!!

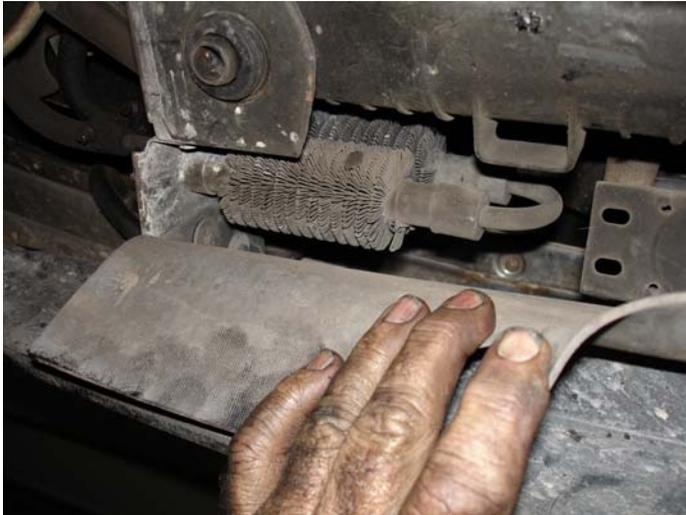
**At Left:** The little oil cooler under the radiator of the Spirit seems to be a token effort at trying to keep the internal fluids at a reasonable temperature.

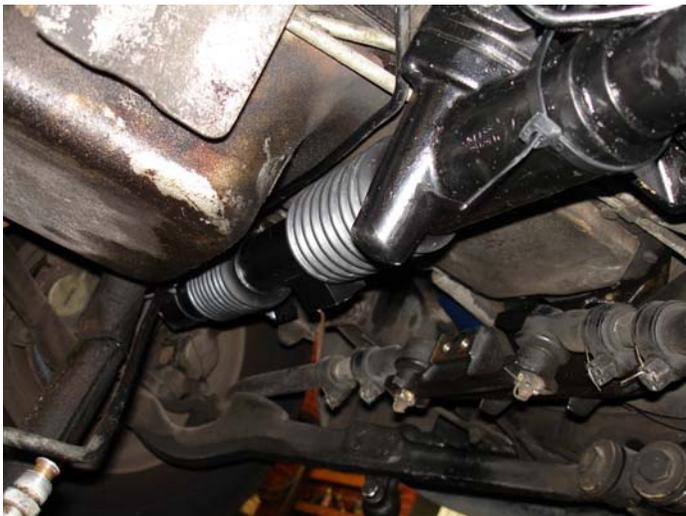
**At left:** One reason I do not remove and replace racks for recreation is the small task of trying to hold the unit which must weigh some 40 lbs while you are trying to thread the pinion shaft onto the end of the steering column and then start at least two of the 4 large bolts that secure it to the sub frame. The plastic tie strap seen poking out on the right of the picture is my method of loosely supporting the thing while you swear and grunt. The large straps are adjustable and are more than adequate to take the weight.

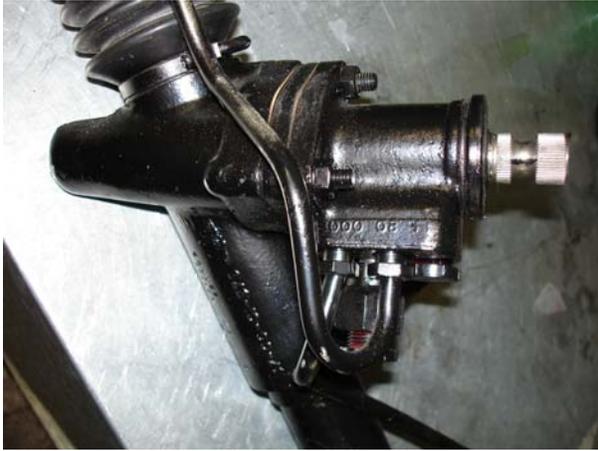
**At left:** The dreaded spool valve which controls the amount of hydraulic assistance to be supplied to the rack. The splined shaft connects to the steering column. This bit of the assembly seems to require more precision in setting up than a Swiss watch!

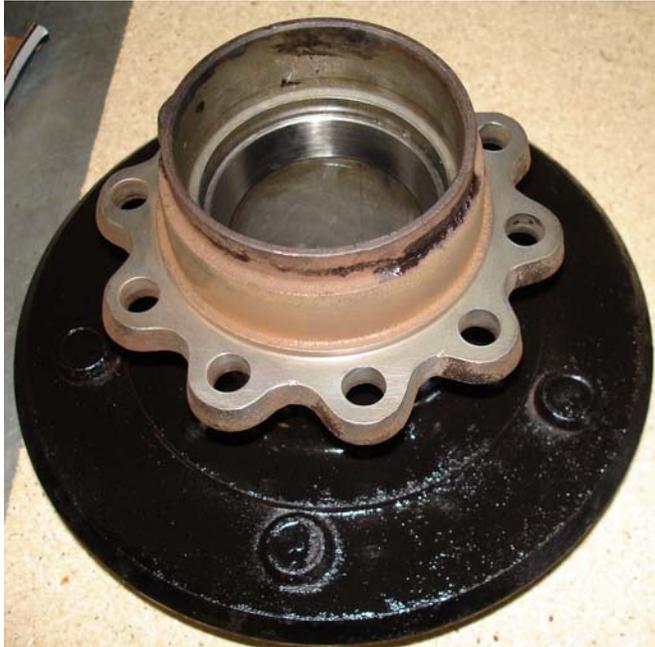
**At left:** The basic hub on which you rely to stay alive. Nestling down inside you will see the outer cone of the inner wheel bearing. When brake rotors are replaced it is not a bad practice to replace both the inner and outer bearings. They are not expensive and although they wear well it is a nice bit of prophylaxis to replace them. It is also a good time to carefully inspect the wheel studs lest some zealous tyre monkey has laid into them with a rattle gun and screwed the life out of them.

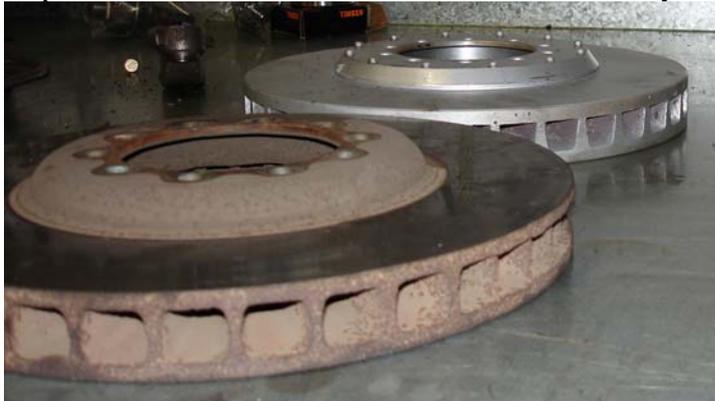
**At left:** Old and new replacement rotors. Notice the difference in thickness due to grinding. The old rotor in this case was well below the minimum required thickness. The new rotor in this case was manufactured for R A Chapman Automotive in Melbourne, the only after market supplier of brake drums and rotors for our cars.

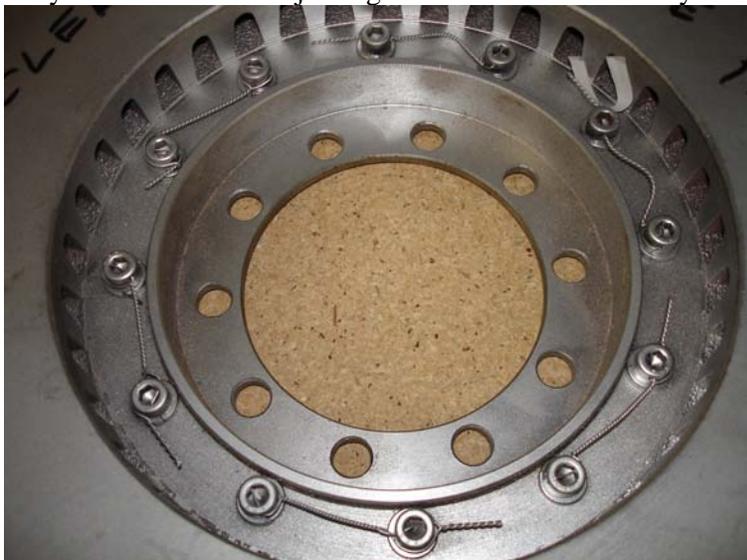
**At left:** An internal view of the Chapman Rotor. Note that it is comprised of two pieces, a small hub and the brake 'disc' itself, the two being bolted together. This is considered a more substantial method of connecting the two pieces and in addition when the 'disc' is worn out it can be unbolted and a new one fitted to the hub. This is a considerable saving as the central hub is the more expensive item to manufacture.

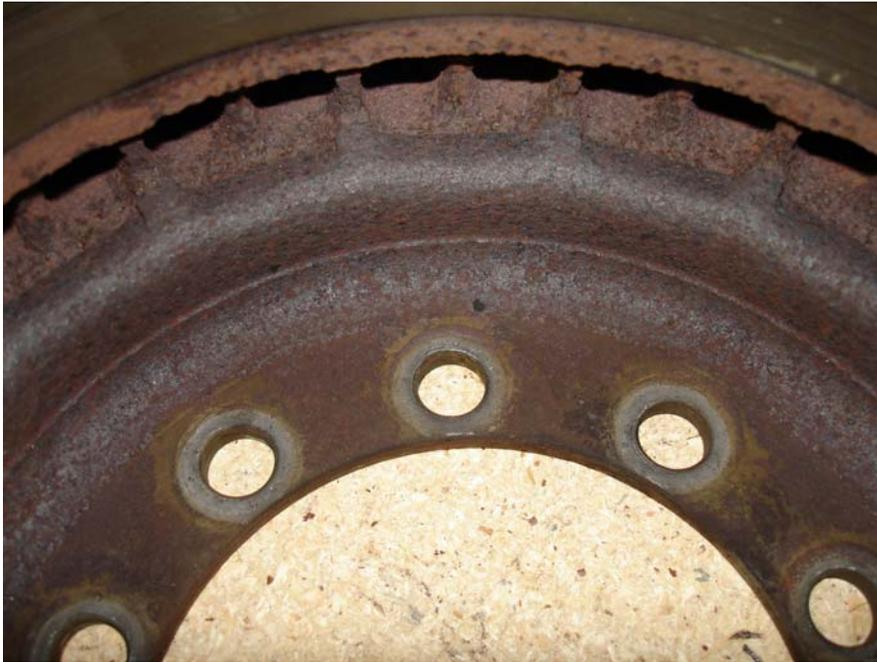
**Below:** For comparison, the genuine item which uses a method of crimping the 'disc' to the hub. Unfortunately the crimping is subject to rust particularly on cars imported from the UK to the extent that the 'disc can shear off the hub!

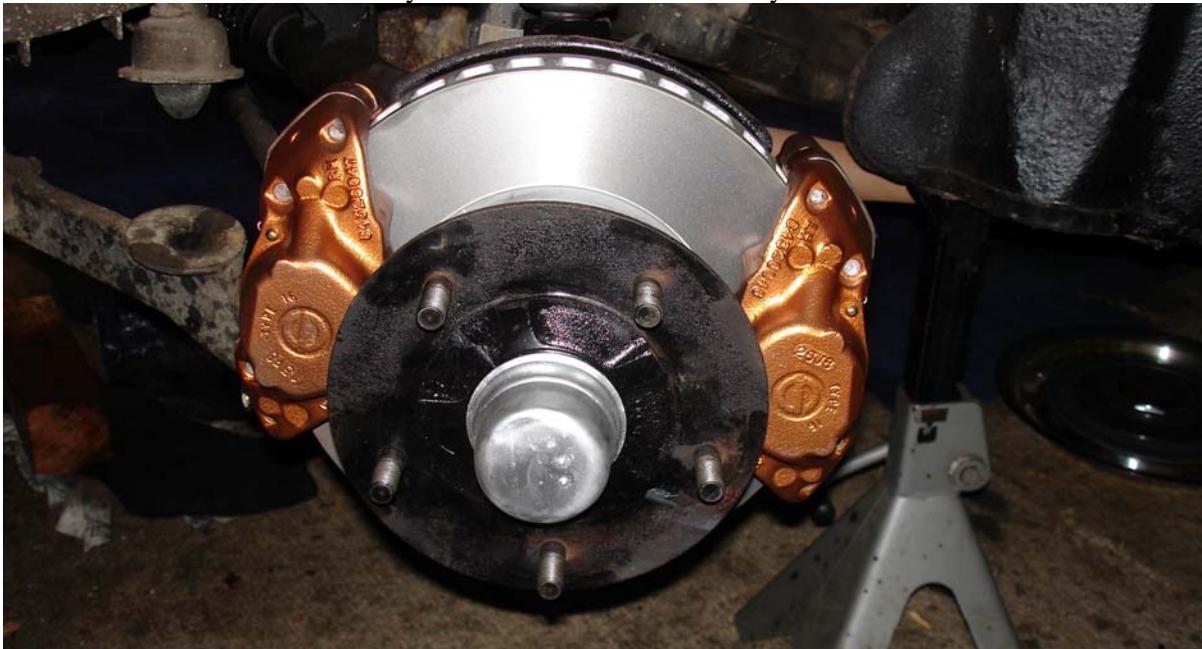
**Above:** While you are at it, have you had a good look at your callipers lately? Unlike disc brakes they really give very little trouble. Giving them a good clean with a strong hose and keeping an eye on the rubber boots is about all that is required apart from ensuring that there is plenty of meat on the pads.

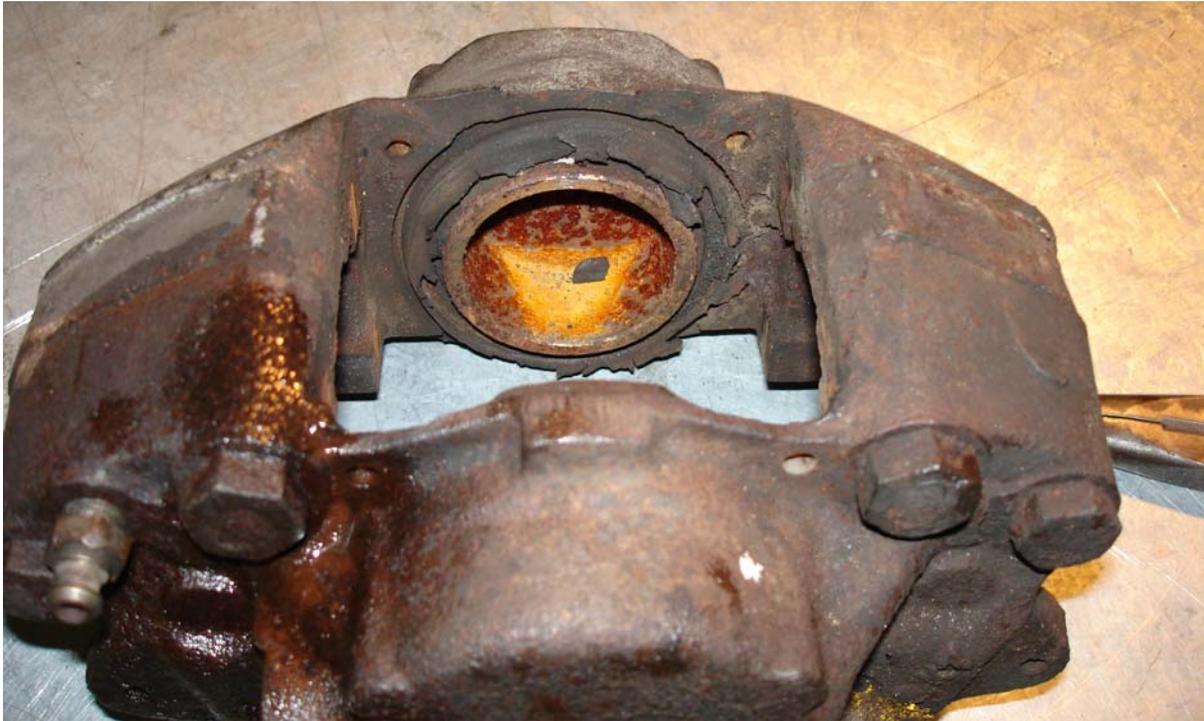
Here it seems nobody bothered to look at the boots on a 1978 Shadow II. I suspect they are the originals. Note the burred bleed nipple. Please don't do that!

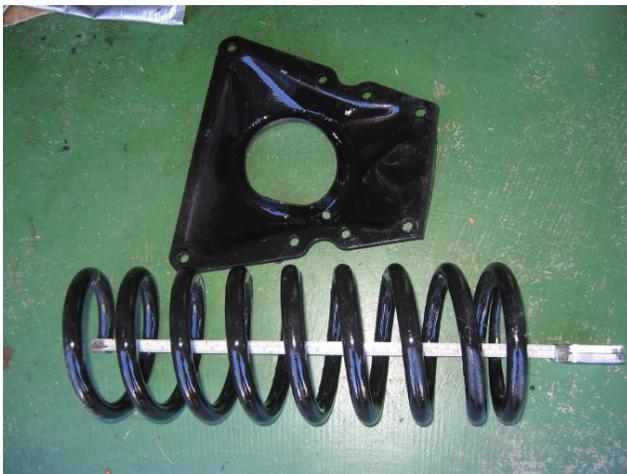
**At left:-** Part of the rather ingenious supporting system for the front springs. Note that the top of the spring is ground flat but the bottom is simply cut off. The later fits into a dinky little hole in the support plate shown here. Being picky, the Factory were very fussy about not having paint between mating surfaces particularly around bolt holes. The easiest way to fix this is after painting wack a suitable size rotary brush in the power drill and polish off the offending paint.

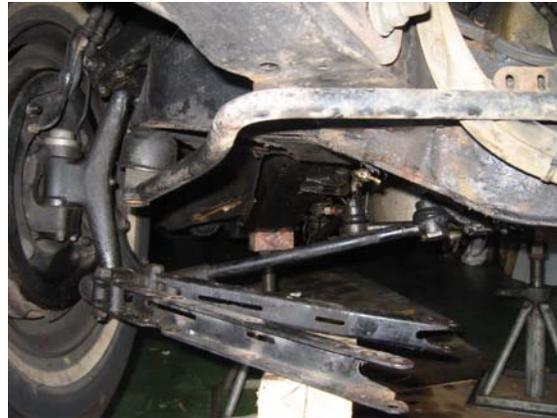
**At right:-** The lower control arms with the threaded piece seen in the previous picture removed. Note the relatively light structures of the suspension. This was beefed up considerably in the S2 and S3 chassis.

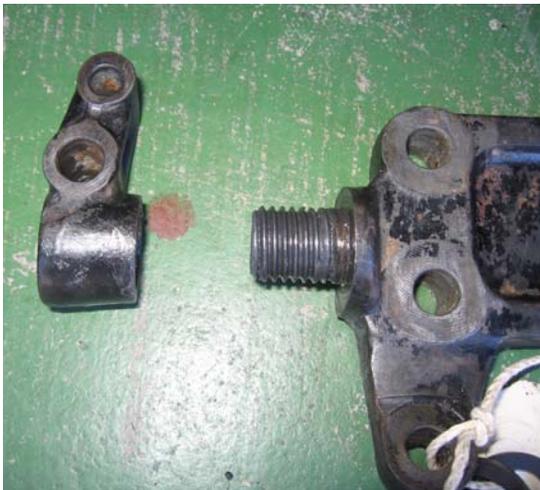
**At left:-** a typical threaded bearing used on all the S series. The piece to the left screws onto the central mounting plate at the right of the picture.
