TEE-ONE TOPICS

Number 55 July, 2006

LEAKING HYDRAULIC PUMPS

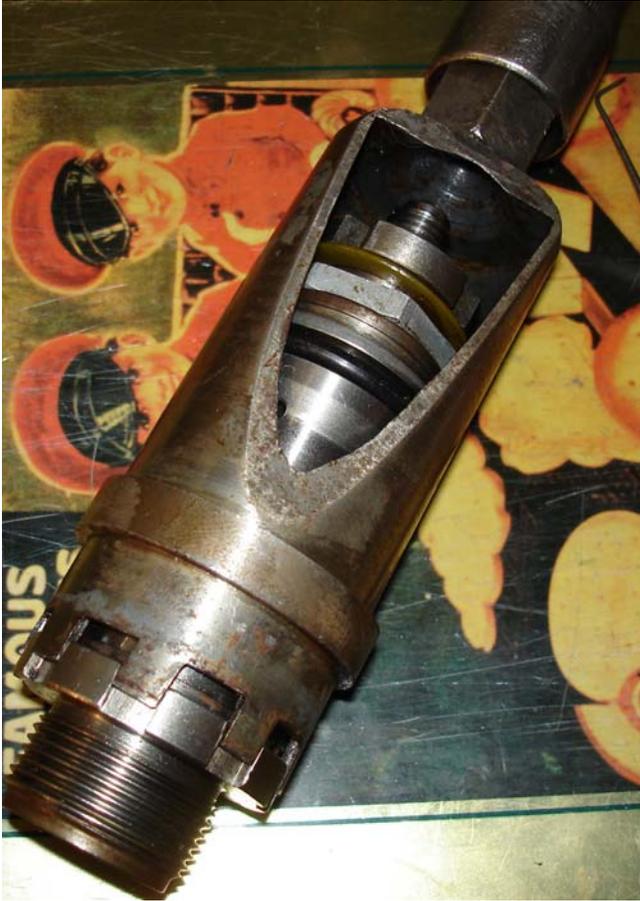
If you are fortunate to have a pump spanner, having removed the outer casing of the pump and the two pipes attached to it, you can easily screw out the whole pump. In the picture to the left one of the upper 'O' rings can be seen through the aperture in the spanner. These spanners by the way can be made by any fitter as long as you give him a sample pump to get the serrations right.

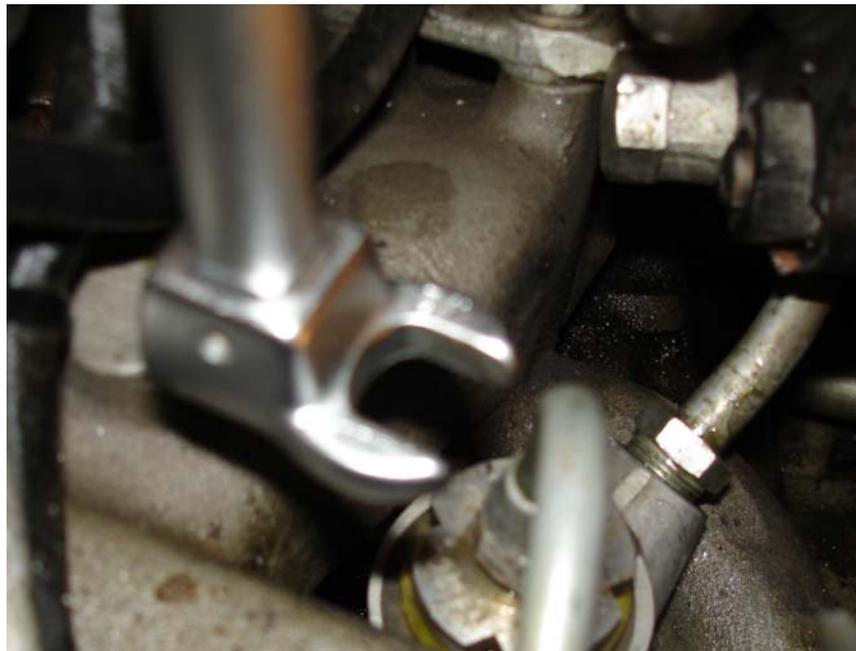
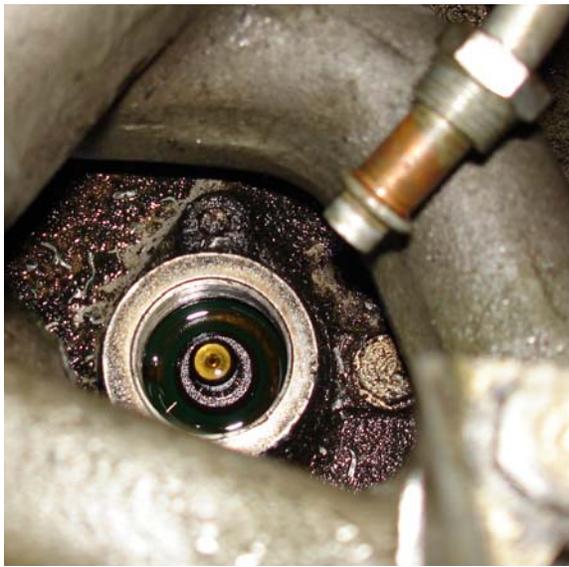
At left we see the evidence of a leaking pump. The pushrod coming up from the camshaft department is also visible. And below is a view of the bottom of the pump showing the base of the pump plunger. It is the gap between these two that broadens with age that gives that characteristic clacking noise common to post55 cars. When replacing the two principal 'O' rings you should also replace the small 'O' ring on the neck of the inlet pie seen at left.

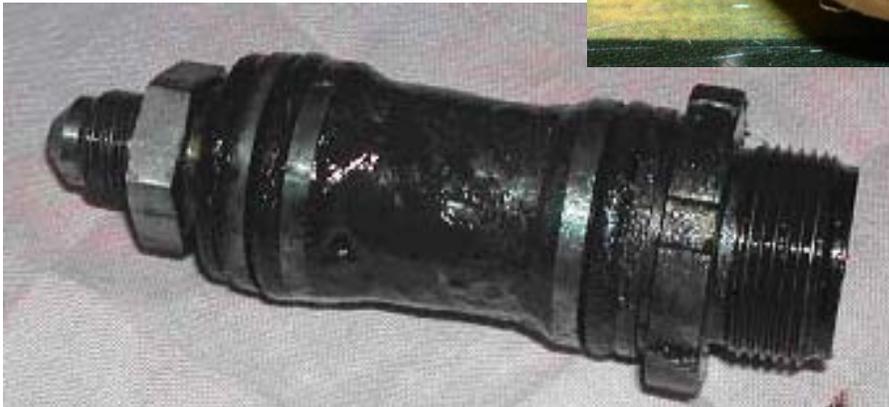
Hopefully you will not see a dirty pump body like the one below when you remove the casing. This is a result of not regularly changing the brake fluid in an RR363 car. What can be seen are the upper and lower 'O' rings which you will be replacing.

And here is the pump in section. The dark dots are the errant 'O' rings. There really is little to go wrong with these pumps other than they get clogged up through neglect.

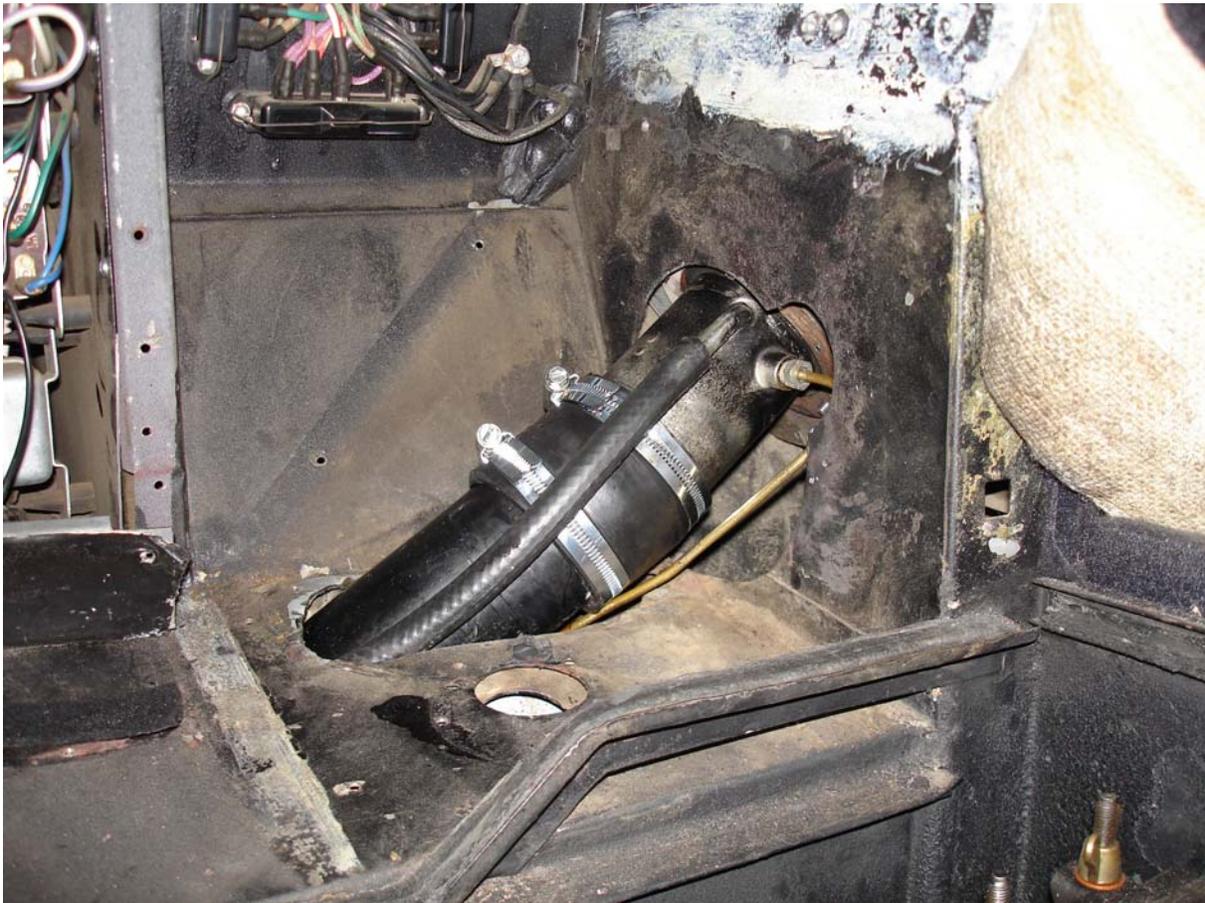
There were reports of the smell of petrol in the rear compartment. Not an unusual complaint in any car but considering 36 years to brew up a leak I thought it must be a perished hose. The large one seen in the above picture is one of two. The actual filler tube is screwed to the body shell and the tank, is slung from the chassis. The latter area it will be appreciated is subject to a certain amount of movement given the weight of a fuel tank and the fact that it hangs out beyond the supporting rear axle. Certainly the body which is flexibly mounted moves relative to the chassis so a flexible joint between the filler tube and the tank is required. But the distance is significant so the Factory placed a bent tube which can be seen in the picture in the line and connected it with two large diameter rubber hoses. The latter by the way are perfectly standard hoses available from your local friendly hose man.

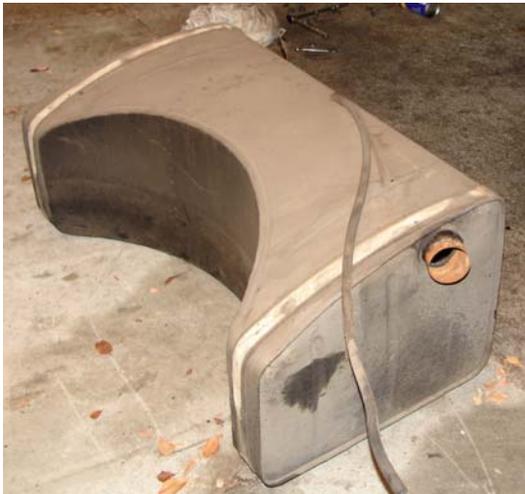
The other possible source of smell was the blow back tube. This is seen snaking up the outside of the main filler pipe and vents immediately below the filler cap inside the filler tube. At left is the hose on the top of the tank. This was a modification on early Clouds and later Phantoms to stop blow back when filling with high volume refuelling hoses. The modification was simple but time consuming. An 'L' shaped pipe was fastened into the top of the tank and the hose above was connected to it. Air trapped in the tank during a fast fill is then able to flow out right at the filling point

The blow back pipe is simple standard fuel hosing not even clamped at the tank end since there is absolutely no pressure. The hose lies across the top of the tank untethered and I wondered whether this might weep with wear and age!

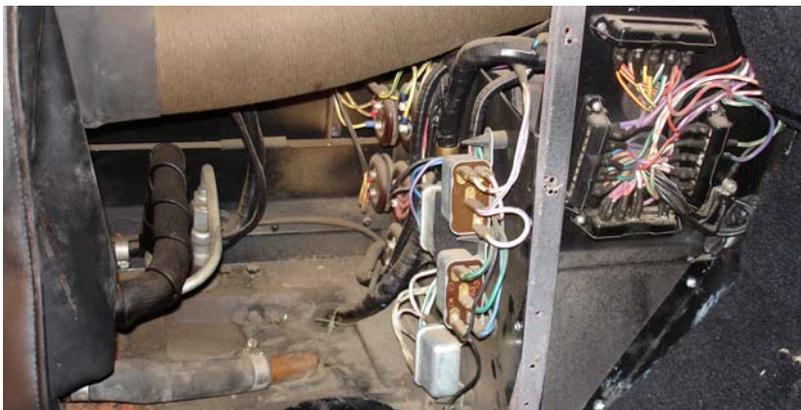
And at left is the maze of wiring and relays to control the rear seat weather. The whole lot could now probably be handled by a small printed circuit!

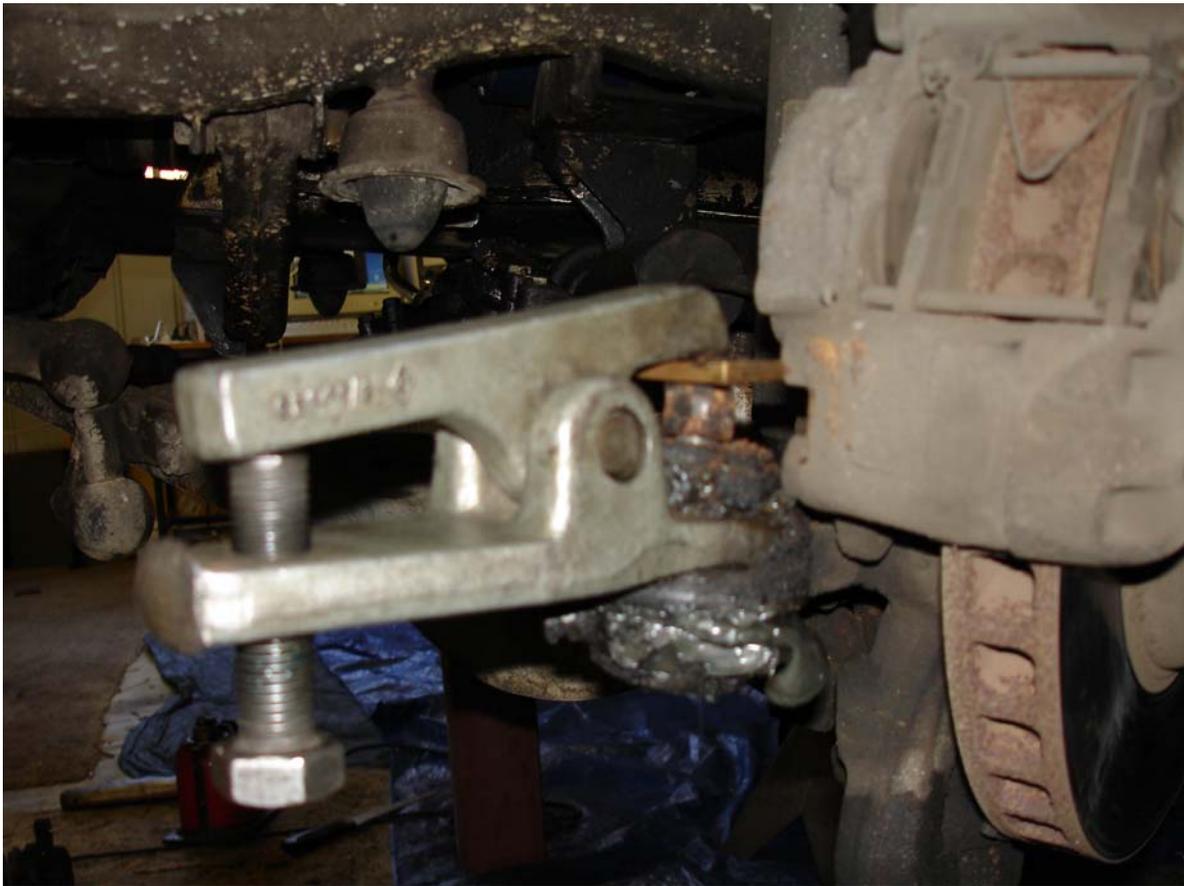
You can buy a 'U' shaped wedge that can be driven between the steering arm and the joint. But as this has to ride over or under the grease retaining rubber boot protecting the joint, the latter is usually badly damaged in the process. The remaining method involves pushing the tapered pin out of the arm. The factory advocates specific 'pushers' which they make and supply but of course not to John Owner and service organisations are a little reluctant to hand them over! One solution I have used for many years is the scissor pusher seen in the picture. They are readily available and

universal in application. They are incredibly strong, the only thing likely to fail are your nerves. I have done one of these up so tightly I frightened myself. Turning to get a larger spanner, there was just one Hell of a bang and the whole thing came apart as I almost did!

The only limitation with the tool is getting it on squarely and the amount of 'gape' the tool can handle. If the distance the thing has to open is too wide there is not only a possibility of it slipping off backwards but also damaging the end of the pin. As far as thread damage is concerned try and loosen the nut on the pin until the face of the nut is level with the top of the pin. Then if there is room pop a small piece of brass in between the pusher arm and the nut. I apologise for the messy picture but I think you can see what I am preaching.

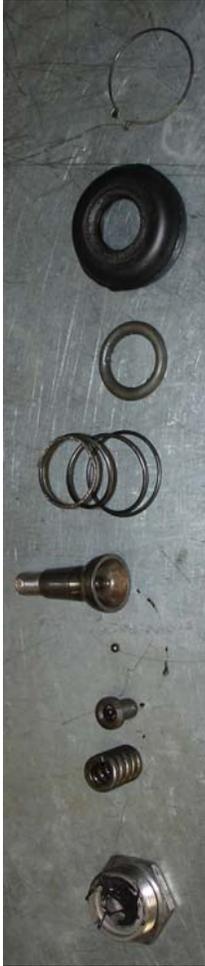
At left: The guts of a Shadow II tie rod end. The tie rod with its housing is still on the car. Starting from the bottom is the base which screws into the housing. The spring sits in the base with the 'top hat' bit poked into the spring, next comes a tiny ball bearing which sits in a recess in the top hat. Then there is the ball pin itself in which can be seen a machined recess to match the ball bearing. All of this is screwed very tightly into the main housing when the actual frictional load can be checked by rotating the pin with a tension wrench. The tension can be raised or lowered by placing steel shims under the rim of the screwed base. It's all in the manual. Before poking the ball pin back into the steering arm the rubber protective boot has to be installed. The large loosely coiled spring sits on the top of the ball joint housing, the dished washer next sits on top of the spring then the boot and finally the circlip clamps the boot to the housing. No wonder they gave this design away!

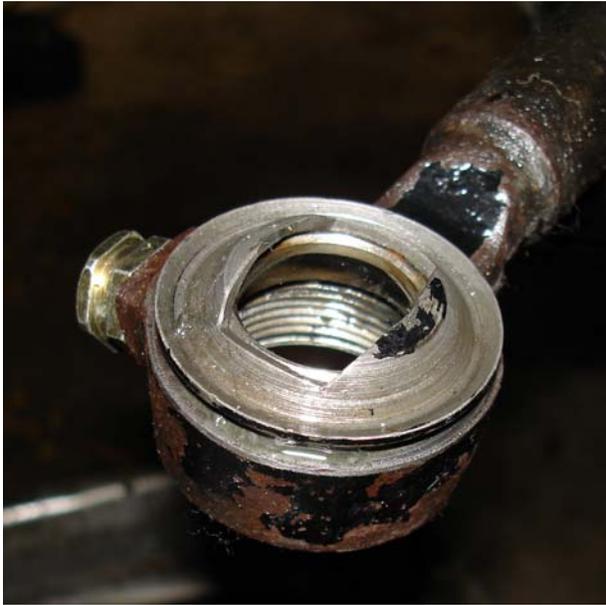
At left:- Here is the tie rod housing into which all the gubbins screws. What you don't remove is the upper bronze cup into which the ball pin is forced. This can be seen through the central hole. If this has to be replaced it requires a press to remove it.

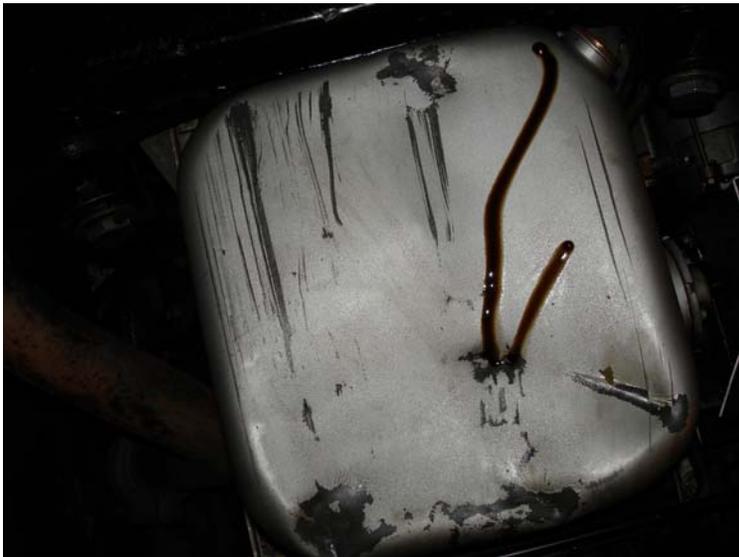
An old saying but my way of warning drivers to be aware of what is dangling under their car as well as watching out for the glossy paintwork! The picture is of the former sump on my Silver Spur. Forgetting that we were not in the 4WD I gently nosed down a track that had been built up with sand. That in turn had been well rained on but it was smooth the slope was negligible and the track was interesting. I stopped to point out something and when I went to move off there was a scraping noise much like a branch caught underneath. Given that there wasn't a likely looking branch in sight this simply demonstrates my optimism! The following morning there was a nice little oil slick running away from the car. Hope springs eternal as they say and I concluded the rear engine oil seal must have given up.

Eventually back in my own garage, I jacked the car up and was greeted with the above sight. The 'branch' I had run over was a rock under the sand. The wheels had sunk into the damp sand just enough for the sump to engage the rock and my driving off did the rest. One of my mentors said that sump casualties were almost common and what was more interesting was that drivers seldom realised that damage had been done.

Repairing the sump is apparently seldom practical and hopefully a replacement can be found from a wreck.

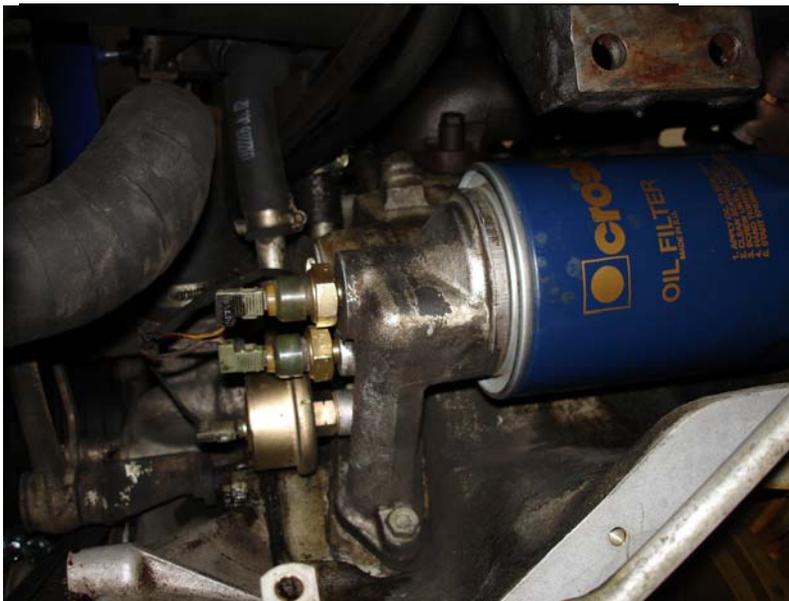
First step is to get the front of the car nice and high on stands under the front jacking pads under the front doors. Don't have the car too high or you will tire reaching for the various bits. The sign on the windscreen says sump drained in case someone wants to demonstrate how well the thing starts.

This should be a familiar sight, assuming you change your own oil filter. The three gadgets screwed into the filter pedestal need watching for leaks. The 'tin can' at the bottom is the variable rheostat that sends messages to the oil pressure gauge on the dashboard. The other two are standard switches, one turns the oil light on the other cuts out the fuel pump(s) if the oil pressure fails such as when you punch a hole in your sump eh!!!

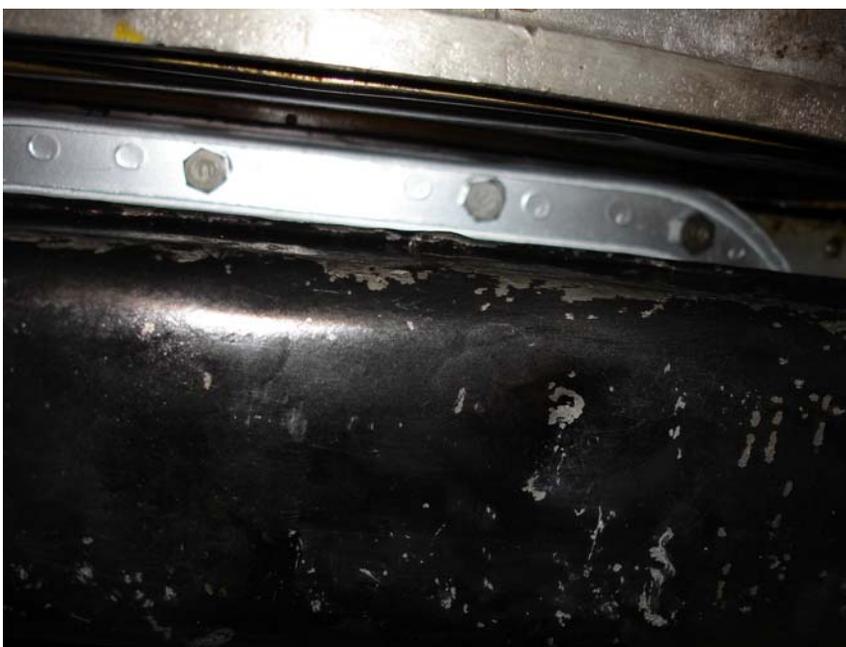
One of the more difficult tasks in this exercise is undoing the rear sump bolts. The designers carefully lined up the engine so that the rear row was just placed so that the row you see here was not quite accessible to anybody but ET! Worse still the bolts immediately above the rear cross member seen filling up the bottom the picture would even confound ET! The solution is to suspend the front of the engine from above and remove the front engine mounting including the handsome cross member bolted either side to the sub-frame. You can do the suspending with a gadget available from most auto supply houses. It consists of a steel cross member that sits over the front

of the engine with its legs sitting in the rain channels either side of the engine bay. A central very large threaded hook depends from it on which you hook a chain. The latter is passed around the front engine pulley and back to the hook. A large nut on the shank of the hook is tightened and lo, the engine lifts and lets
