# TEE-ONE TOPICS

Number 66 August 2007

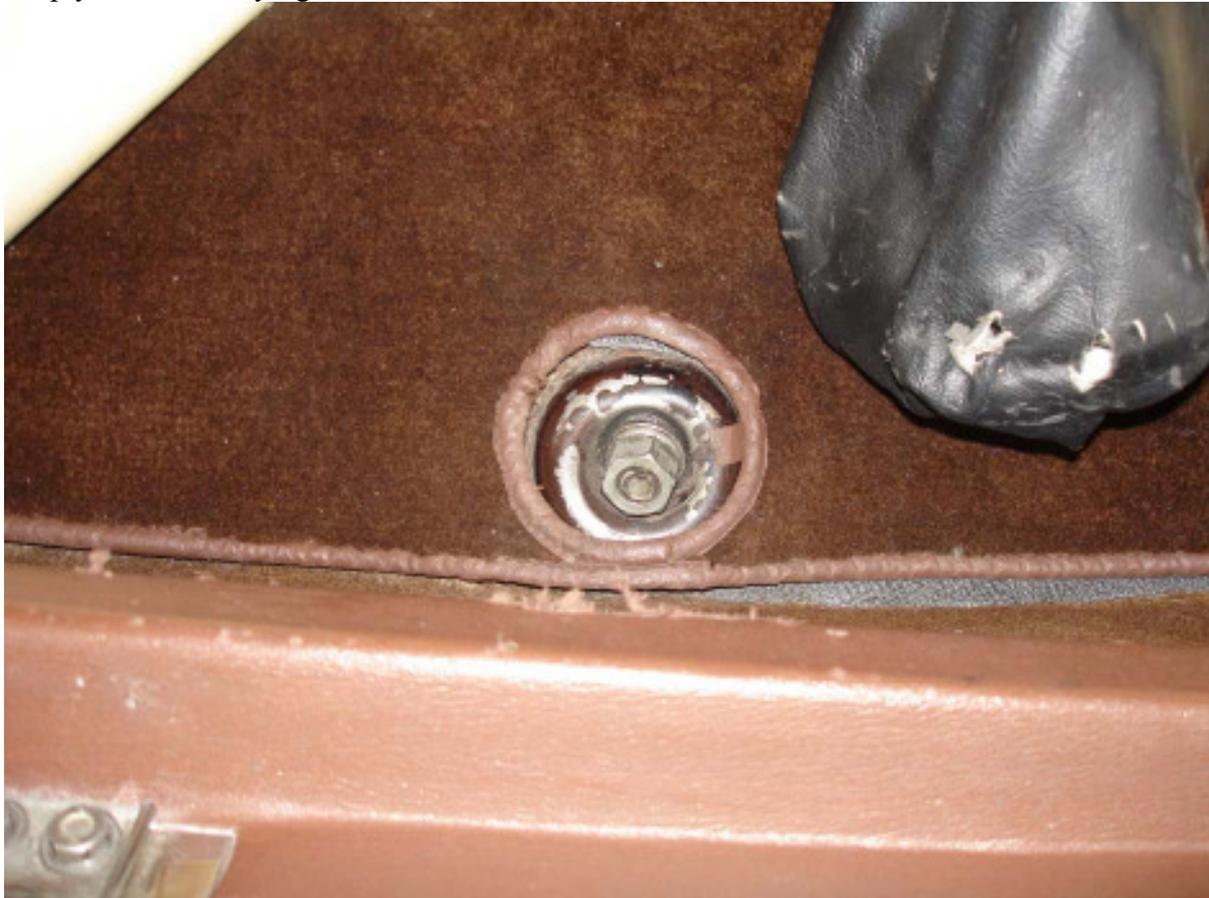
This is the trailing end of a very nice Corniche seen at the Victorian Concours. And there is the standard spare tyre lowering nut we are all so familiar with. What is different is the angle the thing presents relative to the floor of the boot. It certainly is not one of those things you undo with your little pinkies but if you put a spanner on it unless it is a very shallow socket, there is simply not enough room to do the job. And one need only look at the damage to the leather trim adjacent to the nut!

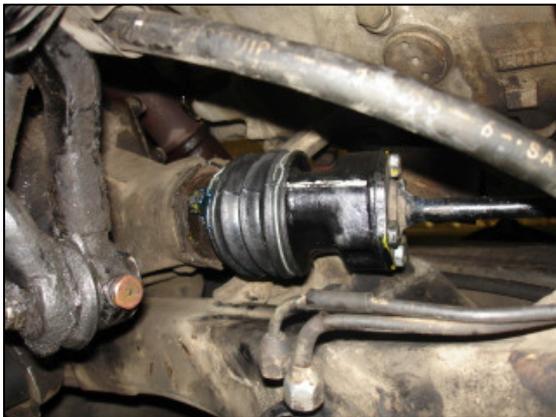
Where are we? Even the most resolute anti-mechanical owner is usually taken aback at this sight. The dirty large member near the bottom of the picture is the right hand section of the front sub frame on your everyday pre-30K chassis Shadow. The tapering large assembly in the top left hand corner is the steering box, on this car a right hand drive model. The greasy horrible thing to the right of the box is a constant velocity joint fitted to the bottom of the steering column and connecting the latter to the former. Given that lots of lubrication is needed for the joint and that it is only a matter of inches from the ground a concertina rubber boot covers the whole lot to protect the mechanism from dirt.

This is generally an area requiring little attention but after some thirty odd years the rubber boot hardens and rots and you are greeted with the above spectacle. At left is the end of the job after the boot has been replaced. The fencing wire clips by the way are standard – who am I to criticise and they do work! Here can be seen the steering column to the right which is simply fastened to the CV joint by four bolts. The other end is fastened with two bolts

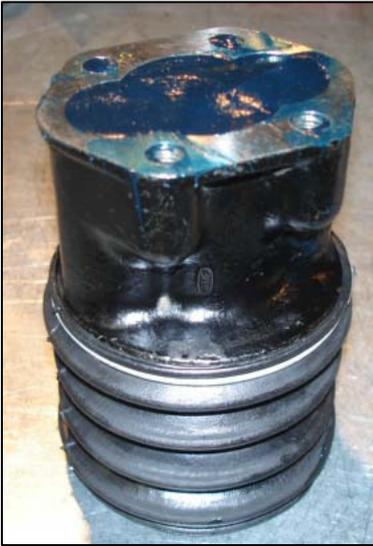
Here is the joint cleaned up and re-booted. The wire clip retaining the boot is simply that – a bit of wire bent with a hook either end. This in turn forces a moulding on the inside of the boot into a groove on the metal body. Should the wire break I suggest you make a new clip rather than buy one!

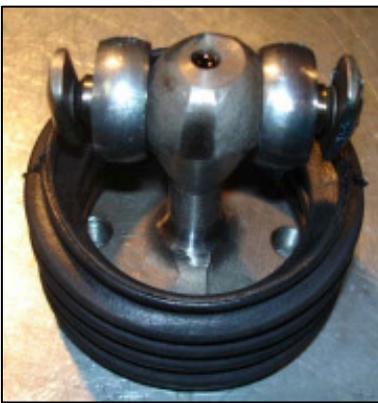
This is the business bit inside. Note the ‘buttons’ either side of the cross shaft and just behind them small Belleville washers. These are made of spring steel, are conical in cross section and if squashed spring back to their original position. The object is to keep the button firmly pressed against the outer casing of the joint. Any looseness shows up as slack in the steering wheel.

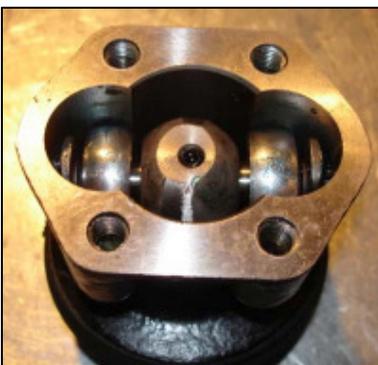
Here is the joint assembled awaiting a mouthfull of grease. This end bolts to the plate on the end of the steering column, the other end is as seen above a solid plate. CV joints of this design have been used by the Factory for many years in propeller shafts and half shafts on the Shadows and early Spirits. They are expensive to manufacture very expensive to repair and where they operate at high speed such as in the drive train they need to have the cross shaft and buttons absolutely dead centre to avoid vibration. In this application it is merely a matter of eliminating any

sideways play.

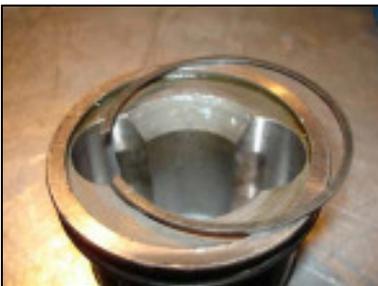
This circlip is fitted to prevent the joint pulling apart in the event of a collision and must be removed to dismantle it.

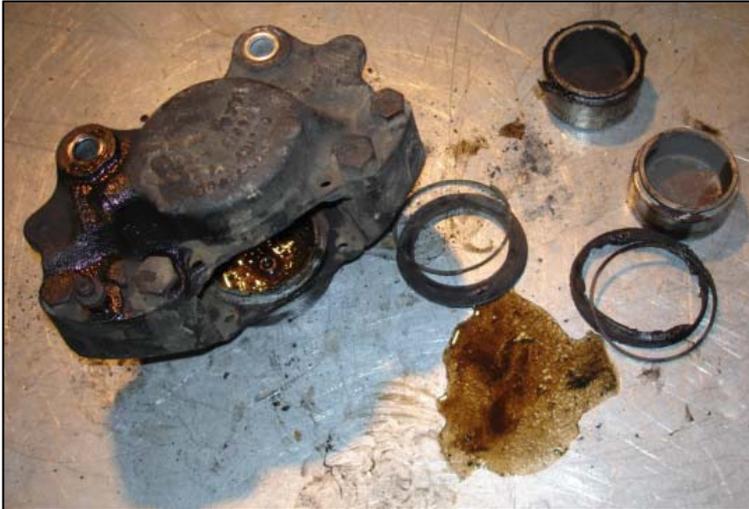
This is the usual sight when the calliper is opened. Notice the sludge in the calliper and the disintegrated dust seal. The internal piston seal has yet to be removed.

The corroded pistons are inexpensive and unless perfect on their seal surfaces should be replaced.

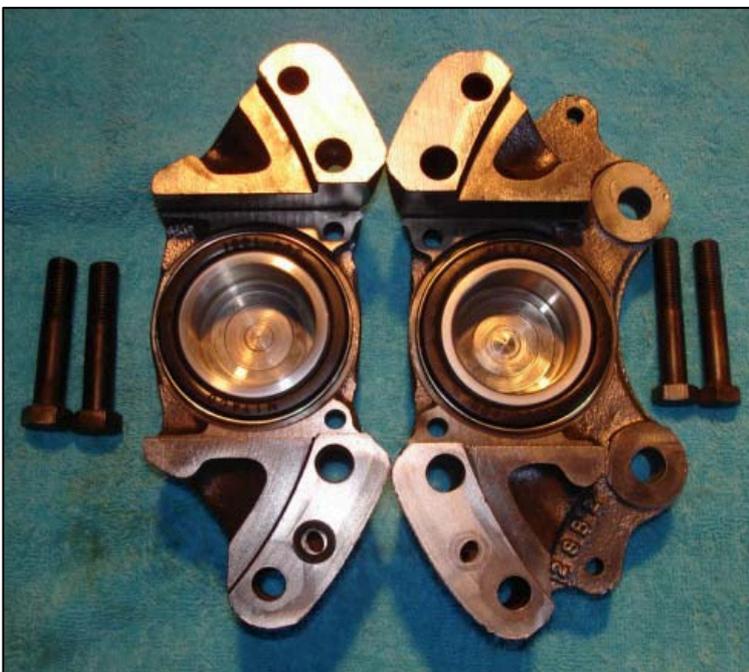
The Factory manual clearly states that callipers should NOT be split. Most repairers would agree that cleaning the things of brake dust and rust, while the two halves are bolted together is however quite impractical. The small special intra-calliper seal can be seen at the lower end of the left hand half of the assembly. All bolts including the ones mounting the callipers to the stub axle need to be torque tightened.

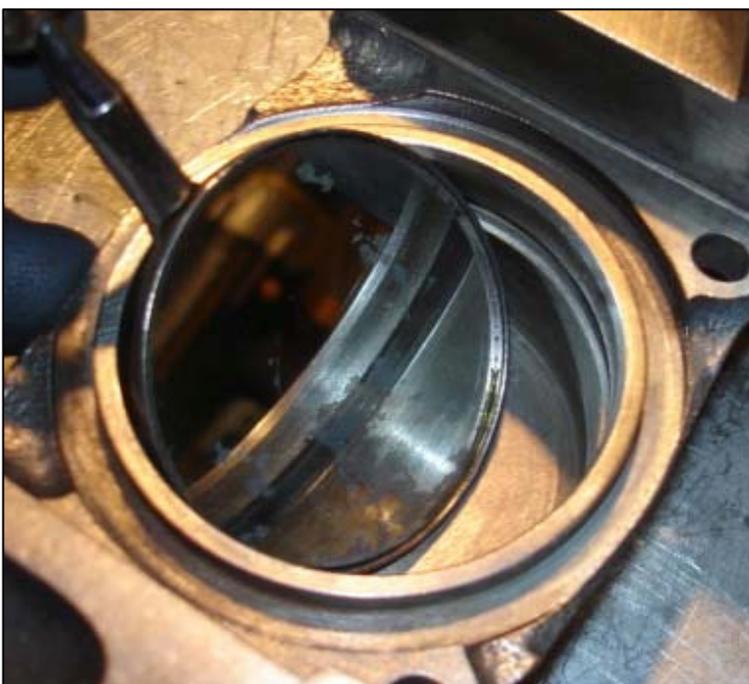
The groove in the calliper body that carries the piston seal has to be immaculate before the new seal is fitted. After many years some of the rubber from the back of the old seal welds itself to the back of the groove. If the groove is not clean and the new seal cocks it will leak. The mirror was used to ensure the cleanliness of this unit. The best tool for cleaning I have found is a dental pick.

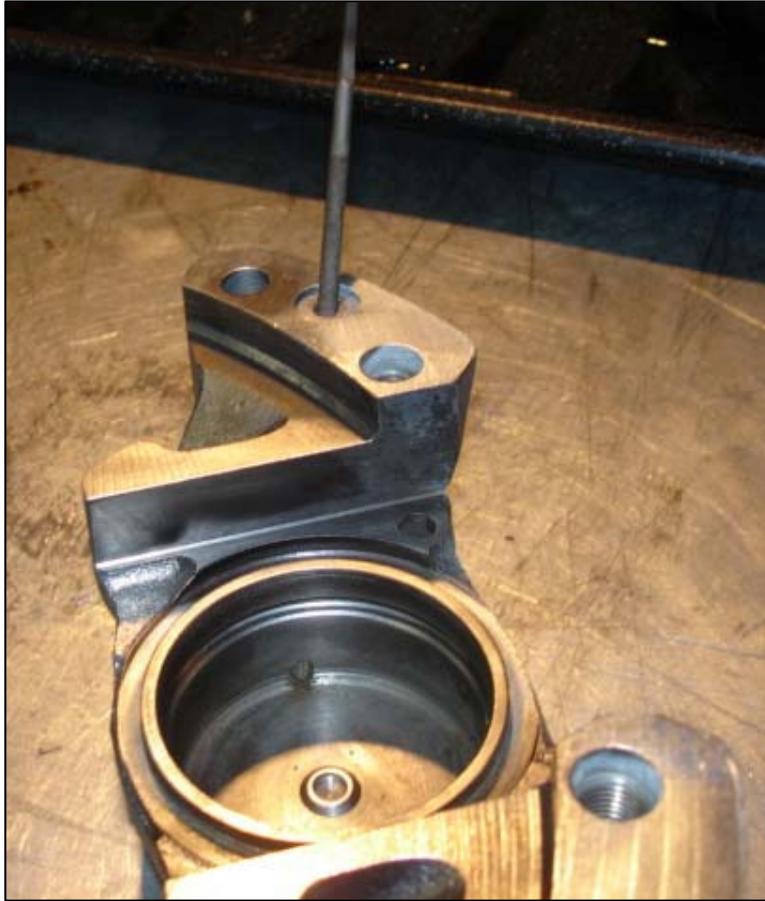
A spot frequently forgotten. The dinky little drillings in the bodies of the calliper connect both sides up to the fluid supply. Brake fluid apart from absorbing water and depositing various deposits around the place can also produce a scale-like deposit which gathers in all sorts of places. These little drillings are typical.

The removal is done with a rat-tail file (available from small rats) which is smartly thrust in and out of these lines. Your keen eye will spot the muck that already has been knocked out of this half calliper!

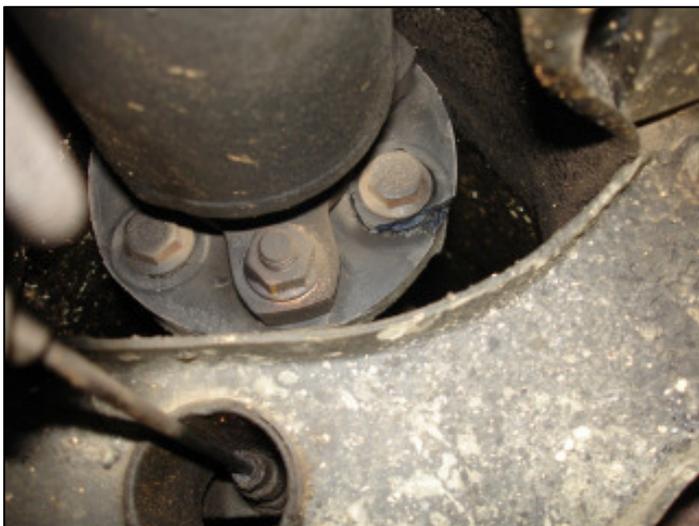
and future! The answer of course lay in the picture at left. The Factory was plagued with the problem of noisy differentials. The noise echoed up the hollow propeller shaft so they filled it with Styrofoam but then decided that the conventional steel universal joints were a good transmitting medium for noise and hit on the idea of replacing the joints with flexible drive pads seen in the picture. They last well – probably 150,000K are not too difficult to replace and should not break the bank. Be sure to replace both front

and rear couplings at the same time. For diagnosis the picture tells it all although these joints have failed without such obvious indicators. The clue is the vibration which is very obvious on acceleration. For the nervous owner, if the joint failed completely there is a spigot

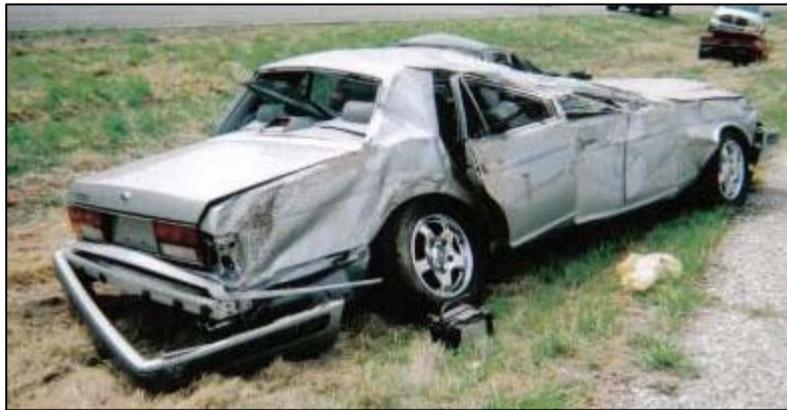
Propeller shafts can be lethal devices but fortunately not on our cars. By now you would be under your car checking out the couplings and will notice that not only does the forward end of the shaft sit significantly over the rear of the front sub frame but that the thing passes

through a dismountable tunnel halfway down the car. In the event of everything breaking the whole shaft would just rattle around in the available space. Lesser cars have been known to break the front joint, the shaft then drops to the ground digs in and acts as a vaulting pole propelling the rear of the car up and over the front in a very neat end for end capsize.

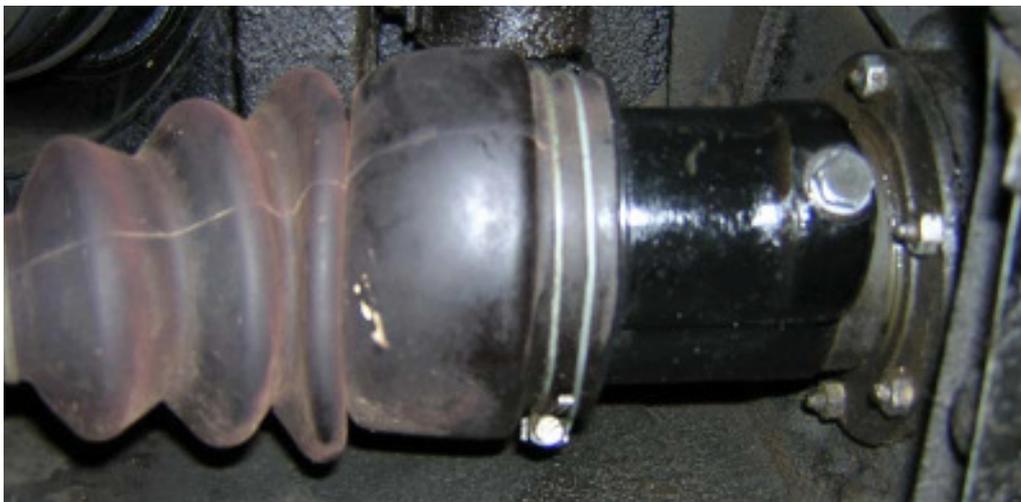
Further to the detail on the CV joint on the steering column, this is a grown up version of the same joint. The joint allows the drive shaft to the wheel to swivel up and down as the wheel passes over the road surface. Again these joints give little trouble and wear well despite the hammering they get from the road surface and the demands of the drive train! But they do require lubrication which is afforded by the injection of rear axle oil into them via the plug

seen in the picture. An easy approach is to use a plastic hypodermic sans needle fill it with oil and pump in about 30 cc's. If the joint is turned to about the position shown above and the unit filled until it runs out that will be sufficient. Always inspect the rubber boot seen in the picture they are prone to crack in the folds and lose their oil!

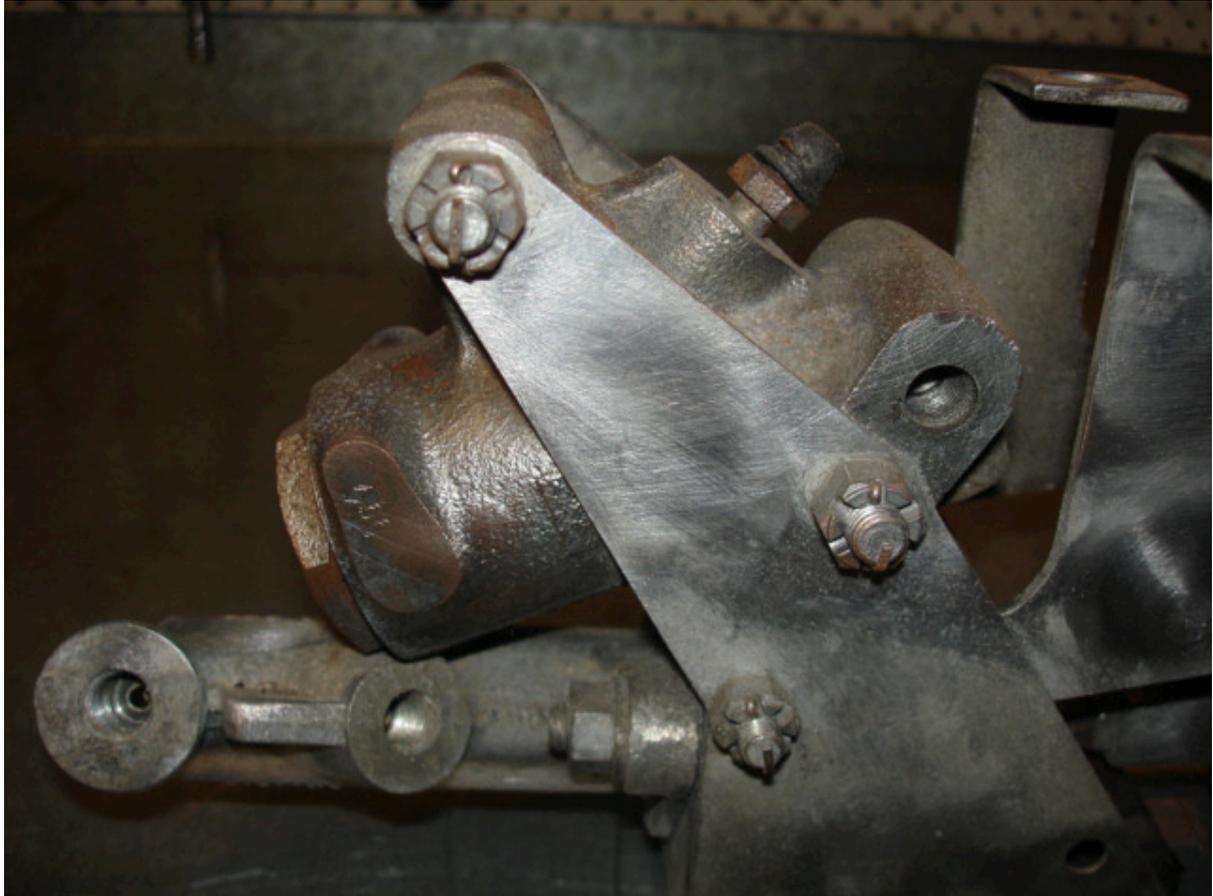
## THE G VALVE

And here it is nestling right at the back of the rattrap above the little master cylinder. In case you have forgotten the juxtaposition of all these bits here is the whole contraption again

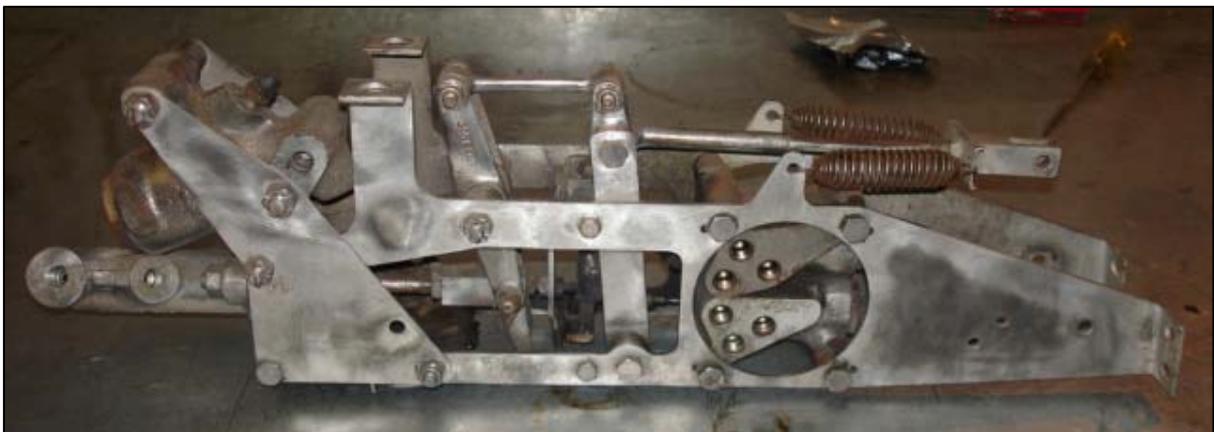
produced below. The overall design really did not significantly change apart from the deletion of the master cylinder right up to the end of production.

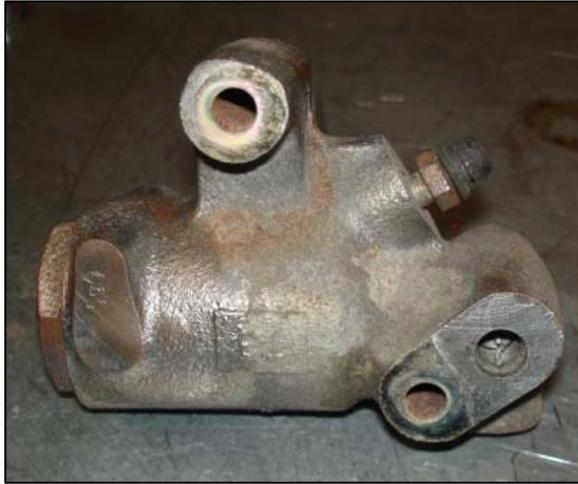
The valve extracted from the rattrap. The inlet is at the left hand end as seen in the picture the the outlet the upper of the two holes seen at the bottom right hand lower end of the picture. The bleed valve seen on the top side is the first bleed point for the whole system after the accumulators. But in practice it is ignored unless the whole system has been drained since it is awkward to get at necessitating removal of the rattrap cover.

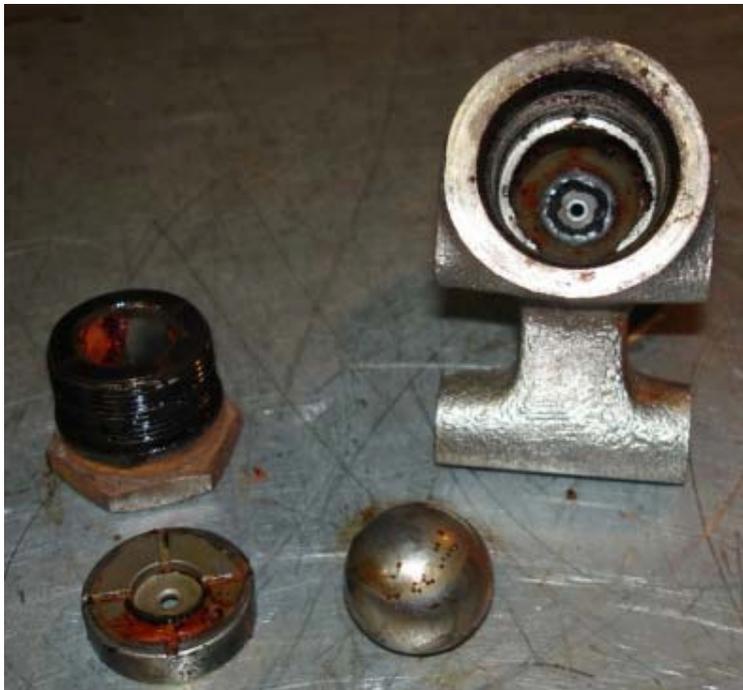
The valve opened. The hexagon headed plug at left has the inlet port. The heavy ball can be seen and the grooved retainer to its left keeps the ball from blocking the inlet during normal operation. With a heavy flow of fluid through the centre port of the retainer there is enough force to propel the ball up the valve body. Most importantly at the bottom of the valve can be seen the orifice leading to the valve outlet, around the orifice is a rubber cushion to help with the sealing and cushion the action of the ball.

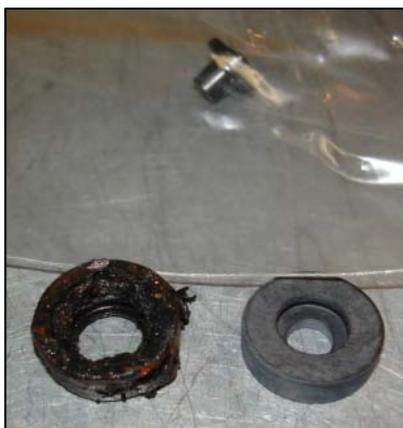
At left is the rotten cushion that gets eaten by the system. Beside it is the new replacement and still in its plastic bag the rivet than holds the seal in position. Left, the rotted seals have been known to be forced down the brake line to the rear callipers cutting off all rear wheel braking!

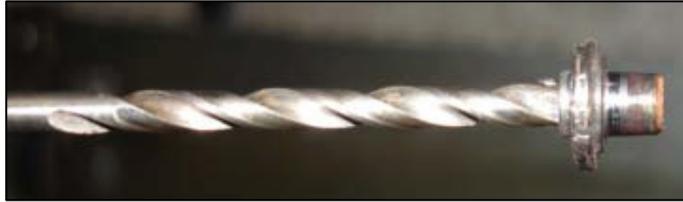
Removal of the seal retaining rivet is done with a small drill or Ezi Out.

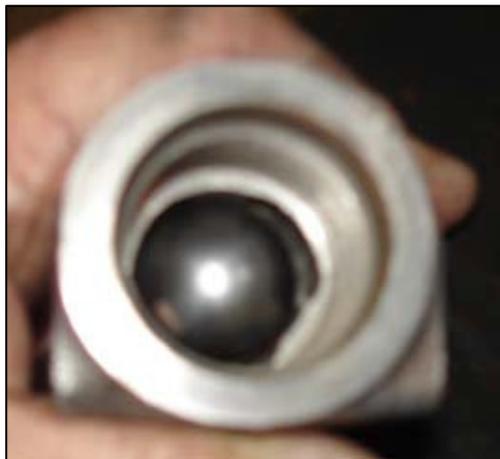
You will notice from the picture the crud in the valve particularly the minor ravages of rust. This was from a 1972 car that had been well maintained however cleaning out the G valve is neither on any maintenance schedule and given its relative inaccessability, is not likely to be serviced.

The valve cleaned up and the ball polished and placed in the bore after the rivet and seal have been inserted.

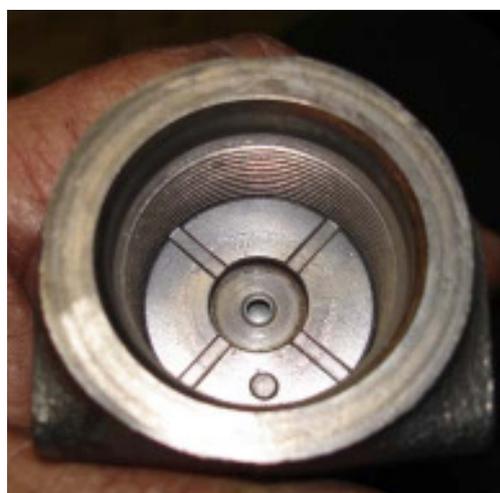
The ball retainer dropped in. The ball can just be seen through the inlet aperture in the retainer. It is important to remember when bleeding the rear brakes, not to open the valve suddenly otherwise the rush of fluid will jam the ball against the rubber seal in the outlet and no further bleeding will occur. If this does happen release the brake pedal, pause, then reapply, then open the bleed valve slowly!

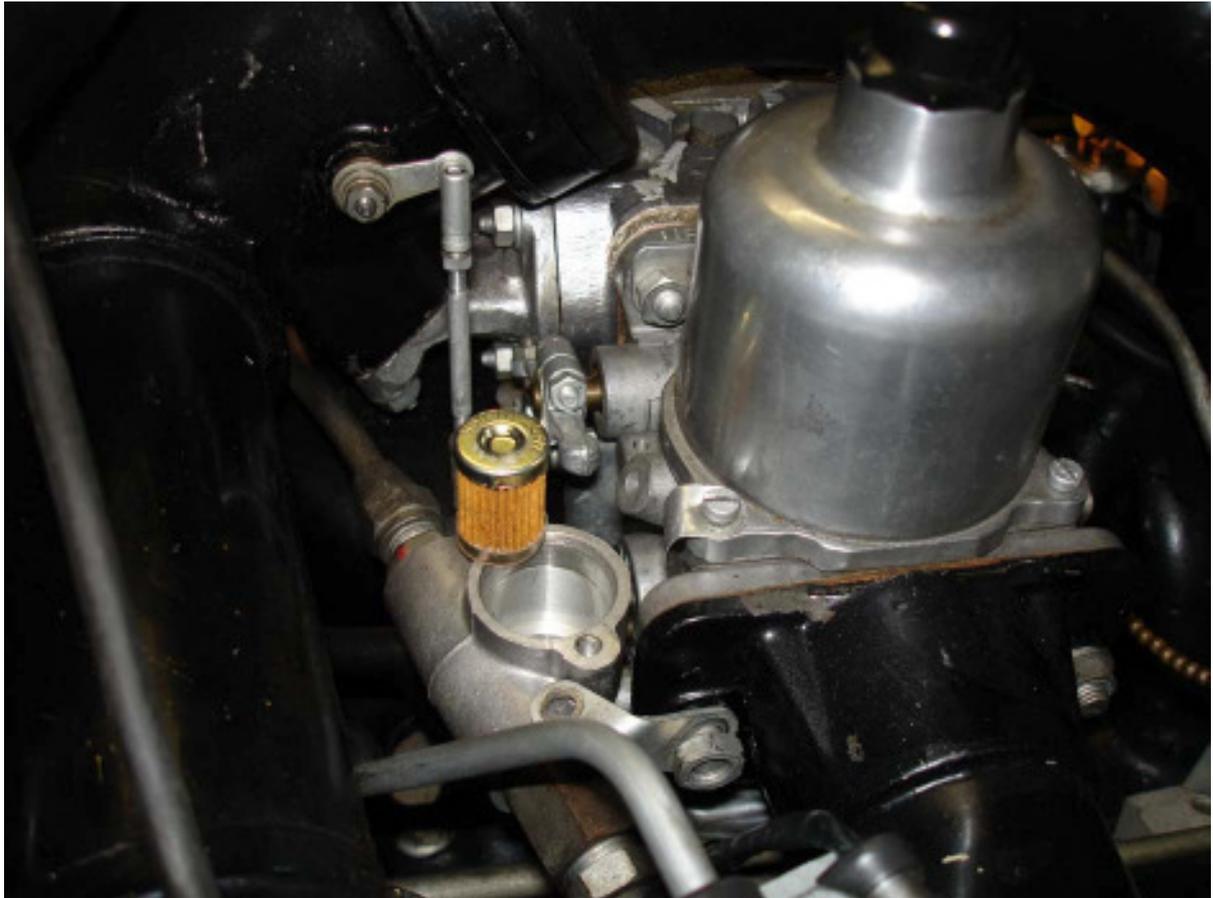
## THOSE LITTLE FILTERS

These little attachments to my eyes scream out 'maintain maintain' but it is amazing how many times cars develop extraordinary starvation problems simply because these little last bastion filters are blocked. And they are so easy to change. They are readily available from the SU agents in Australia, Midel and are not expensive so why ignore them. They are of course an accessory to the HIF SU carburettor (Horizontal Internal Float) fitted to all carburetted cars from the Shadow II onwards.

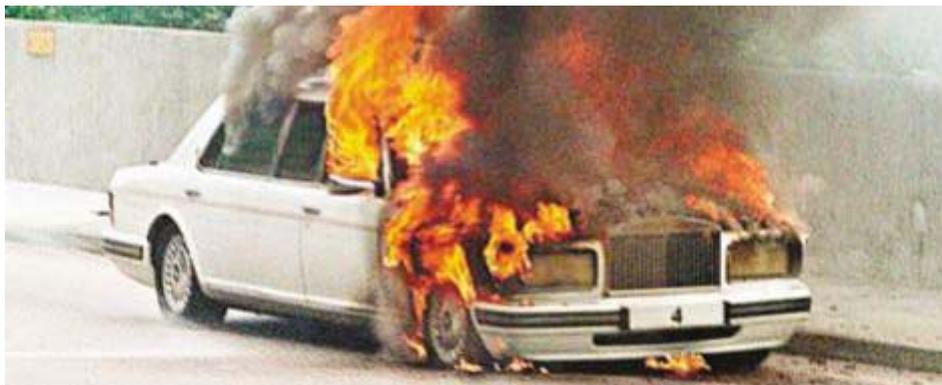
And a reminder, for those with post '55 cars, have you changed your fuel hoses? The life of any 'rubber' hose is 10 years. Sure, your hoses for fuel and brakes look good but perhaps you need a more graphic reminder which I am pleased to supply!
