# TEE-ONE TOPICS

Number 71 January, 2008

## GETTING IT UP AND KEEPING IT UP

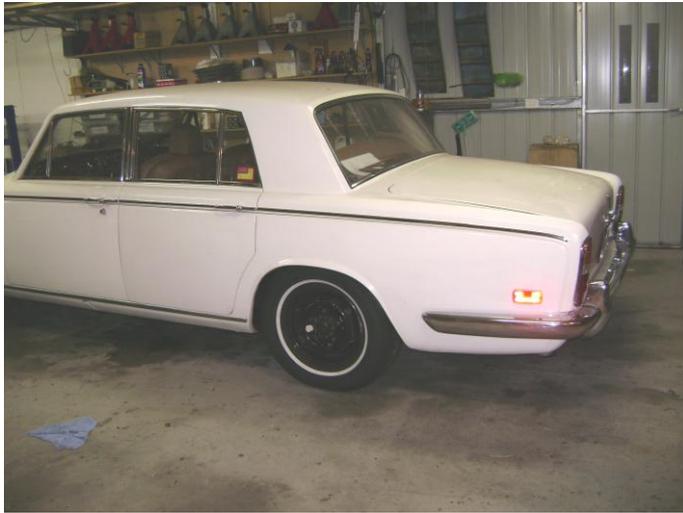
This is the common attitude of many Shadows. If the levelling valves and rams are still working by the time the car has dropped this far they will be working all the time. The usual reason levelling stops is that the accumulators are on the way to be exhausted and there is simply not enough oomph to lift the car. If you have just bought the car, lack of levelling will often be explained by the system having been blocked off.

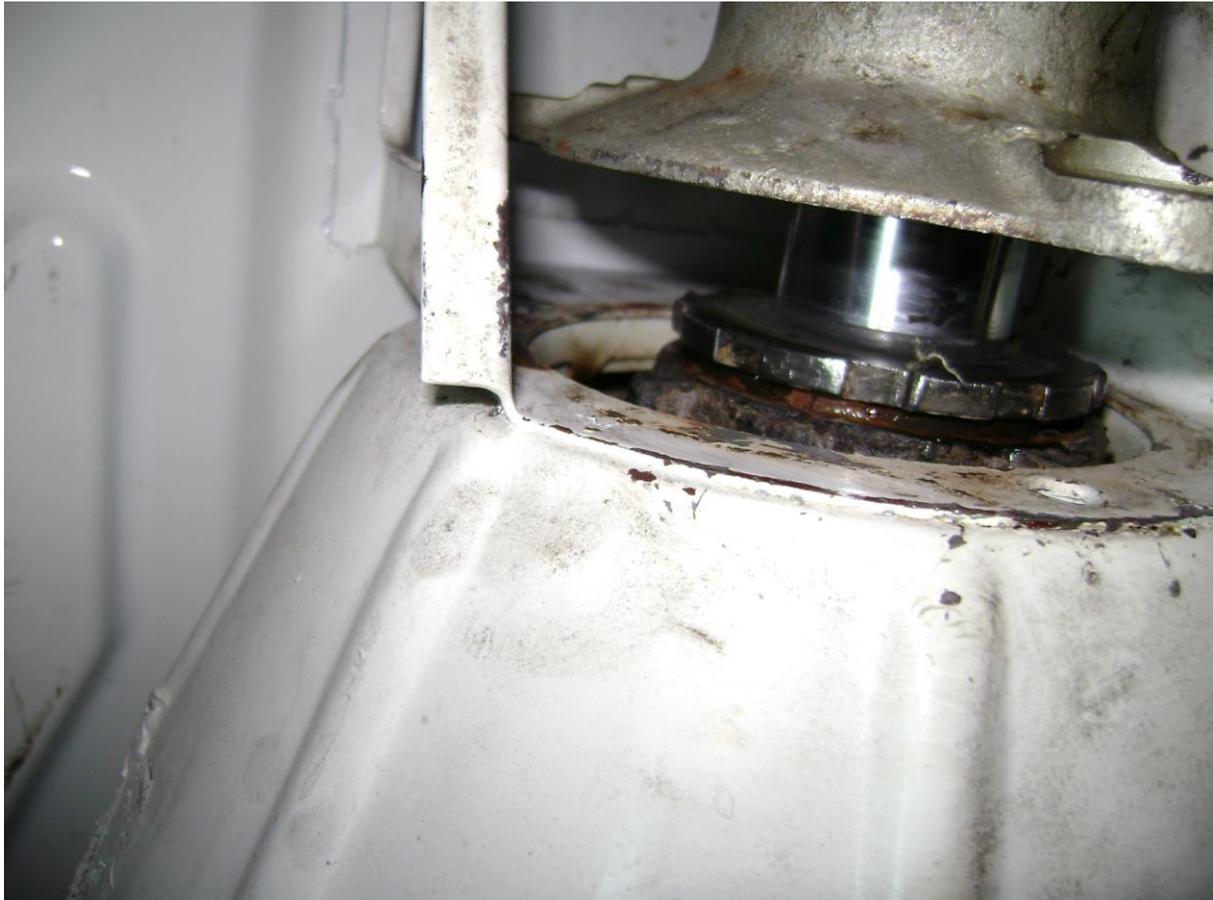
And here is where it all happens. Most owners have peered behind the rounded carpet mouldings in the rear corners of the boot (trunk for the US) and found the ram cylinders which lift the rear of the car. It is sobering to think that the weight of the car is taken on three bolts passing through the flange of the cylinder which is why the manual quietly points out not to use other than the bolts supplied! The actual ram can be seen disappearing into the cylinder in this picture. The serrated flange at the bottom of the ram screws into the spring holder. To remove the ram having disconnected the pipes simply unscrew this flange from the holder. Unfortunately some operators screw the rams into the holder to prevent the car being flung into outer space. Add to that tension some rust because the same operators are too lazy to put plenty of never seize grease on the threads, you can have a real problem.

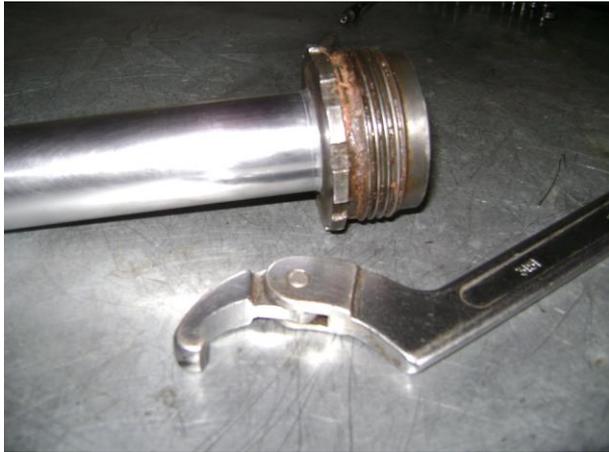
And here is the means by which the ram, now removed, is unscrewed from the spring holder. Note the very coarse thread. Early cars used a fine thread which often spelt doom for the system. The problem is that applying whatever force to the ram, if the thread was locked, turning the ram simply turns the spring holder! Fortunately I have not had this happen to me but if it did there would be a way to bolt on a finger to one of the mounting holes that would project down and engage one of three 'ears' cast into the top of the holder to prevent it turning. If that fails cutting the ram out may be the only option.

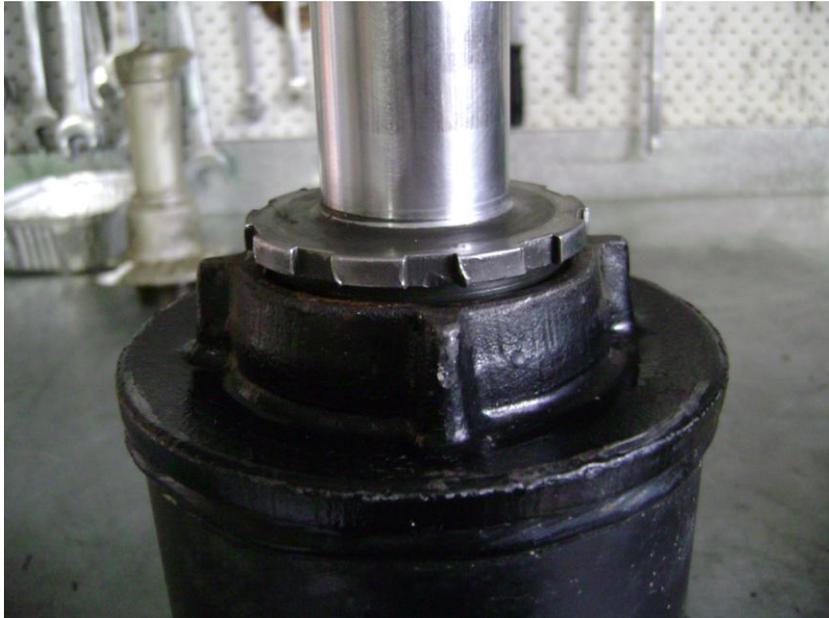
The ram screwed into the spring holder. Note the damage to the serrations from indiscriminate bashing which (blush) all of us have had to resort to at times to get the blasted things to unscrew. When you do get these out please tidy the serrations up with a file for the next bloke (or so help me, gal) use plenty of never seize grease and simply nip them up. They do not have to contain a nuclear explosion!

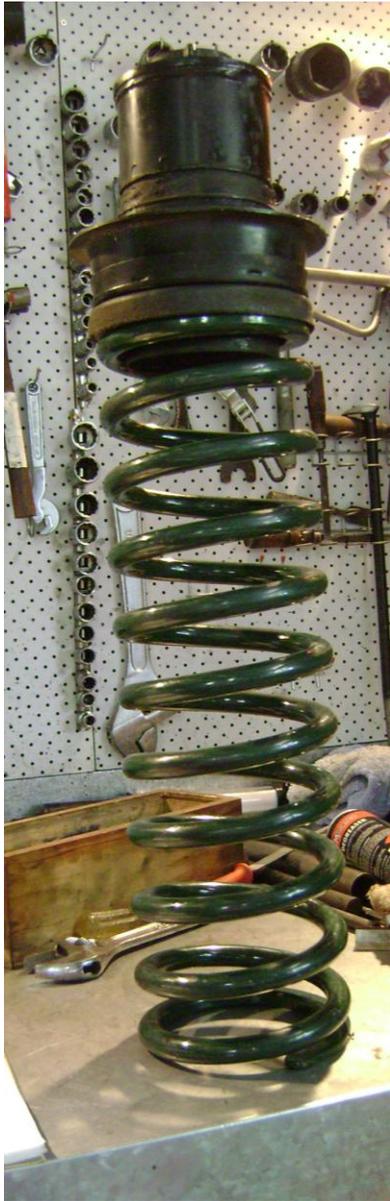
This gives some idea of the length of the spring. Note the fabric collar at the top. A similar one fits at the bottom. These help isolate road noise from the car interior.

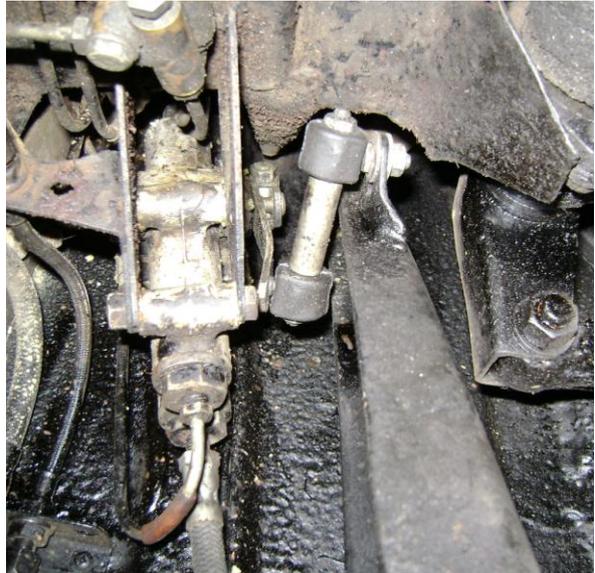
At bottom left you are looking up through the right hand rear suspension arm. Since it is a free agent there needs to be a stop to prevent the arm dropping down so far that the spring pops out. This is done by a strap seen here bolted to the under floor beneath the rear seat. The cable neatly bracketed is the main battery supply cable on its way to the starter solenoid and the hose is one of fourteen used in the hydraulic system to cut down noise and

where necessary to provide some flexibility between items!

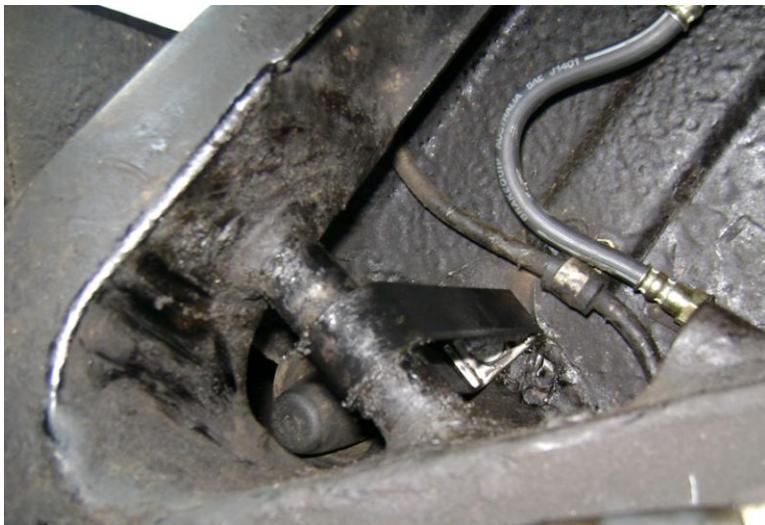
Above. This is one of four points that need to be disconnected before the rear wheels can be dropped right down. The levelling valve can be seen here with suitable encrustations indicating some leakage of brake fluid. On its right side is the operating arm bolted to the lower suspension arm. It is at this point that the 'levelled height' – i.e. using the rams) is adjusted. If this link is not disconnected and the wheels are allowed to drop down the levelling valve itself may be damaged.

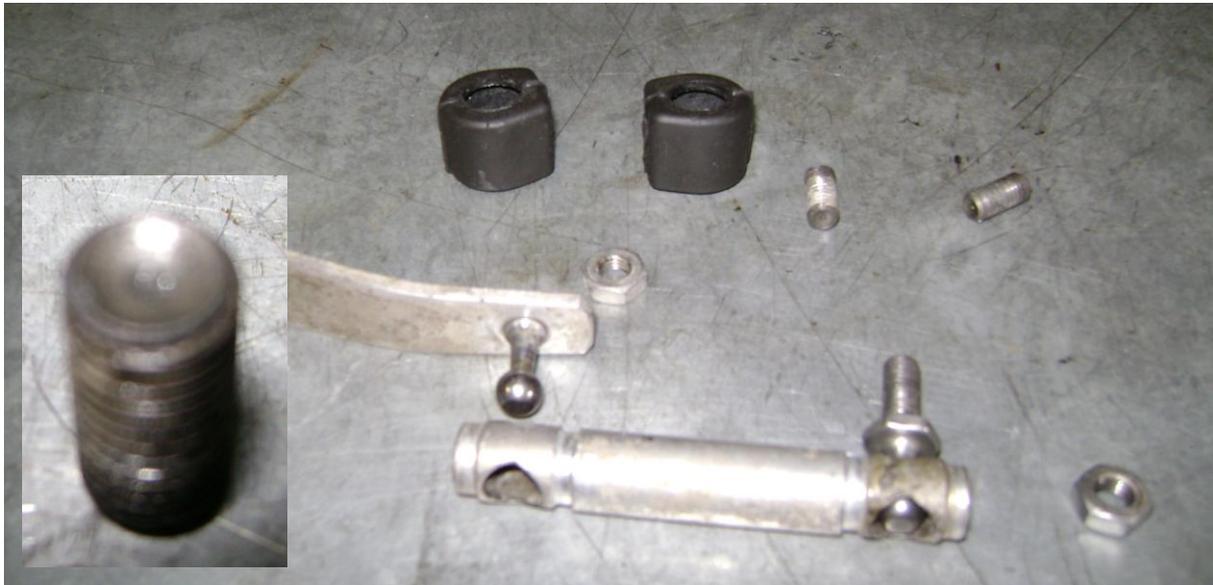
This is one application, the links connecting the rear suspension arms to the levelling valves mounted on the rear sub frame. The two small screws at upper right at first glance seem simple slotted headless bolts but closer examination displays intricate hardened spherical seats on one end (see inset).

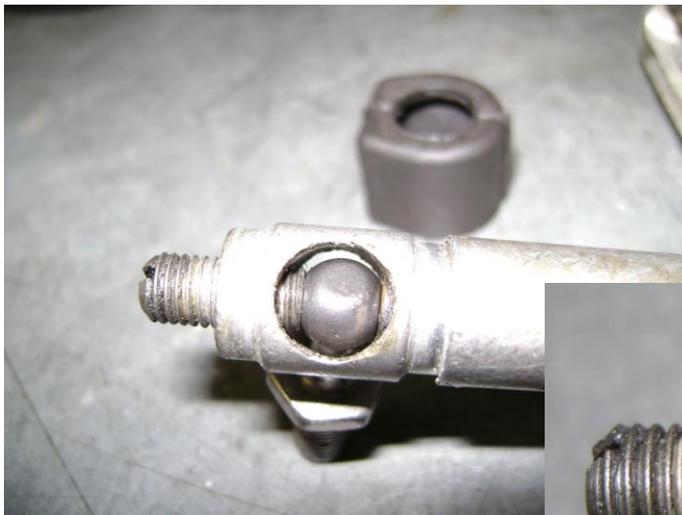
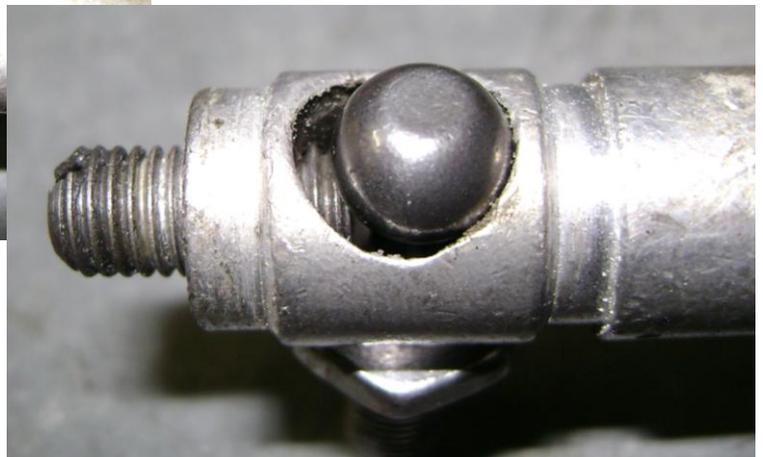
The object is to capture the ball and hold it lightly between the small screw and the hardened pad in the main member. Below is a common mistake especially when the rubber boot covers the joint. The ball is shoved too far through the main shaft and misses the hardened bearing seats. You can feel this through the rubber boot, ease off the adjusting screw pull the ball back and retighten it,

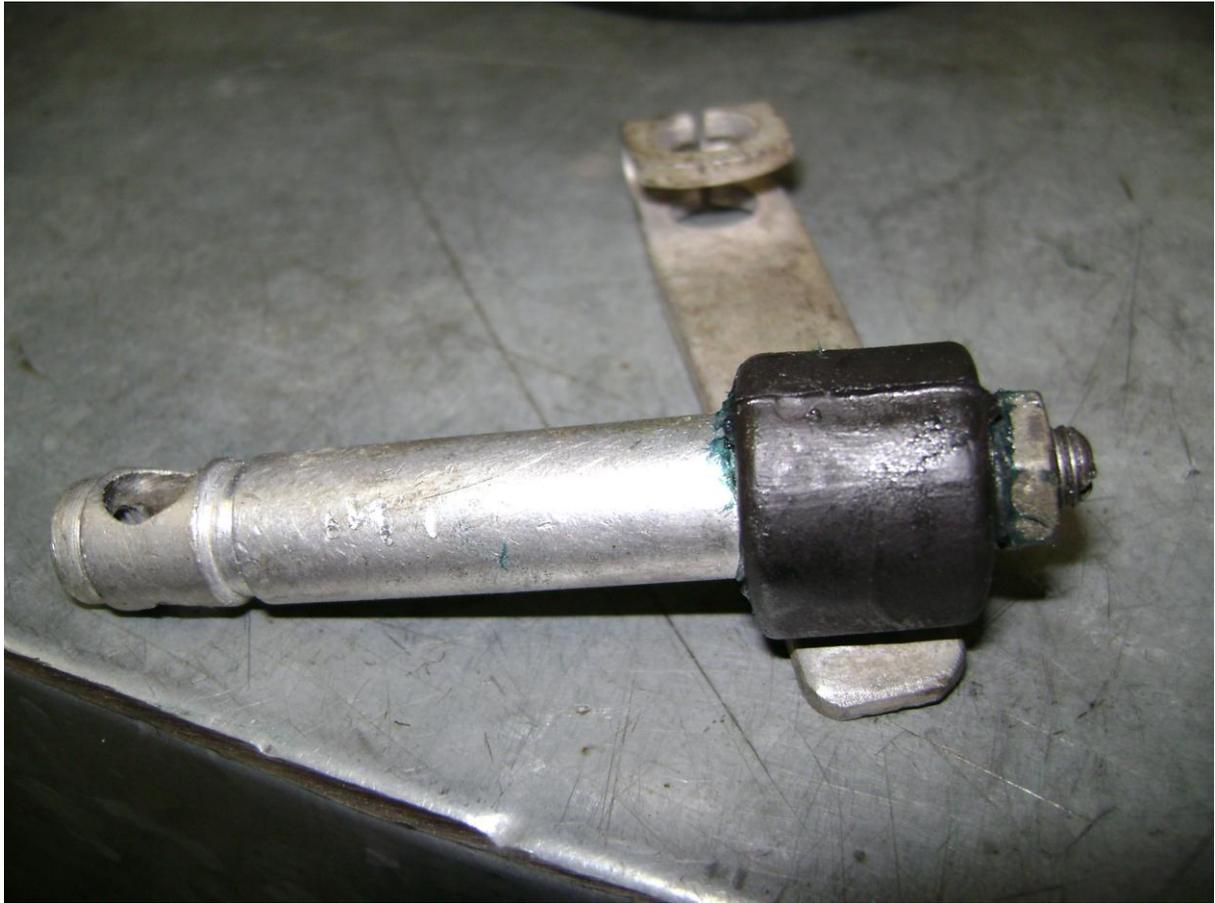
All together. A good check for tightness is that you should be able to swivel the main shaft around the joint. Before fitting the rubber boot clean it and give it a birthday with a good dose of ArmorAll inside and out.

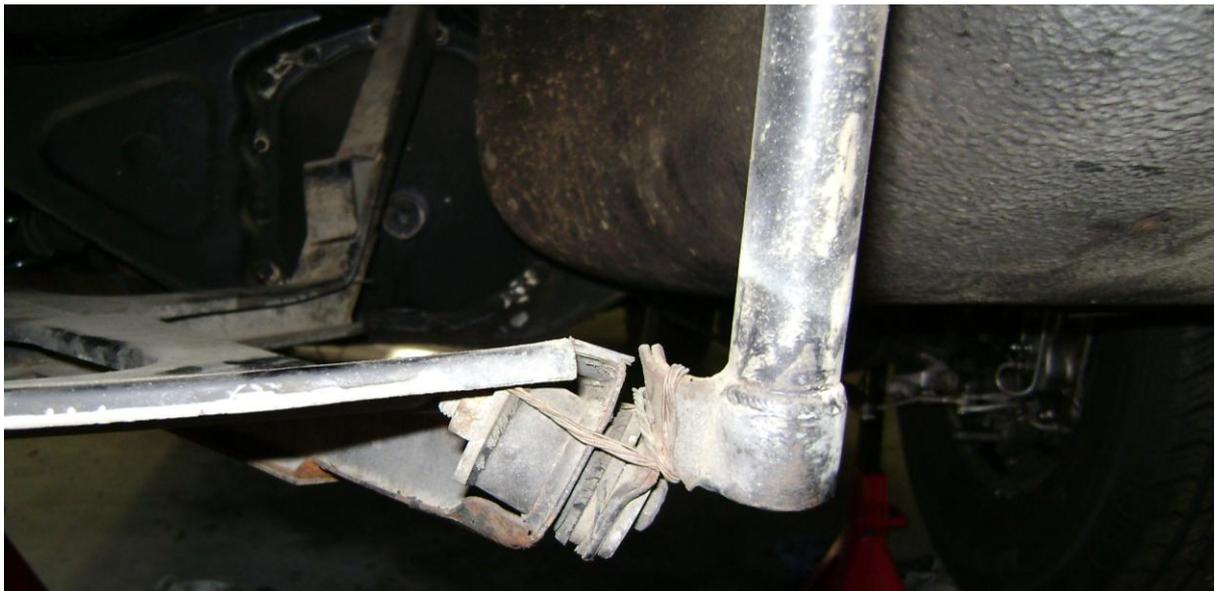
When you are boring along the Autobahn at over 250 kph flanked by other cars, it is very distracting to suddenly find a spare wheel lying on the road in front of you. Whether this has

actually occurred is open to conjecture but as you know if you give a body of people statutory powers they feel compelled to use them. In 1966 Rolls-Royce devised a neat way of storing a spare wheel under the back of the car. I do not recall any case of a spare dropping out the back which is a bit of a feather in the old corporate cap for the designers as the overall design did not change for about 90,000 cars.

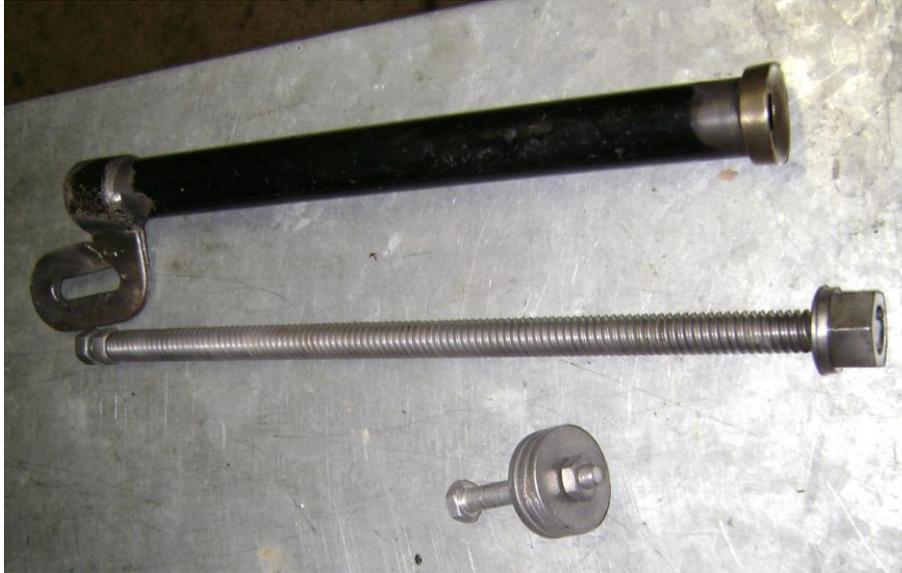
This is the business bit of the spare wheel carrier. It is supposed to be wound down during servicing and the thread wiped and greased. It is so easy to simply remove these bits, clean them lubricate and refit them. Simply undo the two nuts at the bottom of the threaded shaft and screw it up and the other bit straight to the carrier.

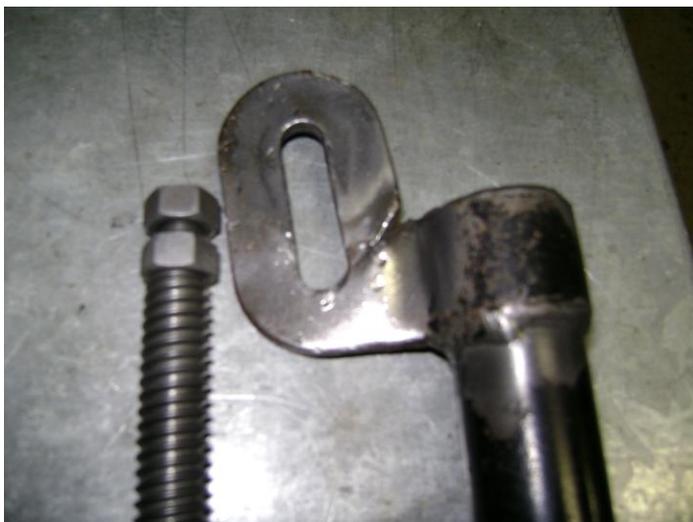
The straightened end of the screw mechanism seen here wearing a crack from its bashing was later welded. The slot allows the height of the carrier to be adjusted to ensure that when fully wound up the tyre is firmly squeezed to stop it moving.

The picture on the previous page probably justifies the stance of the wheel stowing politbureau if you notice the bottom of the winding mechanism tied to the wheel carrier with some good electrical wire. I would guess this was brought about by a driver lunging up a steep driveway and forgetting that his bum would probably drag on the ground – in this case with considerable force.

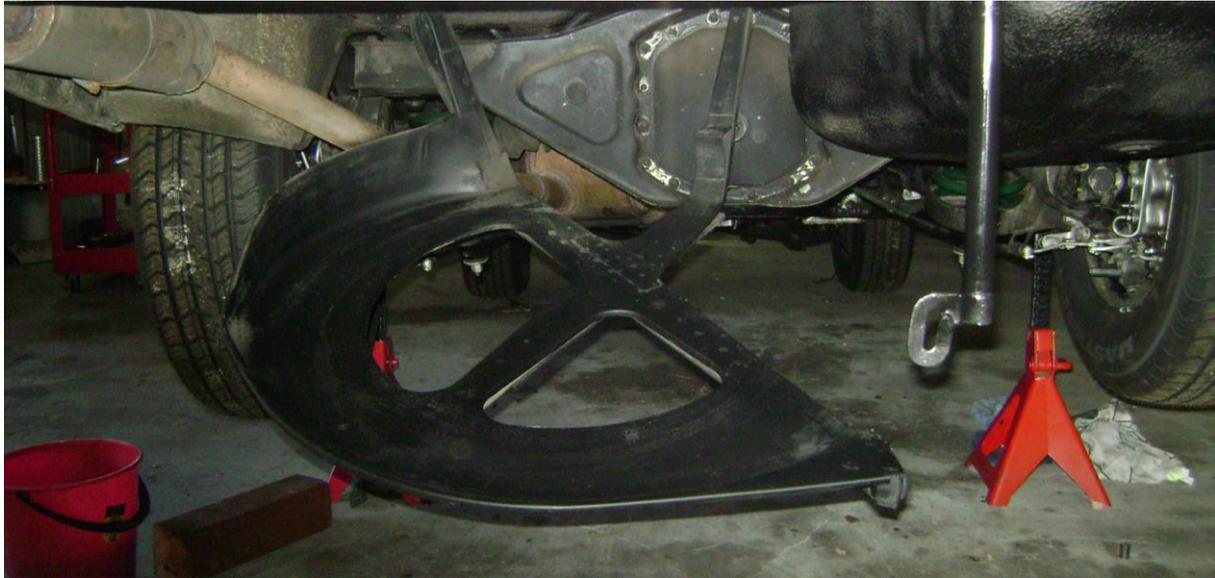
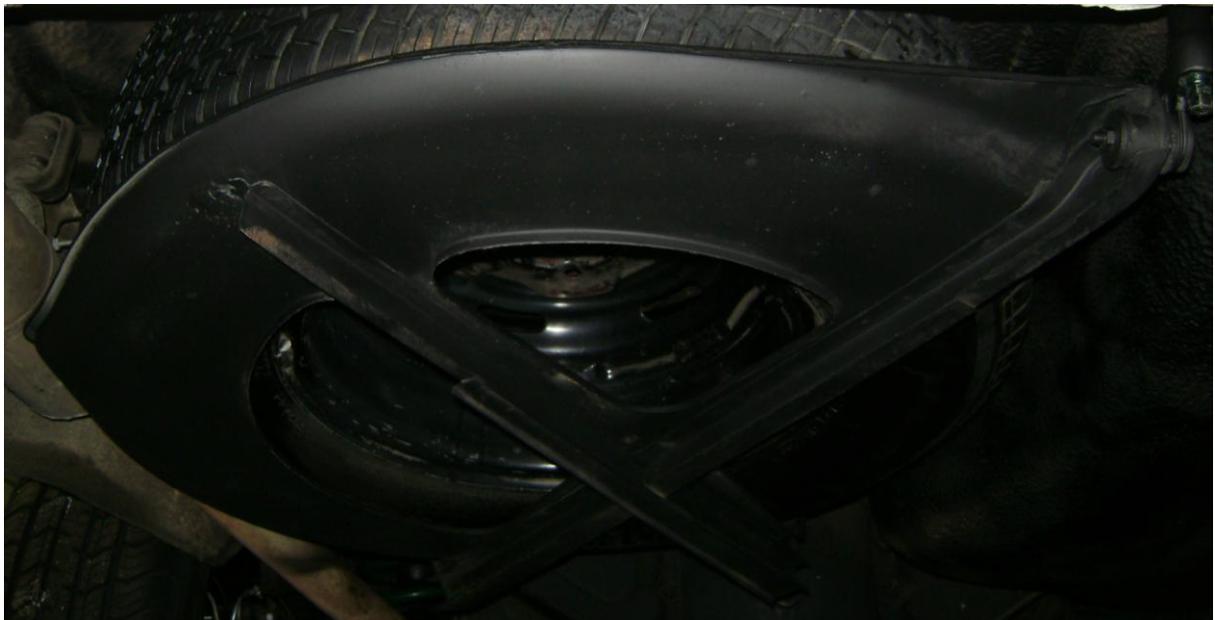
Pristine! An area the judges might like to exercise their talents in.

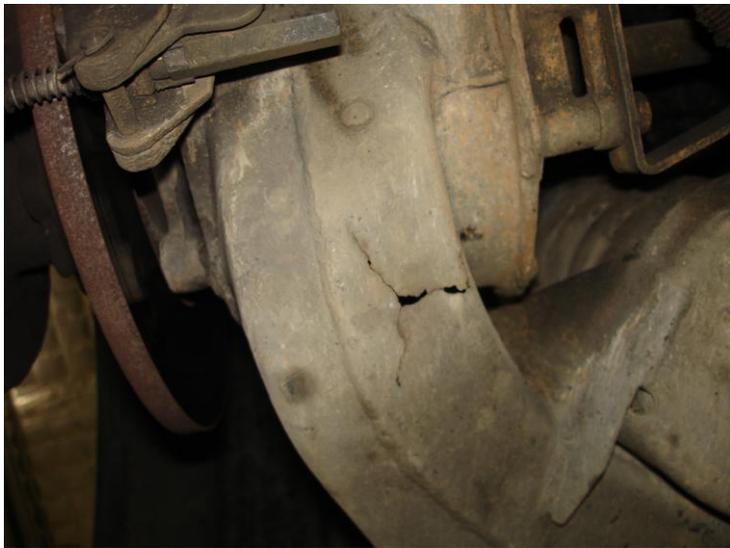
My avid readers will recall this picture on page 975 in Issue 69 explaining that the cracks found in the main suspension arm at the back of a passing Spirit appeared to be the results of condensation within and the resulting rust working out a route to fresh air. It was all simply repaired and we, I am sure, resolved to keep an eye on these suspension arms henceforth. But only today in the dying days of our first month did I

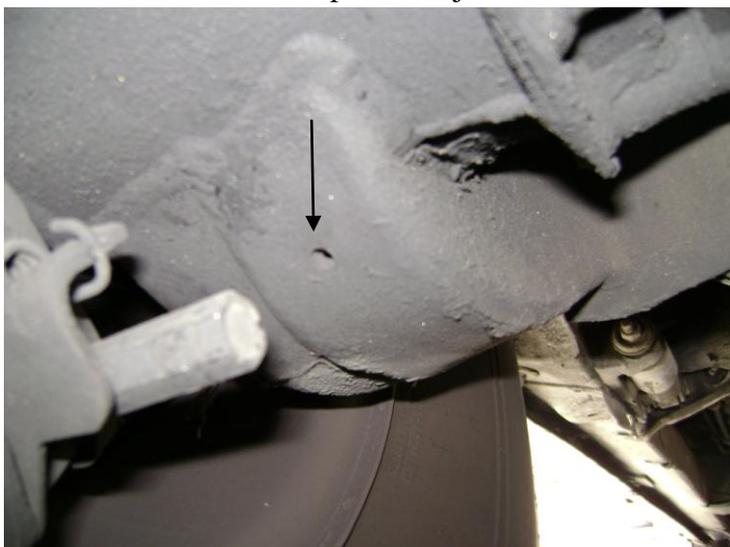
Those of you who are still awake will immediately notice the modification. No?? Observe the small hole drilled in the arm allowing the air inside to breath and hopefully minimise or prevent any condensation. The hole is about 3/16" in diameter. Sadly these sorts of modifications had to be done surreptitiously because in this day's litigious climate such news could well spark demands from customers that the arm be replaced on their car or better still the whole rear

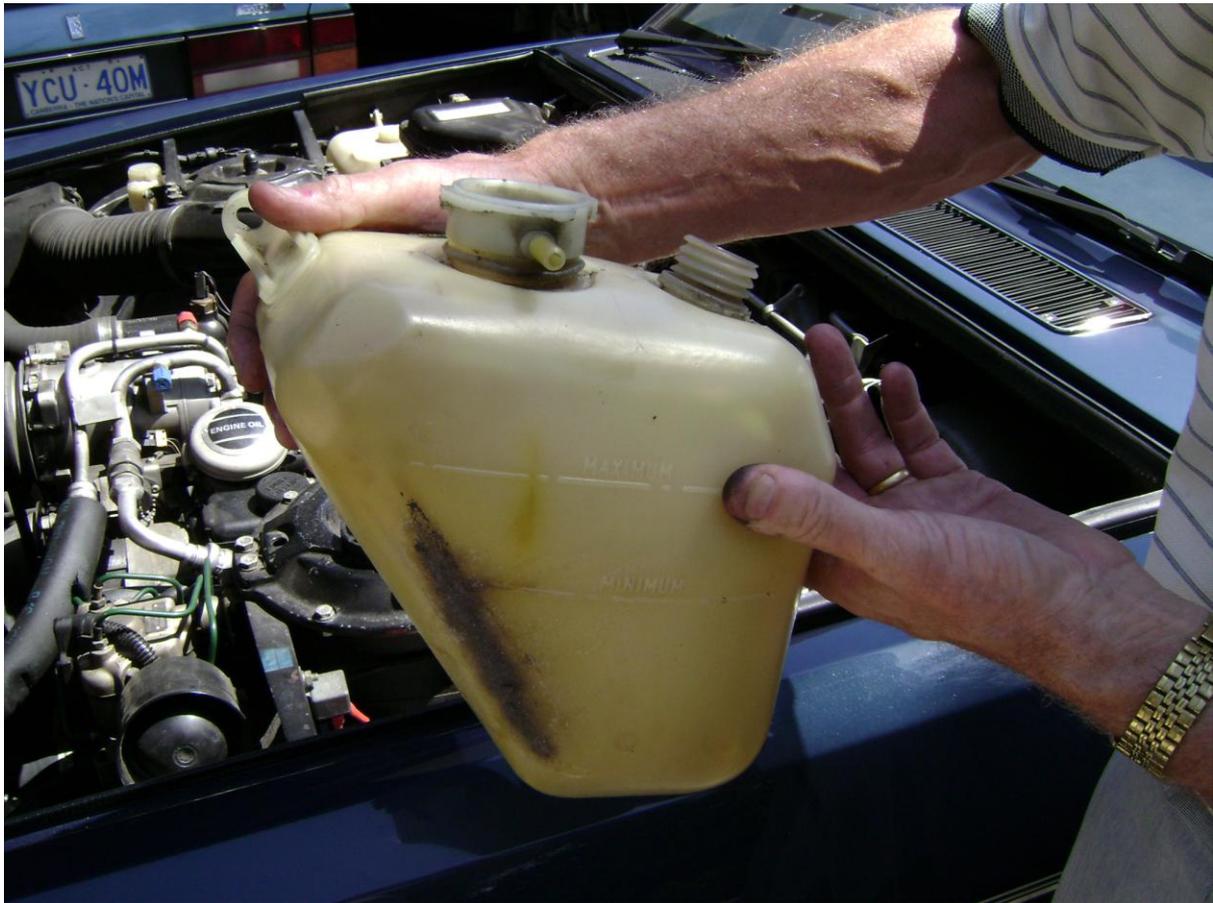
The bottle removed. The dirty mark was where the thing had sprung a leak. In fairness there had been some apparent abrasion from things unknown although there did appear to be moulding faults within the plastic. We did repair it with superglues and solid additives but given the hazard, a new one was later fitted.
