TEE-ONE TOPICS

Number 78 August, 2008

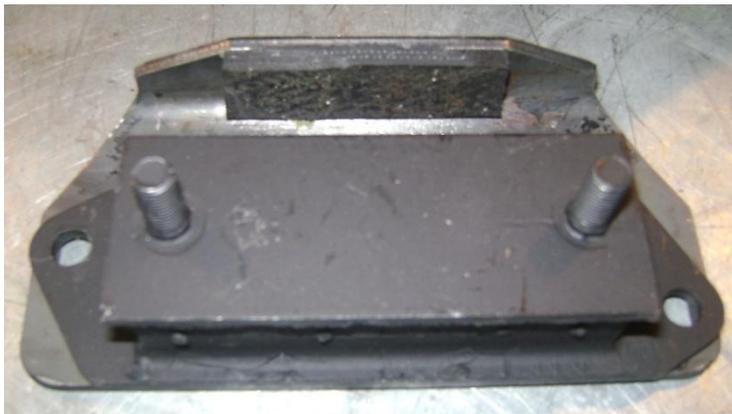
Here we have a new mount and the limiting plate that stops the engine from taking a header into the radiator core. The picture below shows how the limiter 'hook' works. The engine in this case is proceeding to the right.

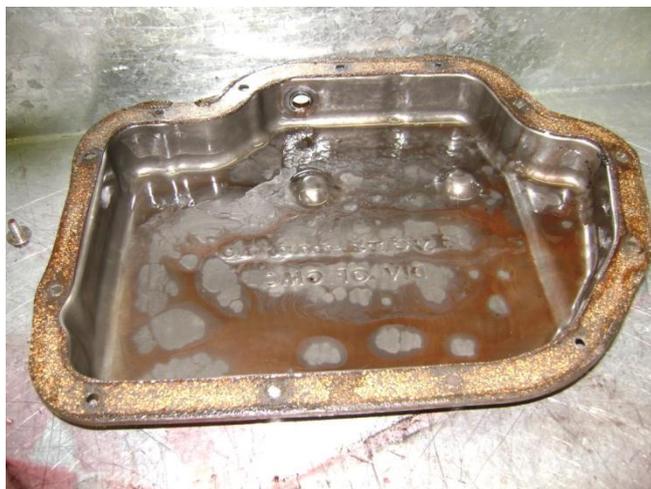
If you drive a post 66 car with a three speed transmission hopefully you recognise the sump or oil pan of a GM400 transmission. This particular pan came off a nice, well used T2 Bentley that had done some 200,000 kilometres. The car drove well, the box changed smoothly, there was no apparent slip and there were no leakages of note.

Try to drop the pan at least once a year. When you get a pan like this you should be relieved and reassured that all is well. There will always be some dust from the clutch and band facings, but what you don't want to see is stray bits of metal.

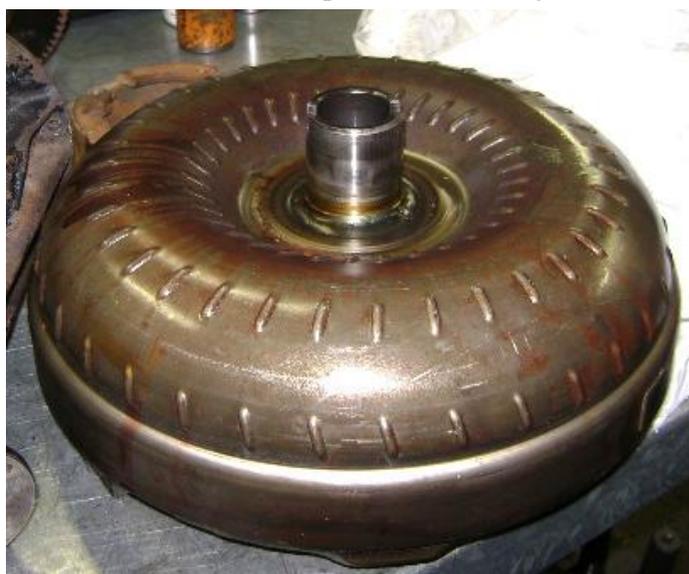
Left. Bushes like these once they start to fail, quickly spread their bits into the whole box. The picture shows the evidence of bush destruction.

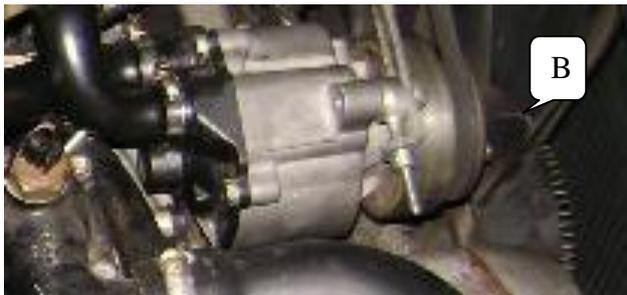
The Air Pump. 'B' This is a gadget spawned by those people who object to being choked by automotive emissions. They have been on the Shadows for years particularly for those cars delivered to the West Coast of America. Given the speed that the engine has to suck in a mixture of fuel and air, set fire to it and get rid of

what's left, you will not be surprised that there is still some unburnt fuel to be found in the exhaust. The air pump therefore fires air into the exhaust manifold and the extra oxygen actually burns up the fuel that has exited the cylinders. The connection to the exhaust manifold is at 'C'.

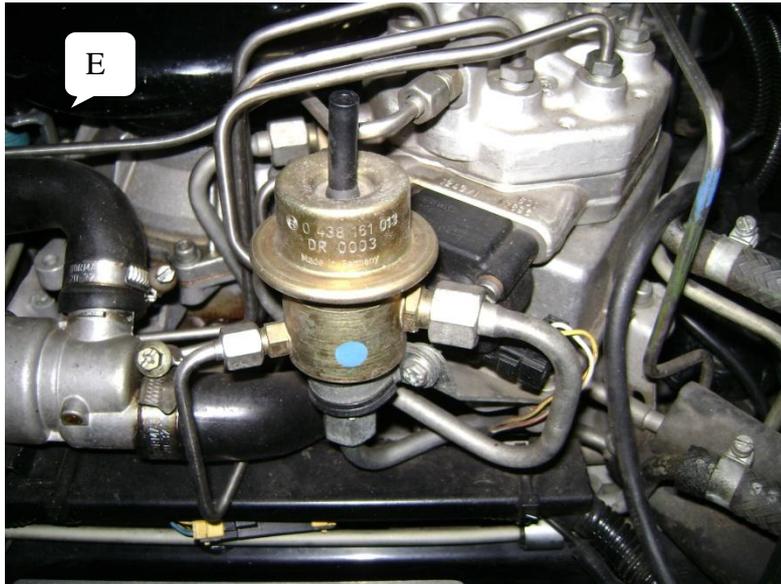
The central bit 'E' here is the fuel pressure regulator. If you are not familiar with fuel injection it comes as a shock to find that the system runs at pressures in excess of 85 psi! This compares alarmingly with the old SU pumps and the Pierburgs running at a pound and a bit! The fuel system is of course recirculating and this little gadget makes sure that the main working bit, the Fuel distributor seen behind the regulator has a constant correct pressure.

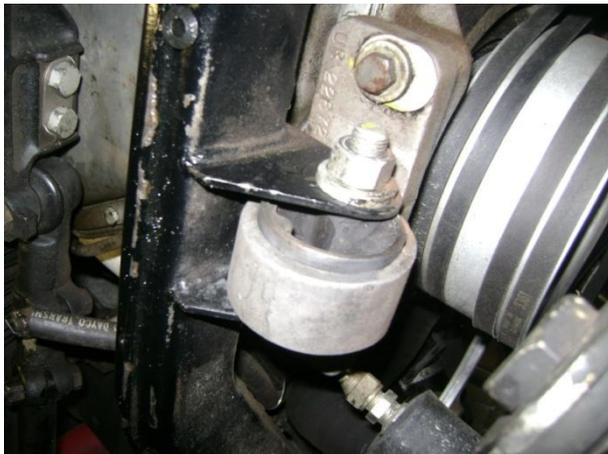
And here is the culprit, the front engine mounting. These circular mounts were used for a while but presumably proved unsuccessful. Note the mount insert is protruding here about 1/4". In addition the whole insert has rotated lowering the engine about an inch.

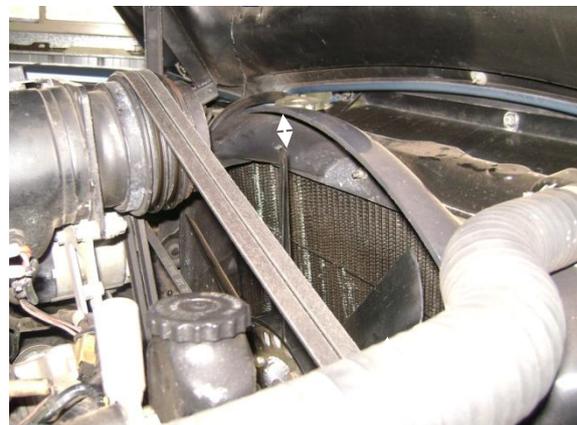
Here you can note the distance between the top of the fan blade and the cowling. Adverting back to the top pic, the rubber insert is shaped to keep the cross bolt nice and high in the holder. In practice the whole thing manages to rotate and lower the engine. A solution to this problem is to install a standard

Silentbloc bush. The rubber is much more dense than that in the original but you would be hard pressed to tell the difference.

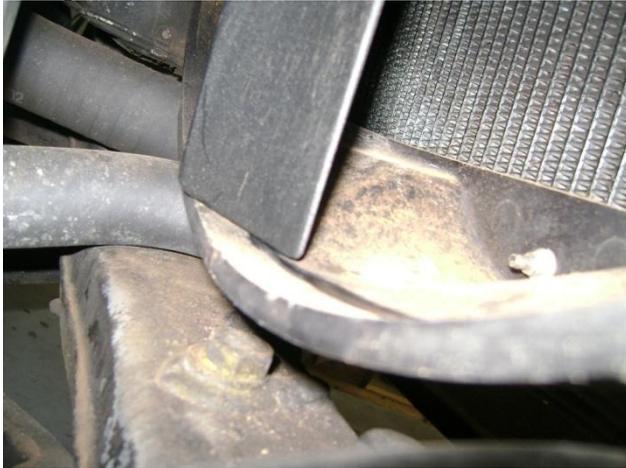
Here note the almost nil clearance between the fan and cowling at the bottom. The location of the engine in post-55 vehicles has always intrigued me. The rear mounts of the vee eight are adjustable (at least vertically) and the front mount sometimes has and sometimes hasn't an extra spacer or two to lift the front of the engine. But I have yet to see any guide as to where the engine should actually sit!

The solution was to replace the front cross member (4 bolts) and install a standard block type front mount with the standard limiting bar to stop the engine eating the radiator! Here the limiting stop has been slipped to one side to show the projection on the front member that it bears against.

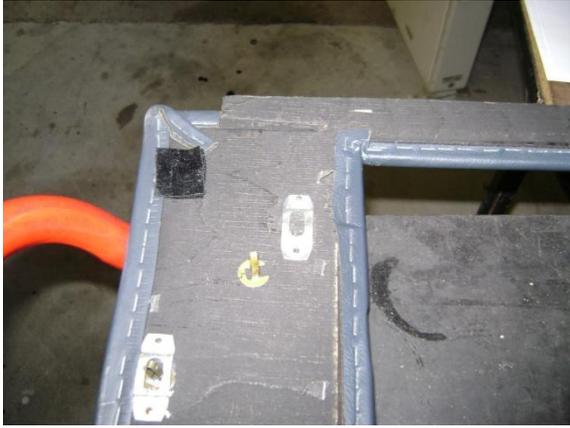
Panel clips to hold the trim onto the interior of the body are older than I am (waits for gasp). They have improved however. The old Mk VI used to fix the 'holders' two of which are seen here, by fitting them with prongs and bashing them into the ply wood. When they pulled out it was a major job to fabricate longer ones and bang them into different places.

Later this method evolved which was greatly superior; they pop riveted the holders in place. If they pulled out you are usually up for replacing the whole board. The actual clips however do break mostly through rough handling or sometimes rust. They are readily available and can be screwed into the holder.

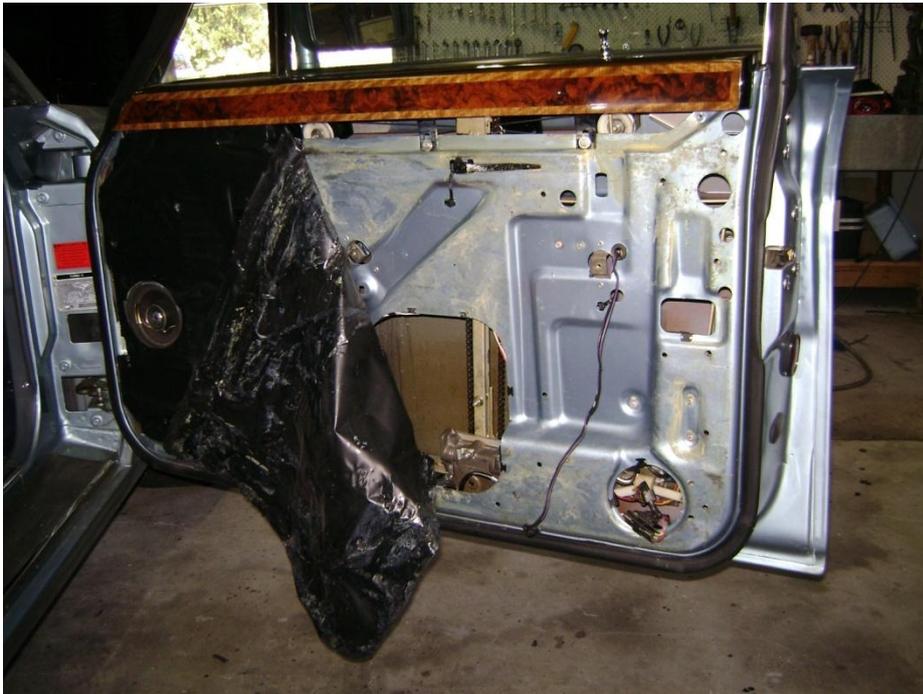
When removing the panel do not pull on it, use a wide spatula, slip it in between the panel and door pressing, slide it up or down until it meets a clip then twist the spatula, this way you

will be prising the holder from the door rather than using the panel to pull the holder away!

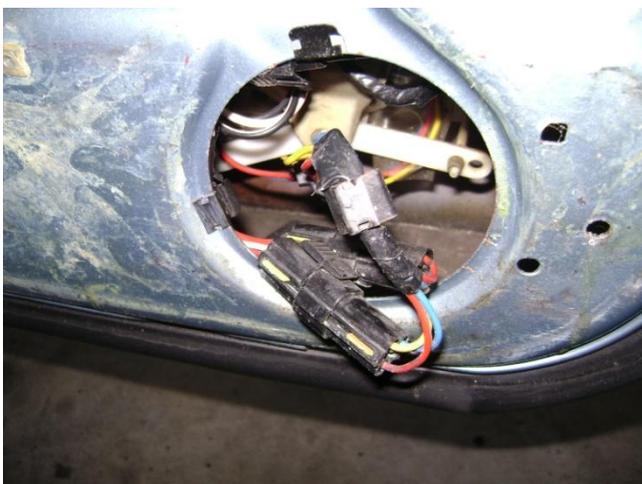
At left is a common source of heavy rattles. The wiring has been pulled free from its clips to make repairs and not fastened back in place. Easily fixed. The car for interest is an '89 Turbo R.

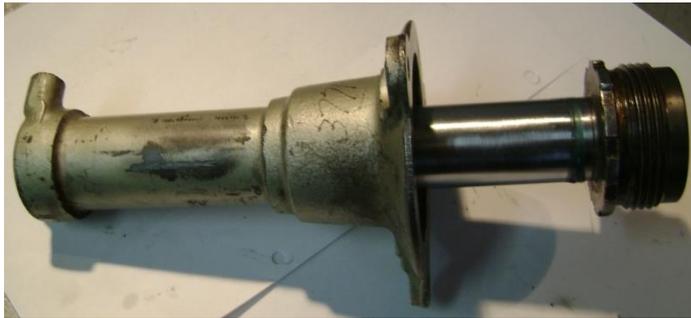
The second picture shows the ram fully extended some three inches. The bottom of the plunger is threaded to screw into the top of the spring holder. The turning is effected with the aid of a 'C' spanner. Very early cars regrettably used a fine thread on the plunger head which with the aid of a little rust requires the patience of Job and the strength of Hercules to unscrew it. When replacing the assembly think of the next operator and liberally coat the thread with anti-seize grease.

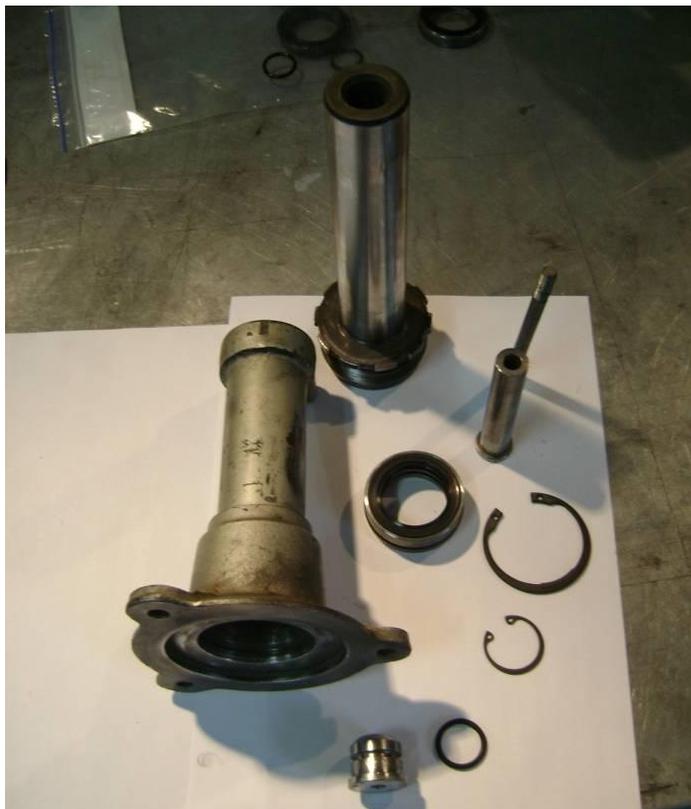
Here is the whole thing in bits.

To keep the high pressure fluid in the ram, a special seal is used inside a metal cup and after this is installed a second 'seal' is pressed in, known as a wiper. This is precisely its function – to clean the shaft as it returns to the cylinder. It should be remembered that the shaft although housed in an under body extension in the boot still gets plenty of dust and road grime which in time would destroy the main seal.

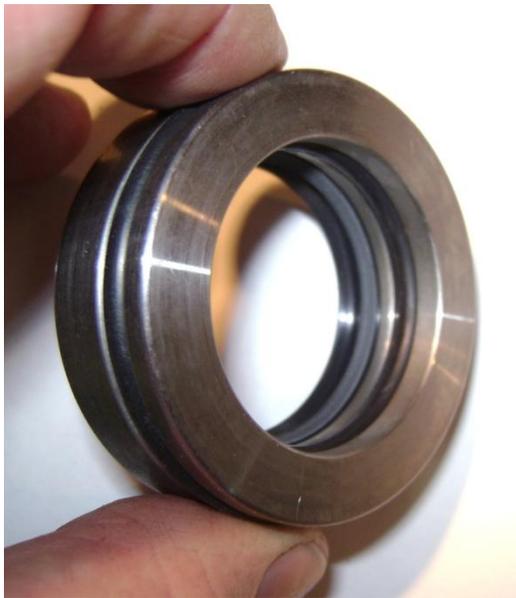
At left can be seen the recess for the seal in the ram housing. The upper groove carries the retaining circlip. With the Chapman seal it is important that the walls of this recess are smooth to aid sealing with the seal's outer 'O' ring.

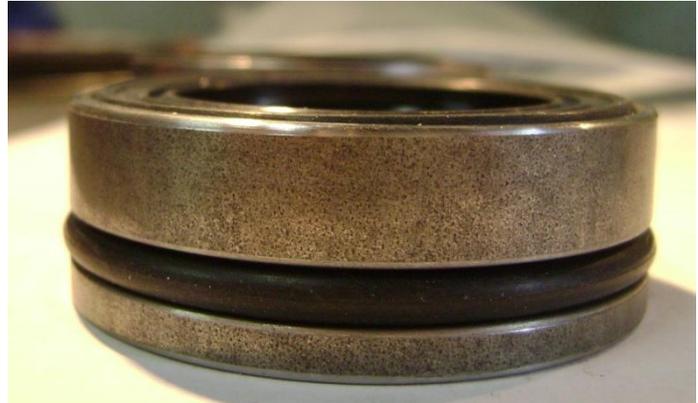
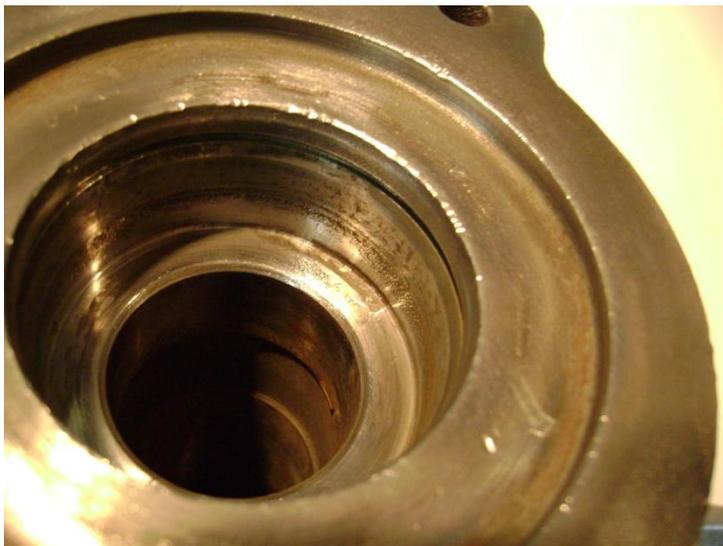
The primary seal however has not been available from the Factory for nearly two years and a number of alternate seals have been used for the job. This particular one is made and marketed by RA Chapman in Bayswater Melbourne. The seal housing and wiper are in one unit, are easily installed and apparently very effective.

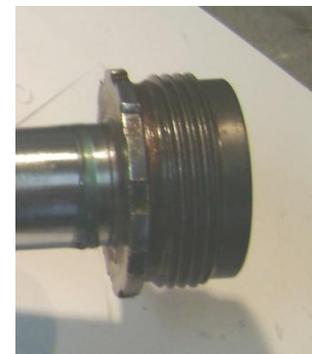
The worst problem you are going to have with ram overhaul is the bit below. As mentioned, very early cars had

a very fine thread on the ram end. This is very helpful when the thread has been attacked by salt or even general corrosion. The notches or serrations are designed to be gripped by a 'C' spanner but if this is not effective resort is usually had to cold chisels and a brickies hammer. This does little for the notches. Assuming you get the thing unscrewed, before replacing it pick up your angle grinder and straighten up the notches, not only for your benefit in refitting but for the next poor coot who has to remove it. And of course as always lather plenty of non seizing grease on the thread before assembly.

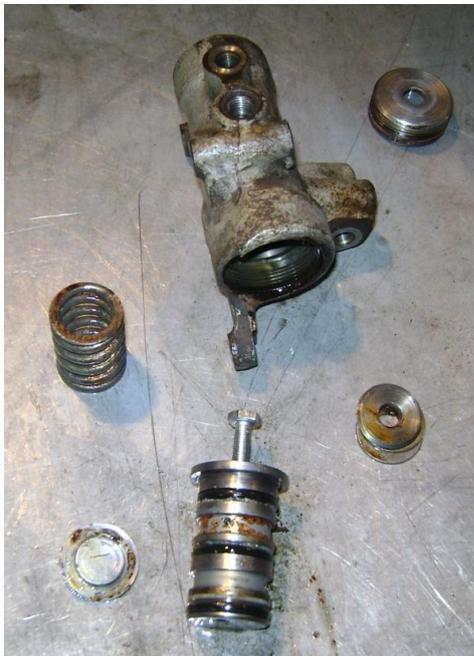
The picture at left is of the control valve that polices what goes on in the accumulator which screws into it. Briefly the bobbin seen at the bottom of the pic fights the big spring, upper left and moves in the housing at the top. The moving force is the pressurised brake fluid coming down from one of the pumps. When the accumulator has reached a pressure of some 2,500 psi the bobbin slides back and redirects any further fluid coming from the pump, back to the reservoir.

These bits are all a bit important and are not helped in their function by having to wade through a field of rust seen here liberally dusted around the various components. This valve came out of one of the much vaunted Corniches which while polished to perfection with quintessential leather and woodwork had a hydraulic system riddled with rust through sheer neglect!
