THE RAVAGES OF TIME

I have noticed of late that I am getting a little fragile around the edges but it seems I am not the only sufferer. A friend decided to clean a 1949 Mark VI cylinder block using the services of [Redi-Strip in Sydney](#).

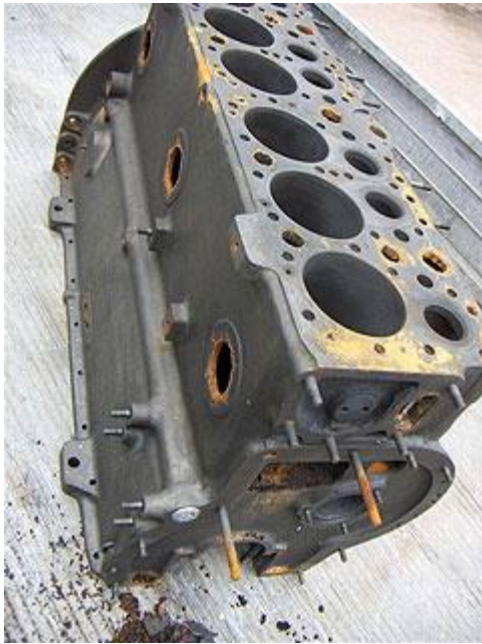
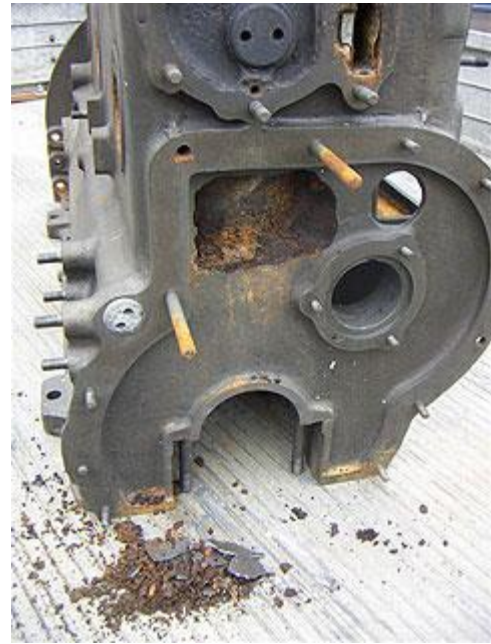
They did an excellent job it seems guaranteeing that no original metal would be removed or damaged by their process. All rust however departs. My friend, idly tapping around the block in the manner of the old railway fettler who used to tap railway wheels, noticed a rather dull response from the front of the block – normally covered by the timing case cover. There was a slight crack in the area evidenced by some residual cleaning solution leaching out. A bit harder tapping produced the following.

He actually broke open the hole you see in the picture which revealed that the casting thickness had been reduced by corrosion to 1-2 mm! Originally they would have been 4-5mm of metal.
