CYLINDER BLOCKS

R-R Silver Dawn, Silver Wraith, Bentley MKVI, R type and S1 cars

N. W. Geeson

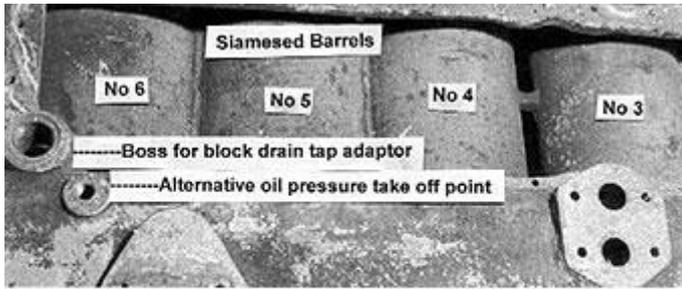
FIG1. Late type R type cylinder block RE 16217, with the side cut away.

Fig 1 shows very clearly the siamesed barrels in a late R type cylinder block, photographed from the carburettor side of the engine. Just out of view, on the left and above the outlet for the drain tap, is the coolant passage between No 6 cylinder barrel and the rear of the block. The small gap between No 4 and No 3 cylinders can clearly be seen, as can the link core adjoining the two barrels half way up the bores. Note how effectively No 5 cylinder barrel is sandwiched between the adjacent cylinders, this situation is also repeated with No2 cylinder. Clearly, the barrel cores restrict the water flow from the other side of the block. When heavy silt is allowed to accumulate, this side of the block can be full, up to 2 inches or even more above the top of the cylinder block tap drain outlet. The depth of the silt can give a false illusion that the cylinder block has been fully drained. In this view the holes around the block periphery are the result of a botched attempt to fit a side plate, in the mistaken belief that this would affect a cure for a cracked block.

Most of the water flow to the thrust or intake side of the block must take the torturous route through the centre between cylinders 3 and 4, or around the ends of cylinders 1 and 6. This situation is made worse if the cylinder block to cylinder head passageways is blocked or if a large amount of silt has been allowed to accumulate around cylinders 5 and 6. If that condition exists, any coolant flow around the rear end, generally the hottest part of the engine, becomes very restricted. If you are lucky and the cylinder block to cylinder head passages are actually free, some coolant may even find a way into the cylinder head. All this of course, even in a clean engine, depends, in the first instance, on whether or not adequate volumes of coolant actually reach the rear end of the cooling tube leading from the water pump. The pump, which normally runs at less than engine speed and with a large rotor to back plate clearance, must be struggling to attain adequate flow, particularly at idle speeds. Silt deposits naturally settle in the rear end of the block and at the bottom of the coolant jacket on the inlet side. My train of thought is that improved scouring and better heat dissipation can only be improved by more vigorous coolant circulation. Of course any minor silt deposits will not disappear and will need removing by regular flushing of the cooling system. Heavy silt deposits can only be removed by physically cleaning the cylinder block, with all the necessary access plates removed.

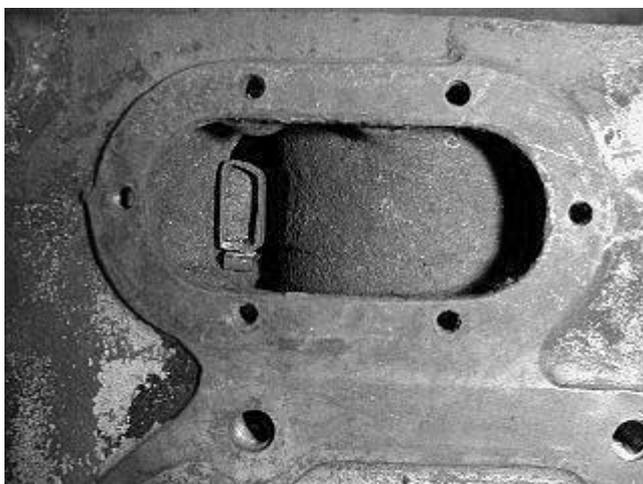
FIG 7D Photograph of Water Gallery in situ with Rear Support Strip.

the front of the RE 16324 gallery. The front end location plate RE 16219 originally fitted with this gallery, is shown at the bottom left of Fig 7B, but UE 524 is the current substitute. Strangely, this original front end plate was omitted from the R type parts manuals and the view of the engine block shows the end plate as part of the water gallery, a view that was still shown in the earlier versions of the S1 series parts manual. The RE16217 cylinder block was the first to be fitted with the front end location plate. This plate is very prone to corrosion and erosion from the blast of silt laden water egressing from the water pump, although it is preferable to having the front of the cylinder block corrode on the earlier blocks. In my own view the owner would be well

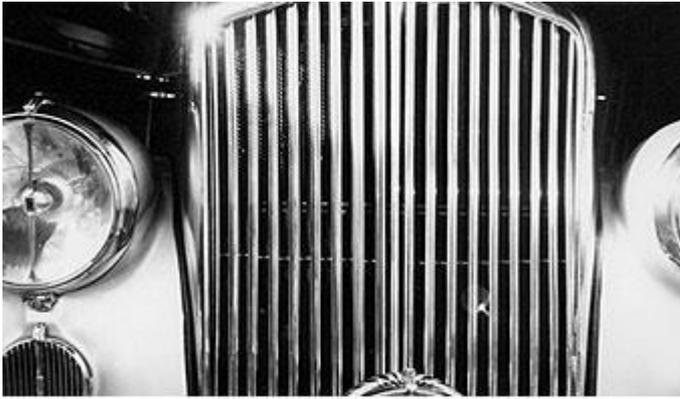
FIG8. Shutters opened out to improve air flow.

Fig 8 shows the appearance of B87 UL where the shutter angles have been increased beyond the production settings to the maximum possible angle that the shutter horizontal holding bars will allow. Although the radiator can be seen from the direct straight ahead position, moving only a few degrees right or left with the eye returns a pleasant facade.
