CRANKSHAFT DAMPERS, SPRING DRIVES AND CAMSHAFTS – PART 2

THE HISTORY FROM 1953 – 1958

N. W. Geeson

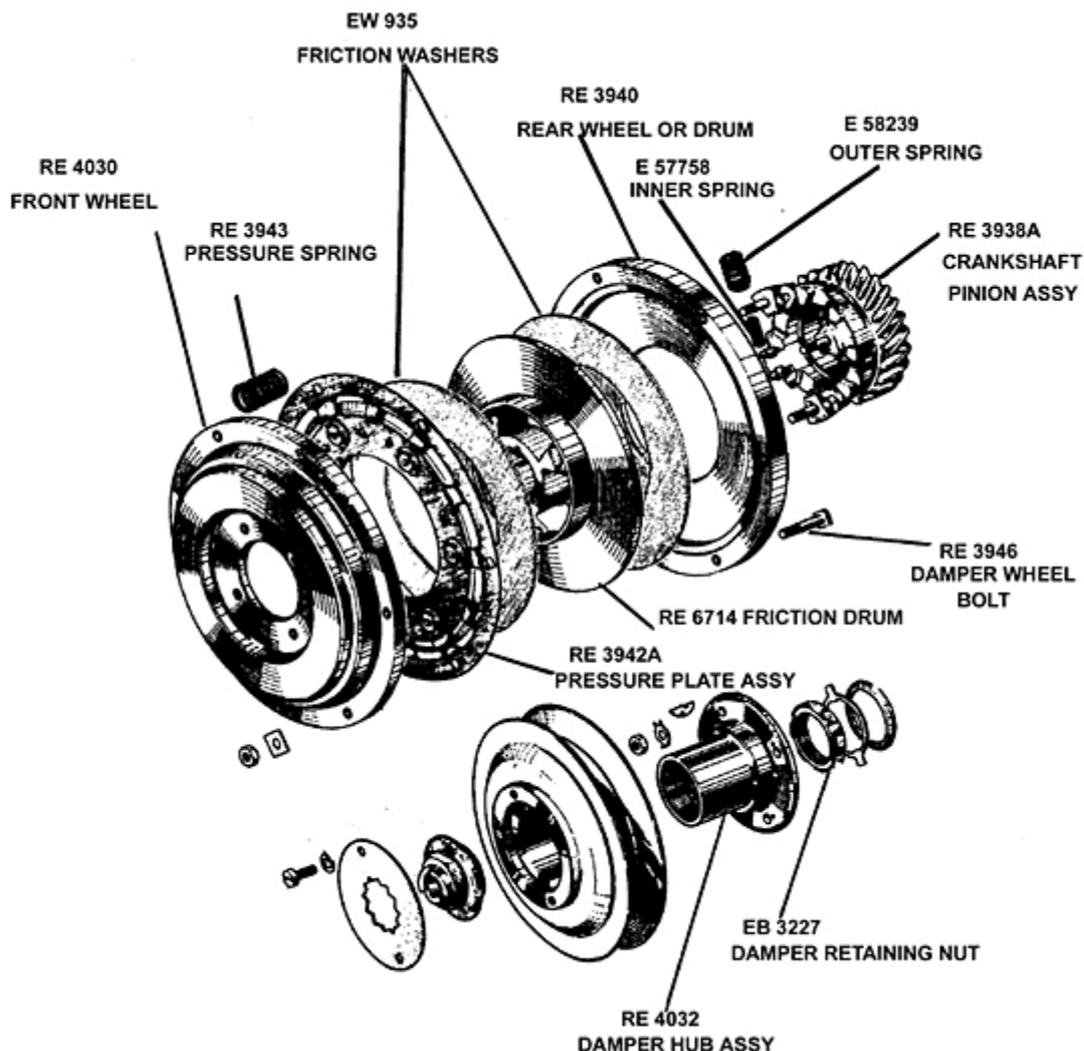
FIG 2 DAMPER COMPONENTS FROM PARTS BOOK

This specific period I find is particularly interesting, as it represents the ultimate in the development of the six cylinder damper, answers a few questions possibly hitherto unknown to most enthusiasts, but also poses the question... “What if, damper development had continued?” For reference a typical parts manual view of the damper is repeated in Fig 2 from an earlier article sequence.
