# PROGRESS LETTER FROM DAVID CHAUNDY ABOUT THE RESTORATION OF HIS AUSTIN 12/4 AUNTY BETTY

November 2009

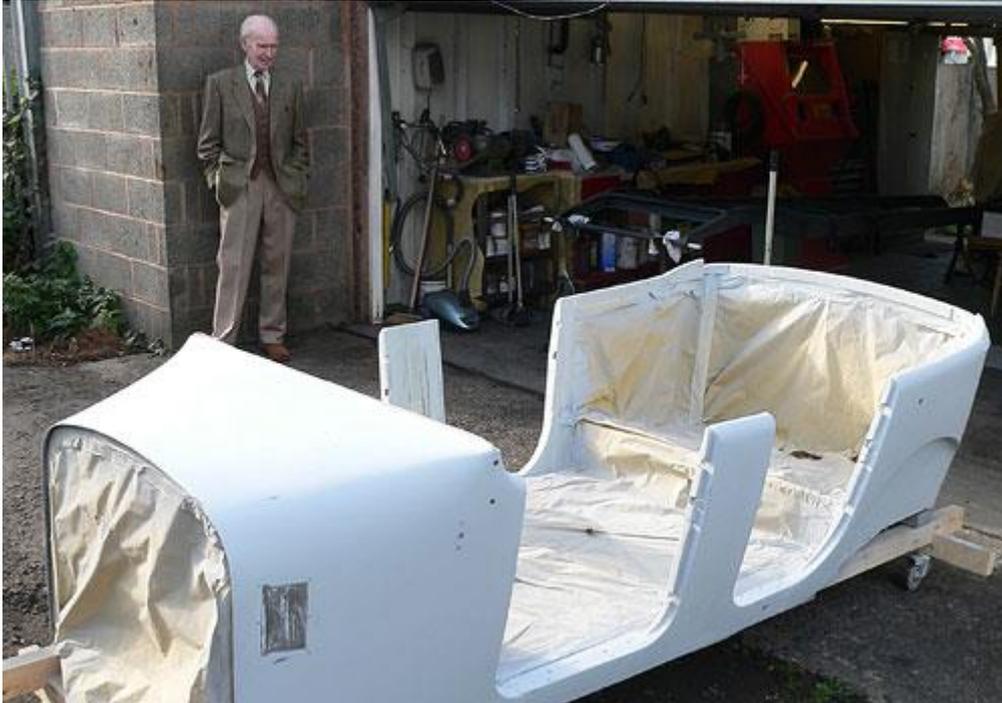
Bill admiring the results of so much of his labour before the blue paint was applied

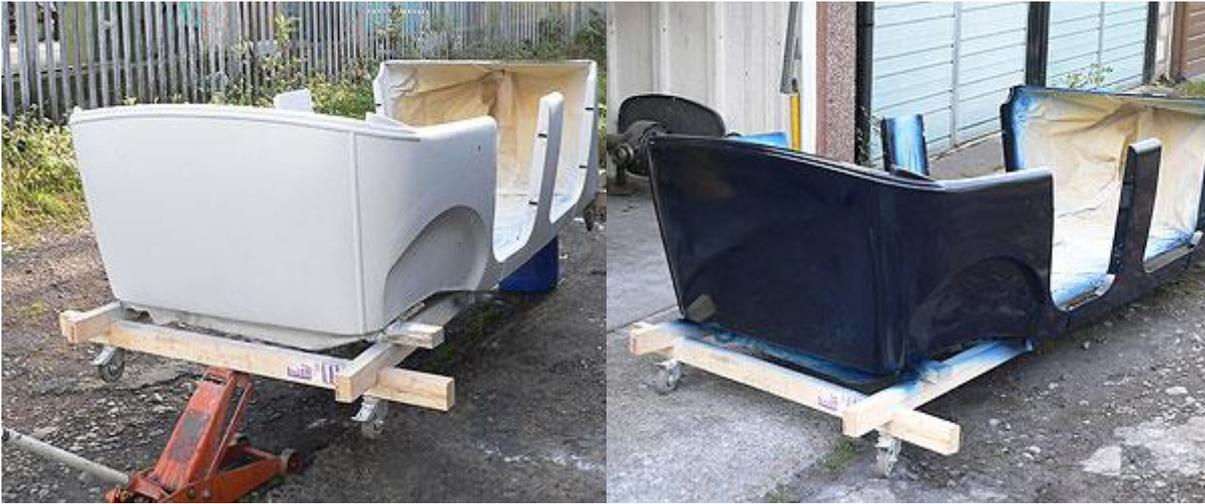
The Chassis has received 10 coats of black surface followed by a thorough flat down, it's such an awkward shape to flat down, and the job took me a week to do! I think the job actually took around 20 hours which would equate to 2 days work for an unhindered chap. I am much hindered so I can only do a few hours here and there, hence it taking a week. With the chassis beautifully flat and smooth I applied 2 coats of high gloss black 2K paint which looked pretty good but wasn't perfect due to the odd run. It is virtually impossible to paint the chassis without runs due to all the angles one has to paint without getting too much paint on any one section. Everyone said I had gone insane when I said I wasn't happy with the job which did look pretty good. It is important to me that everything on Aunty Betty is finished to the best of my ability so I rubbed the whole lot down again removing all the runs and marks with 800 grade wet or dry. This has produced a beautifully flat surface on which I hope to apply a high gloss run free finishing coat. I'm now in the process of masking the chassis up so I may paint it section by section to avoid the dreaded runs. Each section will be painted with most of its surface area horizontal minimizing the risk of runs.

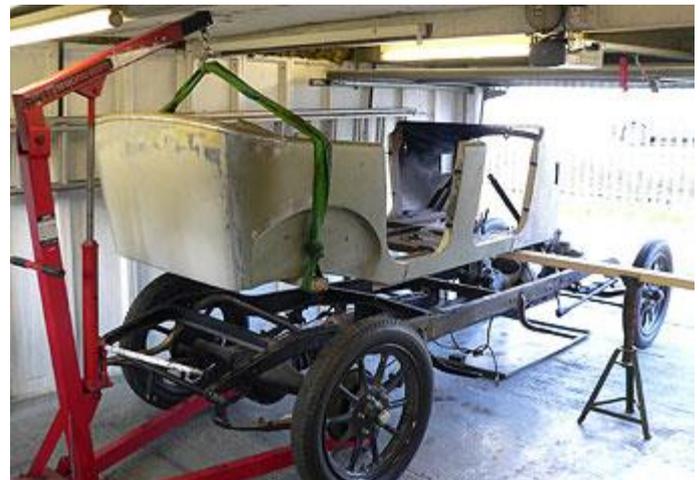
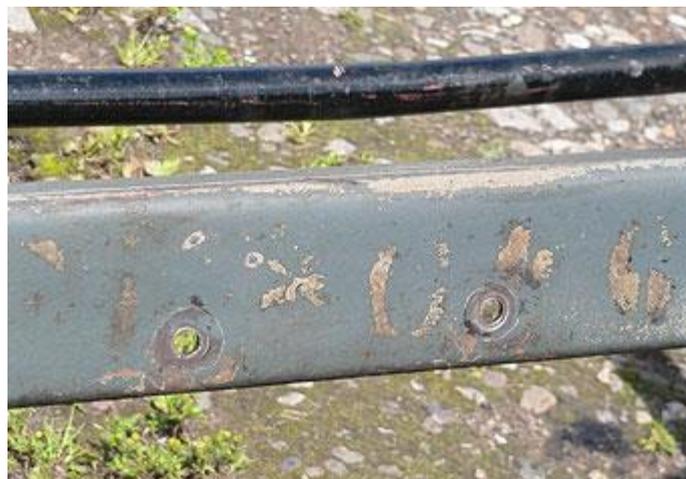
You can imagine my surprise therefore to find my chassis still has 95% of its original paint still present on it and that the paint is not black but Elephant grey. The paint is in incredible condition and there is absolutely no rust of any kind on the chassis due to the whole frame being coated liberally with gas tar at some point in its life. As I'm about to send the chassis in to be jigged I needed to remove the tar and as much paint as possible to make things easier for the chassis specialist. Gas tar sticks like chewing gum to the cat!! It is horrid stuff to try to get off and requires a strong solvent to dissolve it. I've been using cellulose thinners which eventually removes the tar with plenty of scrubbing. As I washed away 85 years of dirt, grime, and 1/8" thick gas tar I revealed shiny grey paint. I soon discovered the whole chassis was grey. Quite amazed at this discovery I rang Tony Smallbone to ask his opinion. Tony said that body colour chassis were popular on Edwardian Austin models, but he had never seen one on any vintage Austin car. He suggested the paint was probably primer. I felt certain that I was right about the paint, I do after all know the difference between primer and gloss enamel. I continued cleaning the chassis and to my further surprise found lettering on the rear cross member. By the time I realised what I was looking at the cellulose had destroyed a significant amount of the lettering which dissolved far quicker than the gas tar! I switched to using white spirit so I might preserve the lettering to enable me to photograph it, measure it and take a tracing of it so I could reproduce it when the chassis is restored. The lettering reads TT 8096. My chassis number is 8096 and it is fitted with a tourer body, so there we have it proof that not every Austin 12 started life with a black chassis!

By the time I realised what I was looking at the cellulose had destroyed a significant amount of the lettering which dissolved far quicker than the gas tar! I switched to using white spirit so I might preserve the lettering to enable me to photograph it, measure it and take a tracing of it so I could reproduce it when the chassis is restored. The lettering reads TT 8096. My chassis number is 8096 and it is fitted with a tourer body, so there we have it proof that not every Austin 12 started life with a black chassis!

It's a silly little detail I know, but to me its archaeology and valuable information. I have now carefully taken a tracing of the lettering and will have a stencil made to reproduce it exactly. The lettering is in stencil font originally designed by Linotype so it can be easily re-produced on a computer.
