# TEE-ONE TOPICS

Technical Library for Rolls-Royce and Bentley Cars - <http://rrtechnical.info/>

## A MYSTERIOUS CLICK

## REPLACING SHOCK DAMPERS ON SY OR SZ CARS

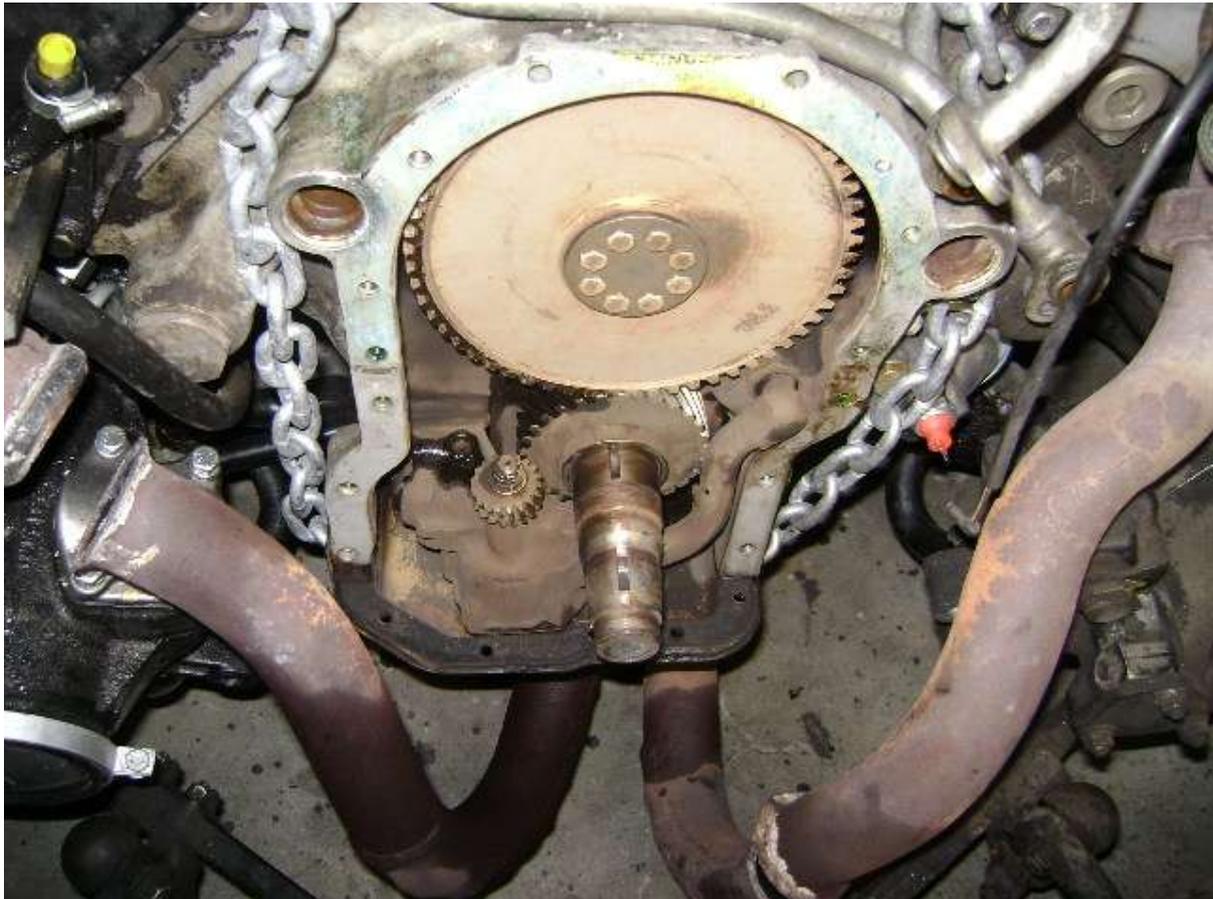
The rather naked front end of a '72 Shadow engine showing the very compact oil pump with its little drive gear, the protruding end of the crankshaft on which is the smaller of the two timing gears which in turn meshes with the larger timing gear which is bolted to the camshaft! The 'S' shaped pipe emerging from under the end of the crankshaft and slotting into the engine block carries the pump output into the galleries of the engine. The chain around the engine is to support it. To remove the lower half of the timing case the removable cross member has to come out which removes the front engine mount!

As you know and as is clearly shown in the first picture the camshaft turns at exactly half the speed of the crankshaft. So if you want to ensure that when the engine is slowly ticking over there is more than adequate oil pressure you either increase the capacity of the pump or speed it up. So if you want to double the speed, drive the pump with the crankshaft! And that is what they did.

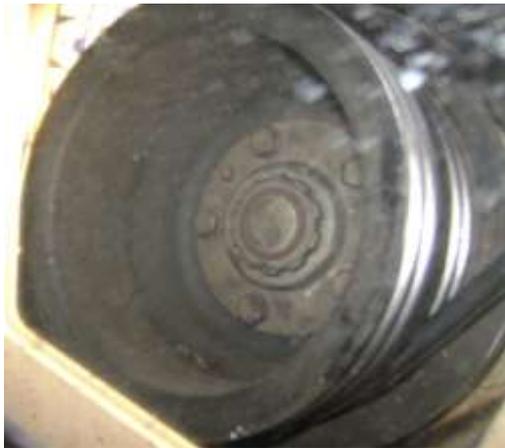
Have you ever wondered what holds that large pulley on down the bottom of the engine? Here is the answer shown in a strategically placed mirror. The lock plate, held on by 5 small bolts, secures the castellated nut. The bolts and the nut having been removed together with the locking plate, the pulley with a bit of wiggling will lift off. This is a fairly critical bit of the engine since the pulley plus the harmonic balancer behind it is a fair weight and if the crankshaft gets up some unsympathetic torsional vibration the nose of the shaft has been known to snap off.

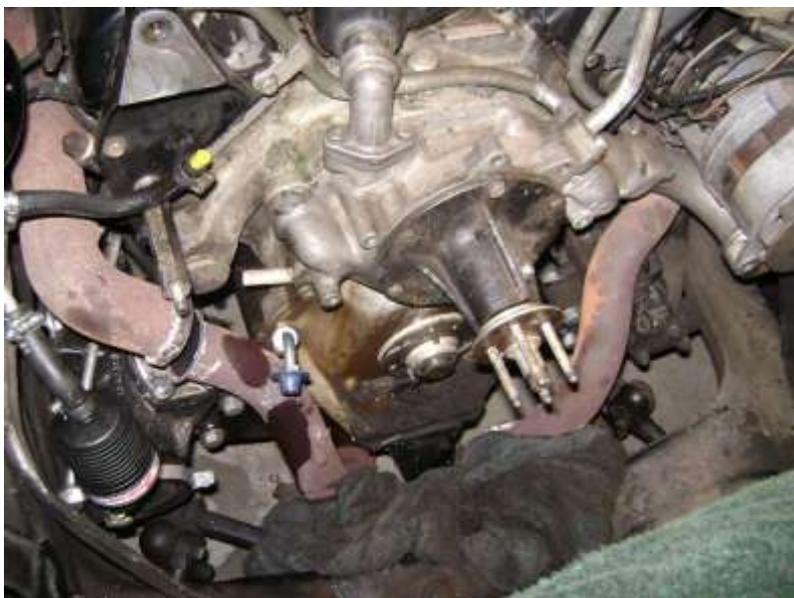
The lower pulley is off, the castellated nut (right handed) holding the adapter on the nose of the crankshaft has been removed as has the upper water pump pulley and the tensioner for the lower belts. Oh and the radiator has been extracted to give plenty of room.

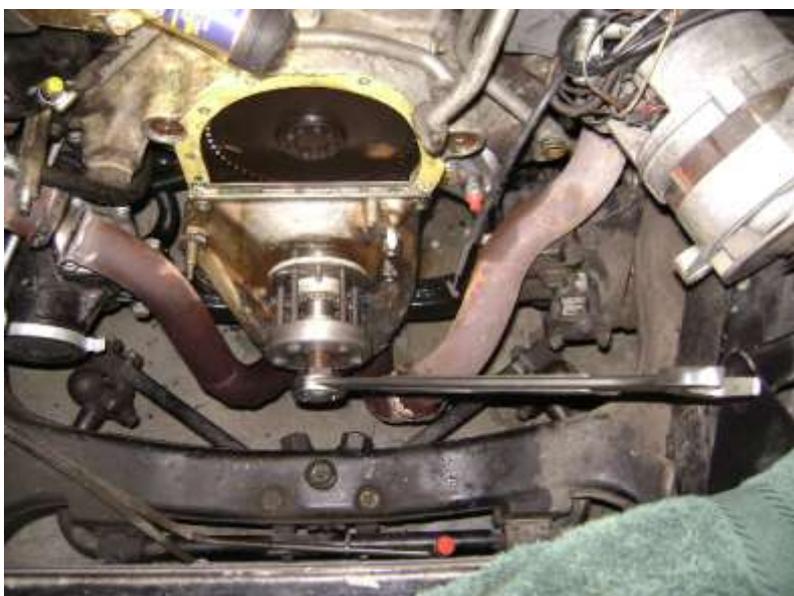
Getting there. The water pump housing which doubles as the top half of the timing gear case has been whipped off and a beautiful puller attached. This is a Factory supplied item worth every penny. One could move the Sydney Opera House across to Milson's Point with this tool!

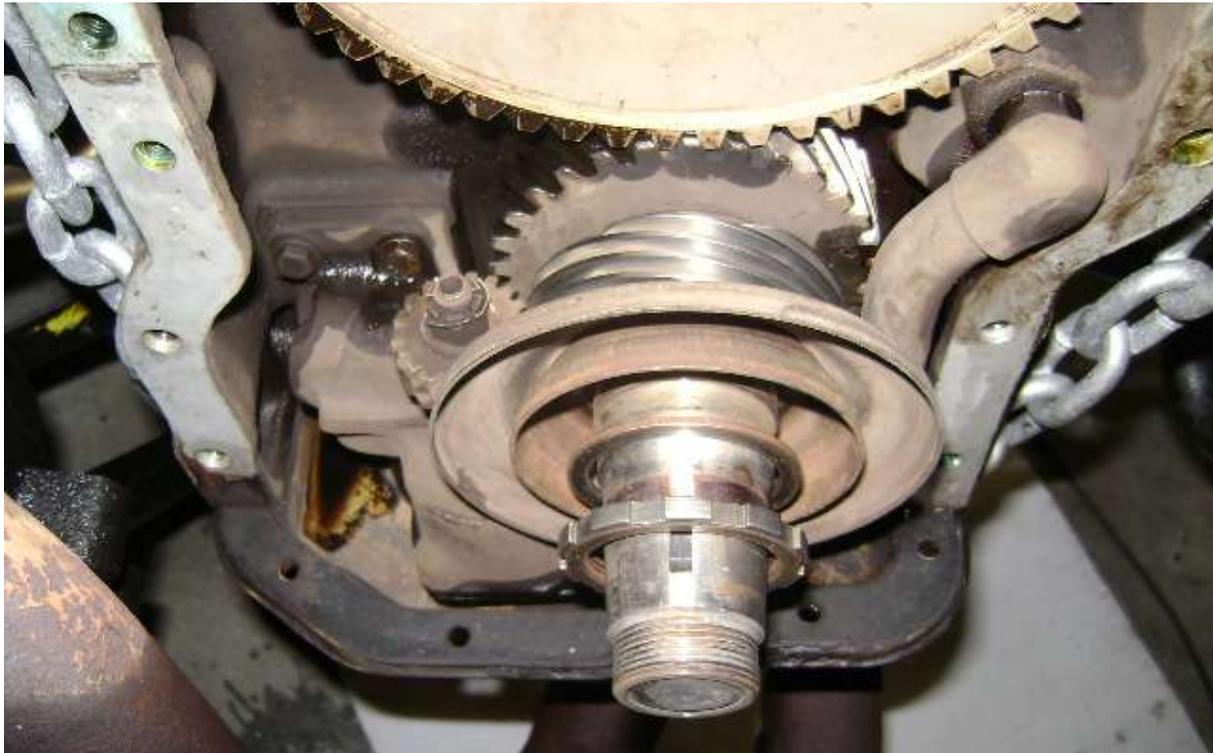
We have arrived! The adapter has been extracted and the Woodruff key pushed out of the groove in the crankshaft which held the former in place. A second castellated nut (left hand thread) seen here idly resting on the nose of the crankshaft – that is the problem child! In this case it was not even finger tight. Behind it is the bearing washer against which the nut is tightened and behind that the two oil flingers. Behind that is the worm drive gear which is the thing that rattles! It also drives the oil pump.

Words are about. The pump bronze gear is driven by a steel gear which is keyed to the crankshaft. To stop the latter gear wandering up and down the nose of the crankshaft it is held in place by a castellated nut complete with a left hand thread which is tightened to some 340 pounds torque! This considerable tension is applied to the driving gear on the crankshaft through a bearing washer and two oil slingers. You will remember in the early cars there was no lip seal on the ends of the crank shaft, simply a reverse helix on the shaft, a very small clearance between the shaft and the hole in the crankcase and all this augmented by flingers to hurl any curious drops of oil that might want to get through to have a look at the world outside.

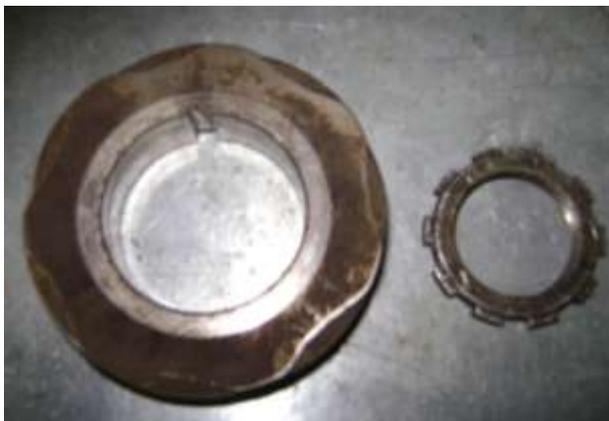
And here is the offending gear exposed with its castellated nut.

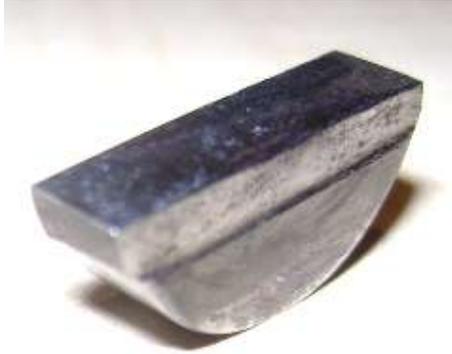
The Woodruff Key was invented in 1888 by a Mr Woodruff of Connecticut USA! As you will see this one with the worm gear whacking back and forth against it had worn a fair bit away! A new key was \$2.00 – a pleasant surprise.

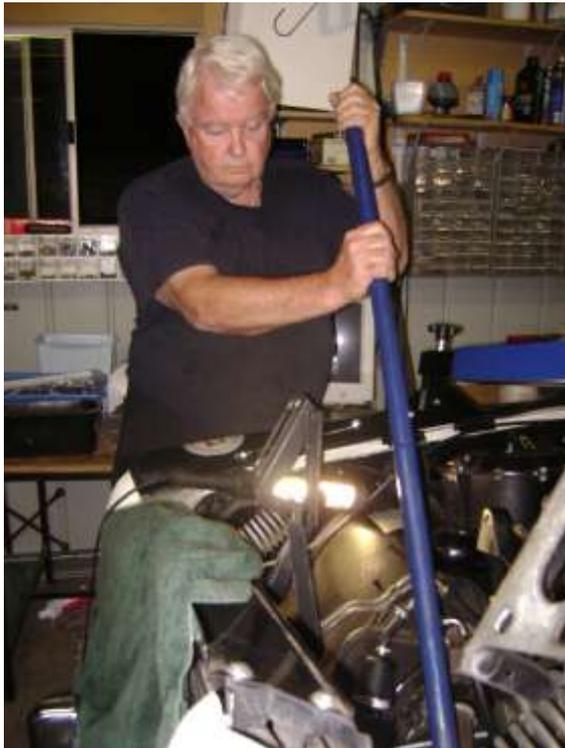
Before you start writing in to join the fan club, the object of the photo was to highlight the problem of achieving 340 ft lbs of torque on a left-handed nut! Obviously I could not apply 340 lbs on the end of a 12" spanner even if I was able to hang on it. So a multiplier was required, one of my trusty jack handles. The second problem was that the tension wrenches that will handle this torques will not do it anticlockwise! One that will is available at some \$1400!

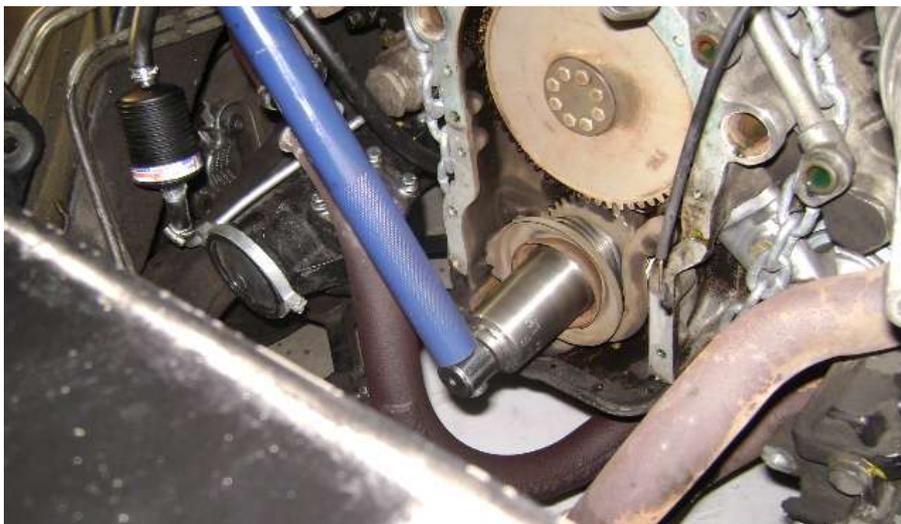
And at the lower end.... The serrated tube spanner again is a Factory bit well worth the money. Some Clubs dare I mention it actually purchase these sort of tools (and reverse acting tension wrenches) and hold them in stock for use by their members.

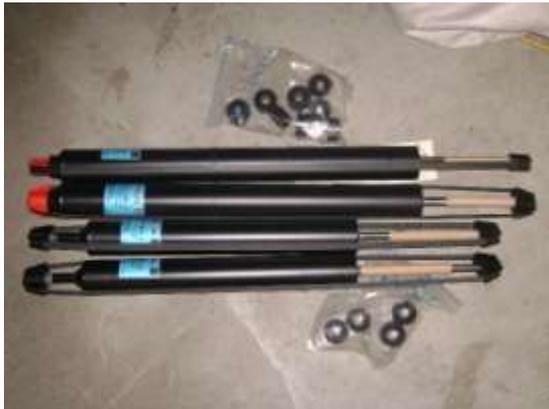
Here are four brand new 'bare' Boge shock absorbers. The mounting rubbers for either end shown here are extra but are propriety items.

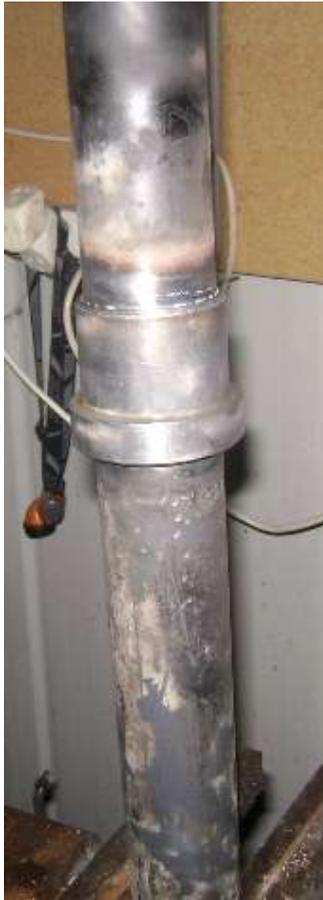
At left is the old shock absorber complete with sleeve. They were truly wedded!

Otherwise assuming you can get to a press you may be able to push the body of the shock absorber out of the sleeve. This is not easy. Because most presses don't have a two foot travel you will need to release the gas from the unit then pump out the oil therein. The gas is removed by inverting the shock absorber and drilling a very small hole in the body. Before doing so wrap a cloth around the unit and drill through it since the pressure of the gas is considerable. Just a case of Gently Bentley! When the gas has exited take the unit to your receptacle for waste oil and slowly pump the oil out. This allows you to push the push rod or plunger right into the body of the shock absorber. With a bit of improvisation the rod can then be pushed further into the body and the ledge of the sleeve supported in the press. When the inner end of the push rod reaches the bottom of the body, continued pressing should move the body downwards and through the sleeve until the latter is released.

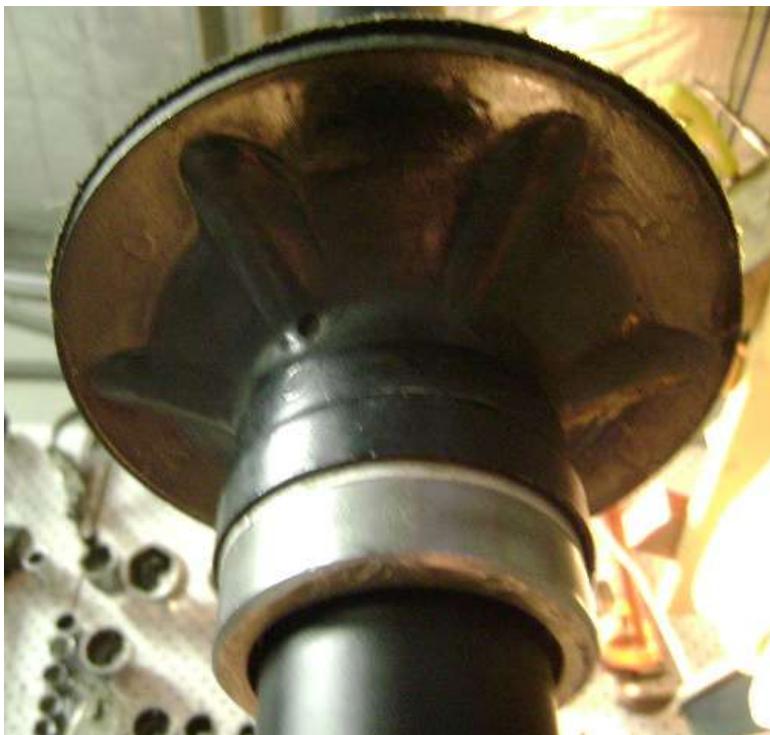
At left is the new shock absorber with the sleeve extracted from the old one you can only see the bottom flange, sitting on top is the spring support every time you rip the wheel off to give the suspension a good hose off! The more alert will notice one of three holes drilled in the spring support which should be kept open with a wire or equivalent these allow any accumulation of moisture to drain away rather than rot the spring support!!!

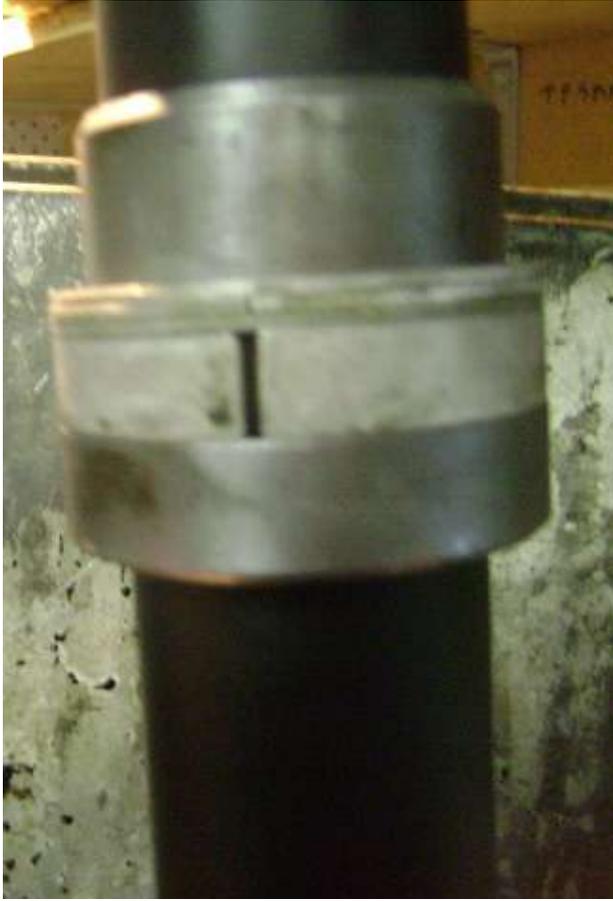
This not terribly clear picture shows the new shock absorber with the recovered sleeve and sitting on the latter's ledge are semi-circular wedges of varying thicknesses to lift the spring support to the correct height so that the car's suspension is at its optimum height!

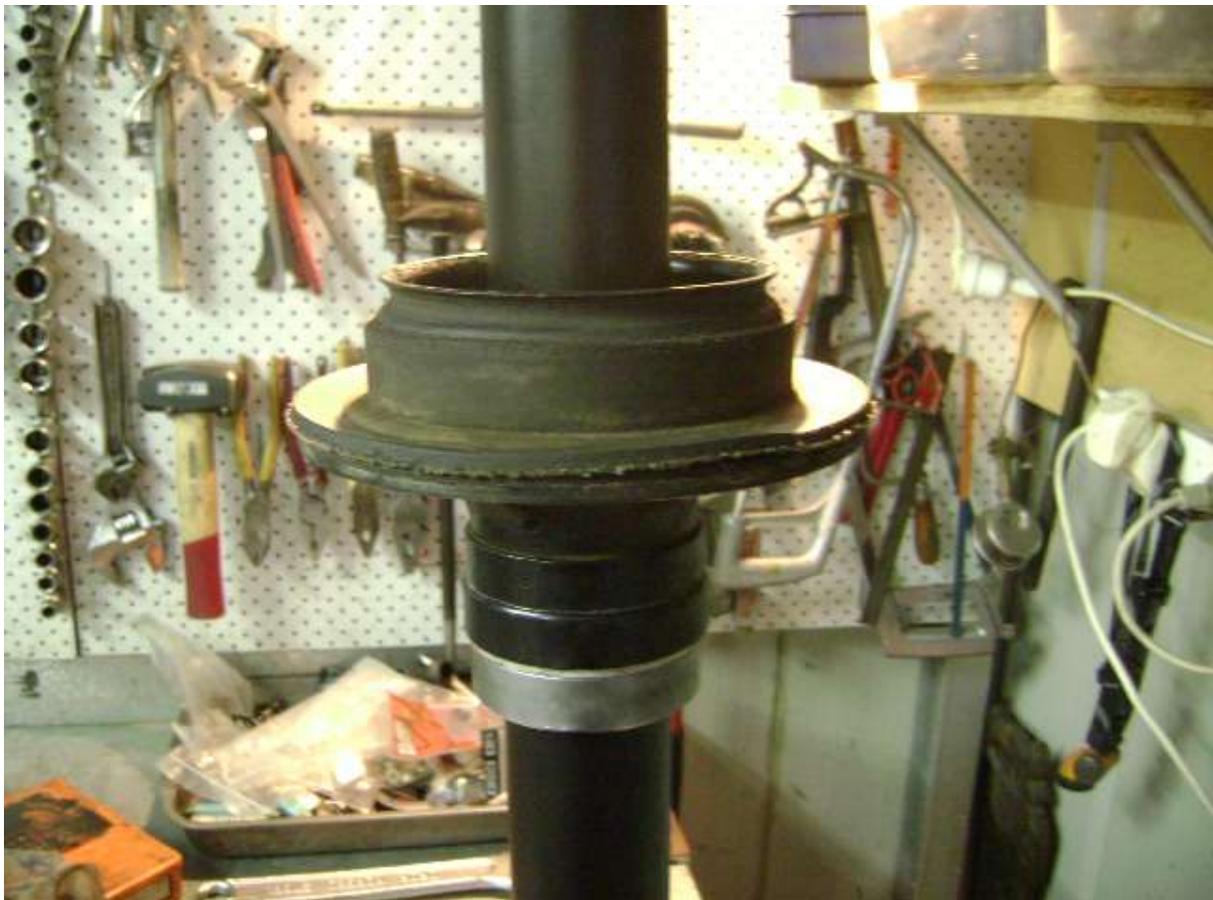
Below is a picture of the spring seat in place. The lower sleeve is covering the height shims or wedges and retaining them at the same time. On top of the seat is the 'top hat' for this model ('72) which insulates the suspension to some extent from road noise. It is made of canvas reinforced rubber which is a bit firm but very wear resistant. If you want to really tart up the system get the newer version of these 'top hats' which come in a comparatively soft rubber and hopefully give better noise insulation and perhaps a better ride!

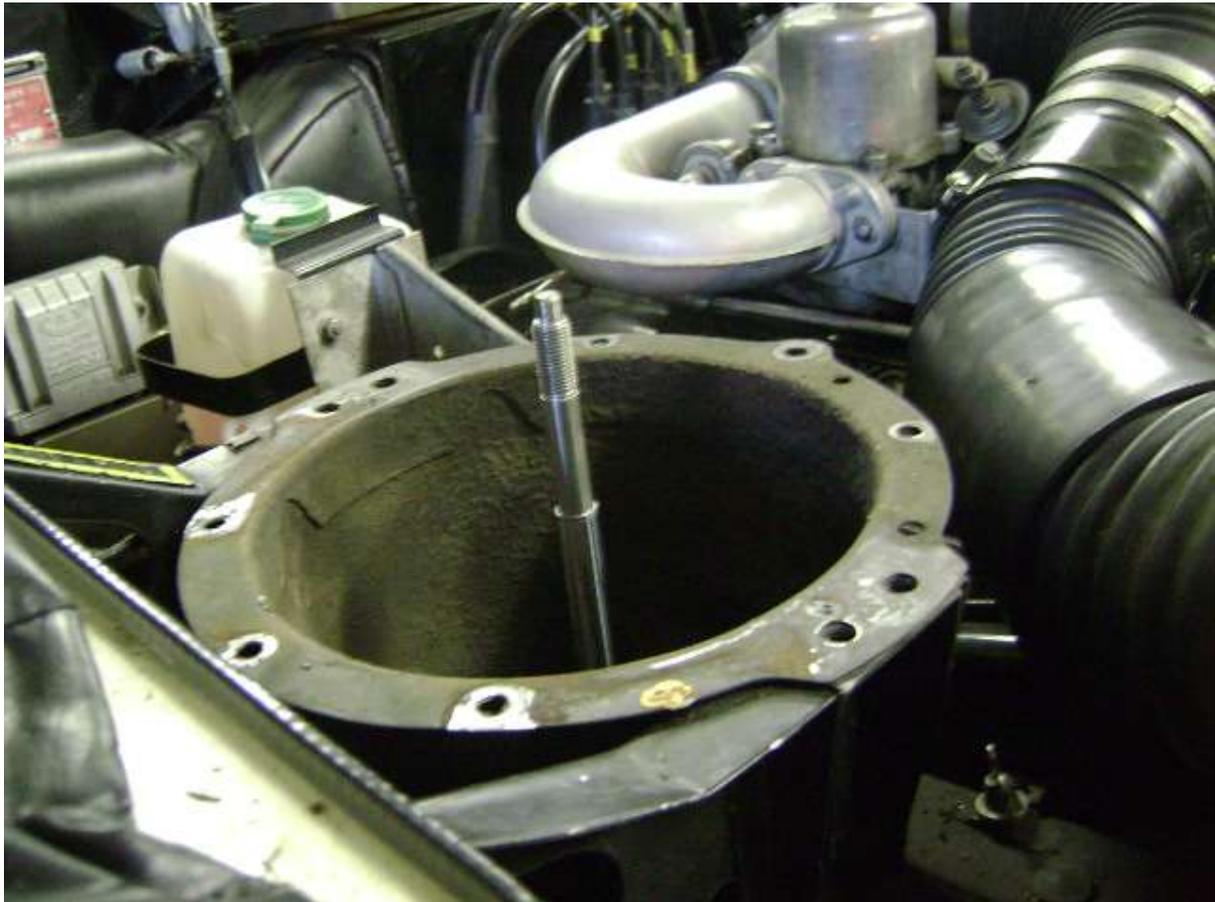
Ah you don't see this too often. Here we have the cover off, the spring out and the shock absorber in! Somewhere in previous issues I have pointed out the refinement used on the latter SZ cars of bolting the top plate down with fibre washers under the steel washers!

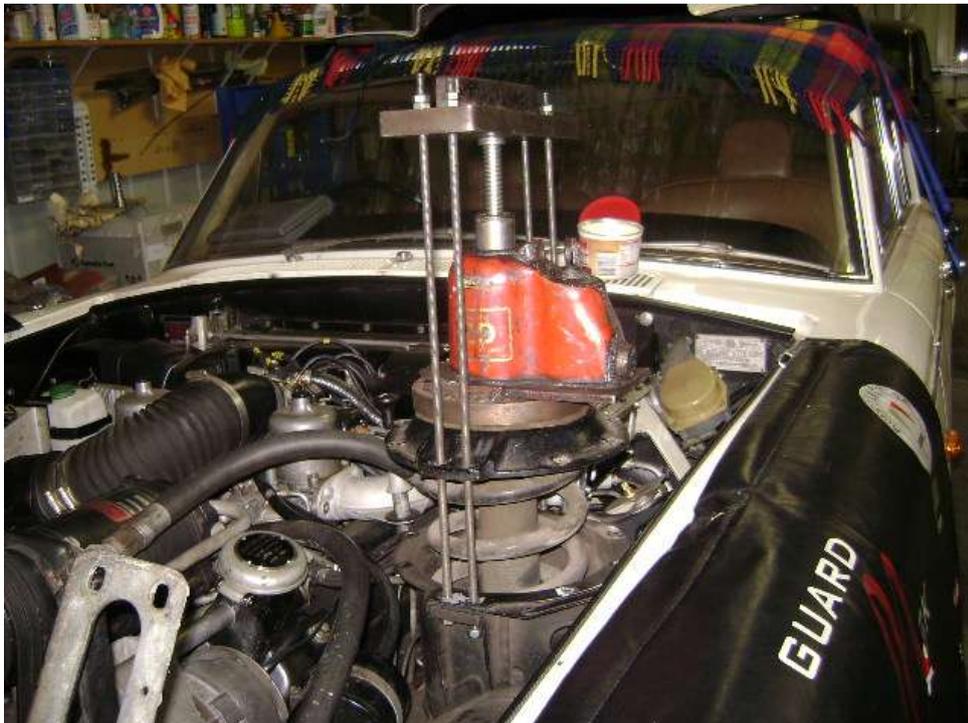
You have seen all this before. For the love of God and in the interests of the car and probably also your head, do not attempt removal of the front springs without careful planning and consideration of equipment. Note the high tensile four rods holding the upper cross piece, the two throw 6 ton jack and the support piece under the jack for starters. The spring top plate is almost like a rolled up magazine when it is under spring pressure!

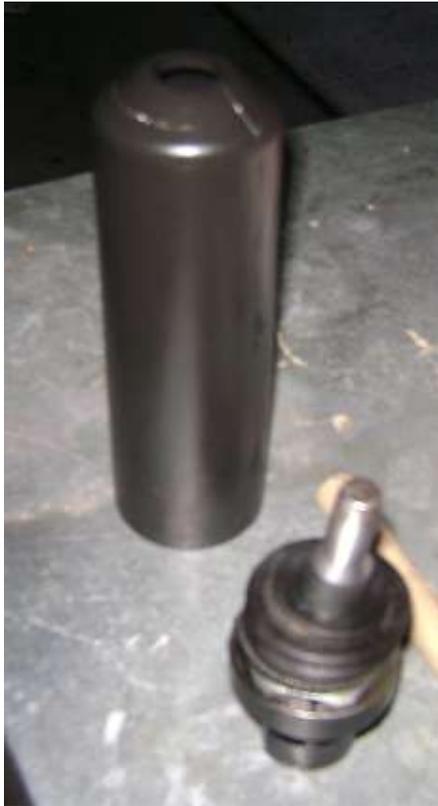
Here is a rubber sleeve 35 years old cleaned and bathed in Armorall and looking like new. The modern version is more efficient but that is a decision you will have to make. The other component not as yet mentioned is the bottom swivel on which the shock absorber sits. This is identical in general design to the lower steering swivel for each wheel. It also happens to be identical to the suspension swivel of an Austin 1800!

When renewing or removing the front shock absorbers these swivels should be unscrewed, cleaned, regreased and tightened down so that the protruding bolt seen here can just be knocked askew with the palm of your hand without incurring the services of a surgeon! This adjustment is achieved by removing shims from within the joint. If they are too loose they will rattle!

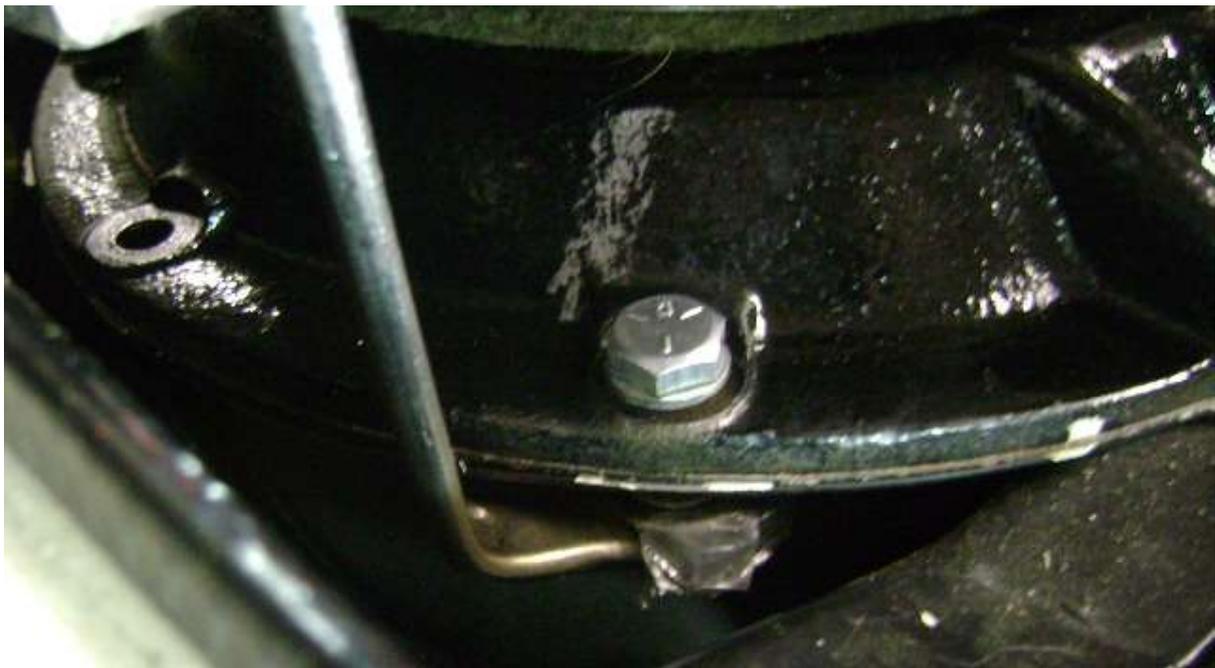
If ET is a mate of yours get him around to help put these 1/4" bolts in to hold down the top plate while the jack is well pumped down to hold it in place. You will drop the washer and nuts at least four times before you get the knack of it. Unless .....

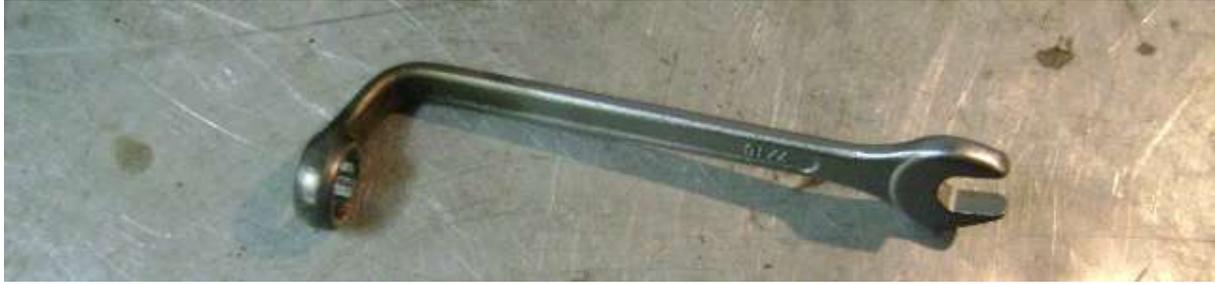
Unless you bend up a spanner like this and .....use it like it is being used in the top picture. The nut is held in place with a little strip of plastic from one of those bubble pop packing sheets. When you have satiated your bubble popping, tear off a bit to adequately cover the 'nut hole' on the spanner and force the nut into it. Carefully place your washers on top and carefully guide it under the lip of the spring pot. Bet Rolls-Royce didn't think of that one.

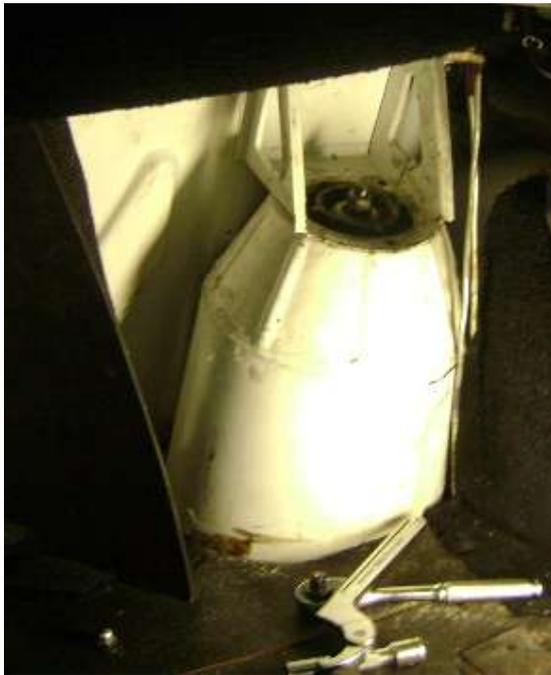
If you are going to replace the rear shocks life can be (maybe) a little easier. The top of the shock is mounted on the rear spring carrier. To get this far however requires removal of the height suspension ram. Removal of this is covered previously.

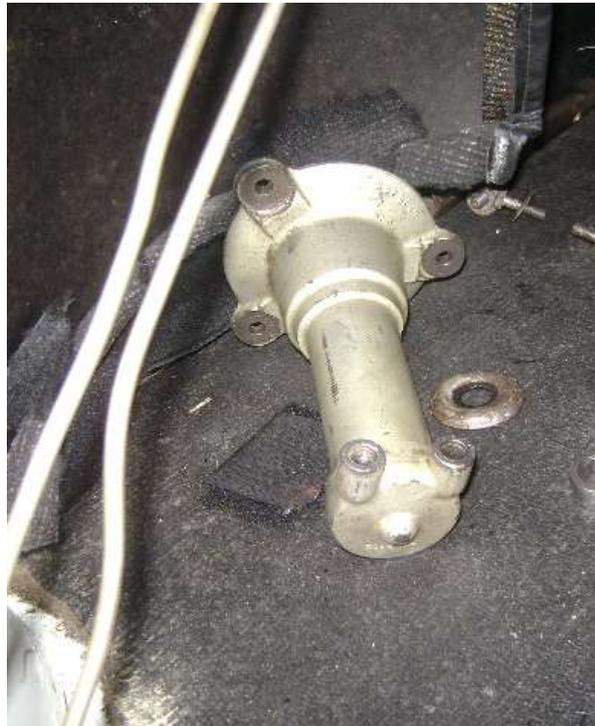
At right is the ram lying on the boor floor having been unbolted and unscrewed. The problem is that often the ram has not been moved since it was installed and as the charming operator who did that did not use any anti-corrosive grease the task, to understate the problem, is difficult. In this case the ram had been out some little time before and all was right in the world!

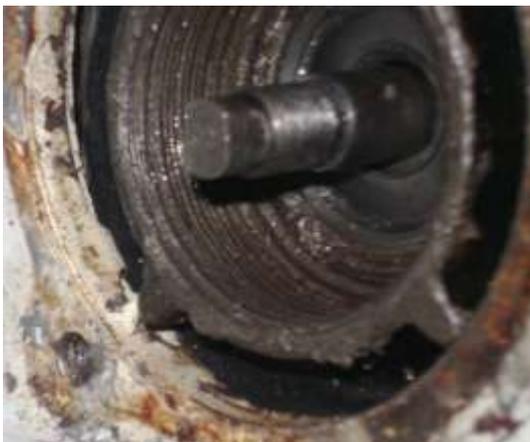
Here is a cockroach's eye view of the top of the spring support with the ram removed and the top nuts, distance piece and rubber mount removed. Note the anti-seize grease from previous installations!

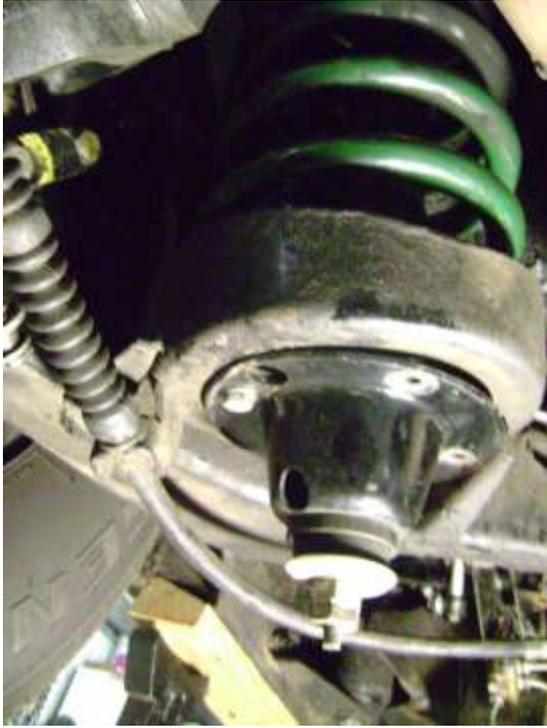
Here is the bottom of the shock absorber – familiar to all. The mount at the bottom is identical to the one at the top but far more accessible. Having threaded the top mount through the hole in the body, the bottom almost gets there but usually needs the prudent use of a small jack to get the cup plate into position.

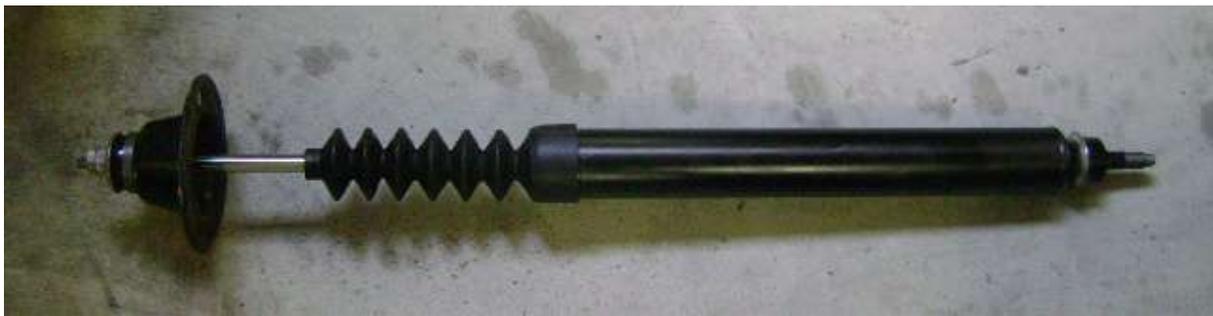
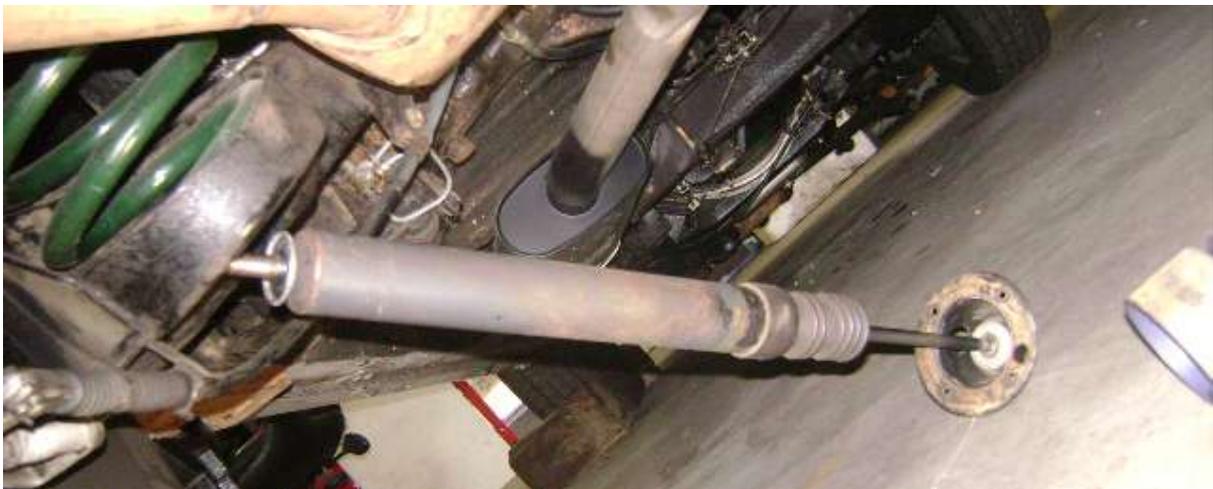
The new unit with new rubbers and the mounting cap installed ready to poke up the centre of the rear spring. Note that Corniches have a very conventional shock absorber mounted external to the spring prompted by the body design. Below is the shock absorber being threaded up the spring. The car of course needs to be fairly high to 'get it in'.

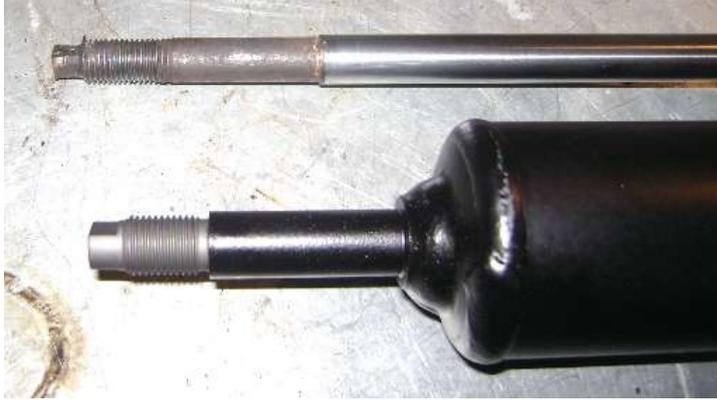
Note that the threaded extension on the top of the rear shock absorber is a size larger than the one on the bottom unlike the front units.
